TECHNICAL SERVICE BULLETIN

Parking Brake Fault Service Now Message In IPC - DTCs C2008, C2007, C1034, U0293 And/Or U0100 - Built On Or Before 15-Mar-2022

22-2143

Ford 2021-2022 Mustang Mach-E	Built on or before 15-Mar-2022
---	--------------------------------

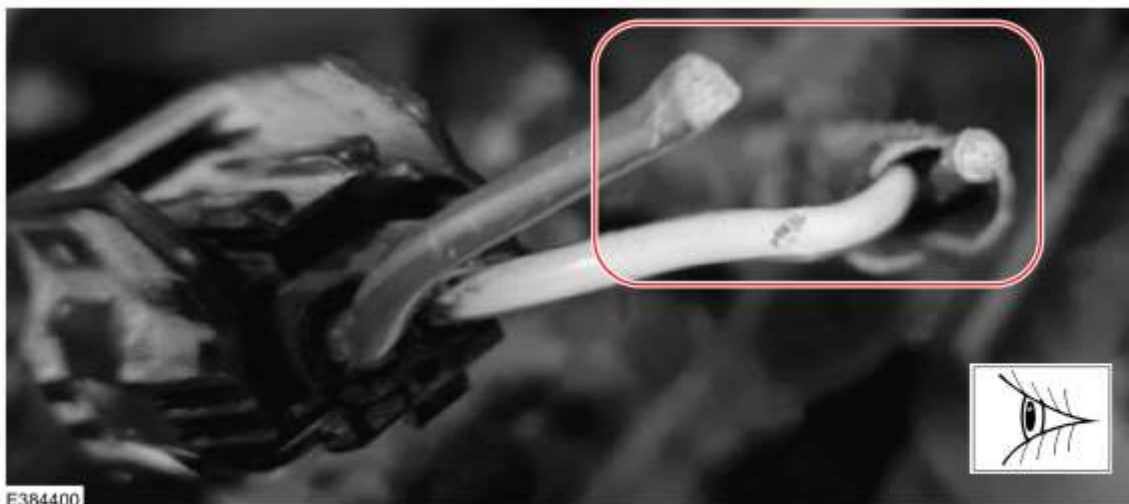
Figure 1

1. Remove both rear tires. Refer to Workshop Manual (WSM), Section 204-04A.
2. Remove the tape and the conduit on the wiring harness to both the left/right rear brake calipers.
3. Inspect the wiring for damage or open circuit. Is there a damaged or open circuit? (Figure 1)
 - (1). Yes - proceed to Step 4.
 - (2). No - proceed to Step 9.
