TECHNICAL SERVICE BULLETIN

Parking Brake Fault Service Now Message In IPC - DTCs C2008, C2007, C1034, U0293 And/Or U0100 - Built On Or Before 15-Mar-2022

22-2143

Ford 2021-2022 Mustang Mach-E	Built on or before 15-Mar-2022
----------------------------------	--------------------------------

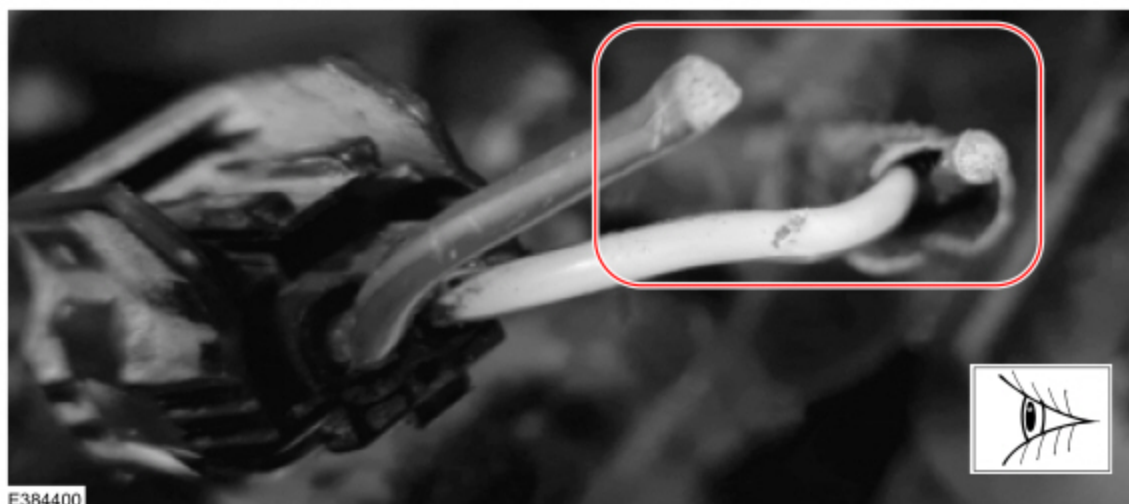
Figure 1

1. Remove both rear tires. Refer to Workshop Manual (WSM), Section 204-04A.
2. Remove the tape and the conduit on the wiring harness to both the left/right rear brake calipers.
3. Inspect the wiring for damage or open circuit. Is there a damaged or open circuit? (Figure 1)
 - (1). Yes - proceed to Step 4.
 - (2). No - proceed to Step 9.
