GENERAL SERVICE BULLETIN

Adaptive Cruise, Pre-Collision And Collision Avoidance System Functionality Diagnostics

23-703102 March
2023

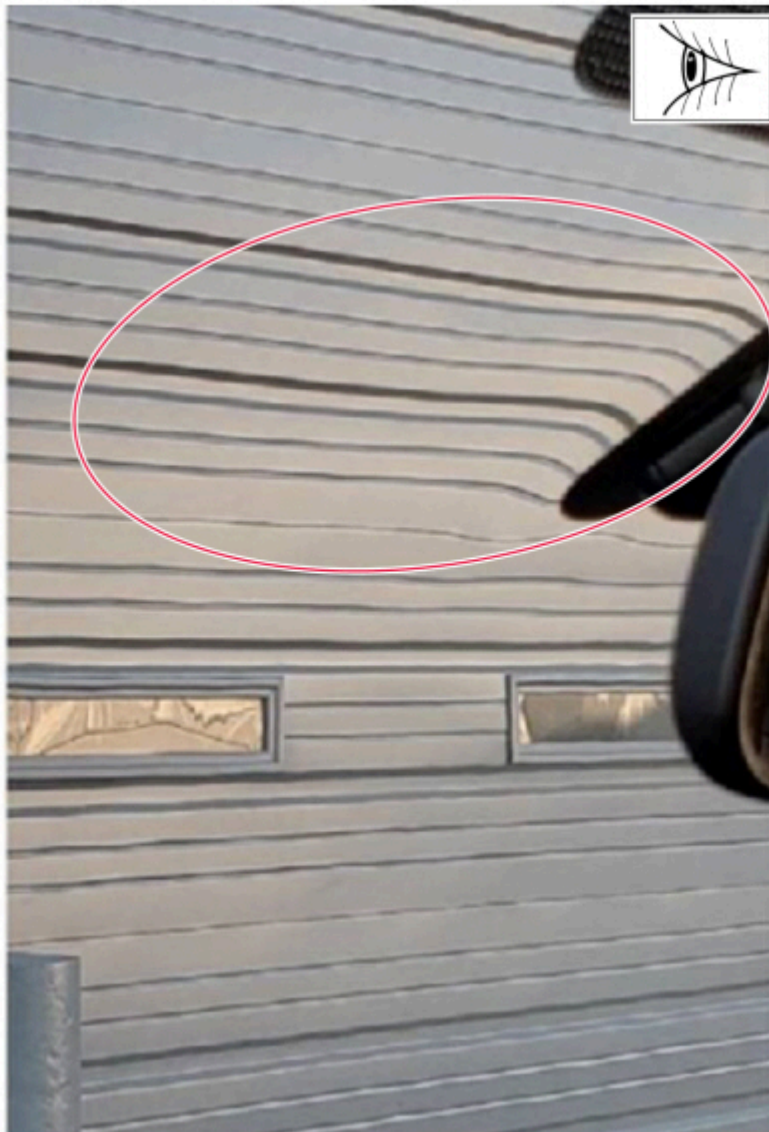
Figure 3

- (1). If this concern began after a recent windshield replacement, inspect the replacement windshield for imperfections and correct installation
- (2). Aftermarket windshield installed
 - Carlite replacement windshield recommended
- (3). Windshield clean of moisture, snow, ice, frost, and dust/dirt
- (4). IPMA lens clean
- (5). Aftermarket tinting or windshield banners/stickers
- (6). Glass distortion can distort the camera's view and prevent camera alignment and functionality (Figure 3)

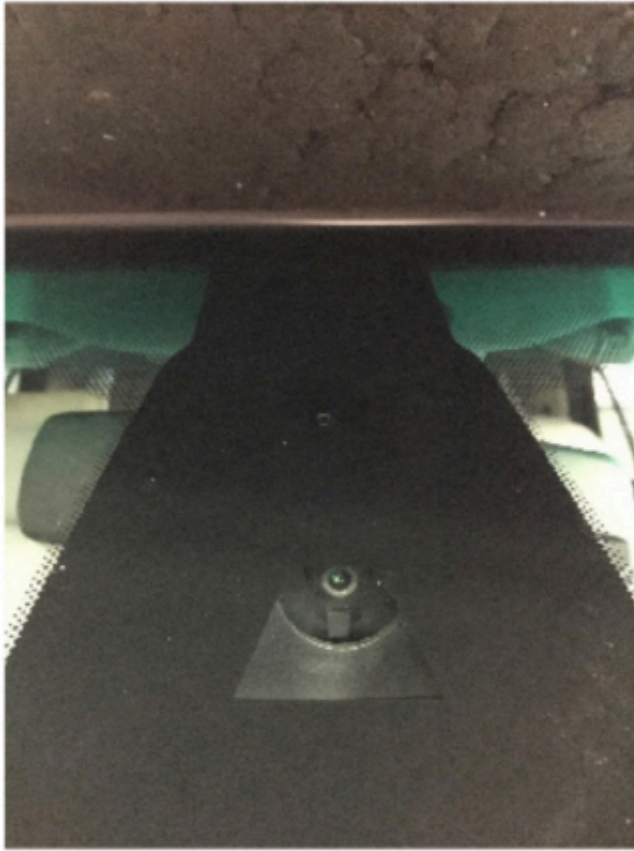
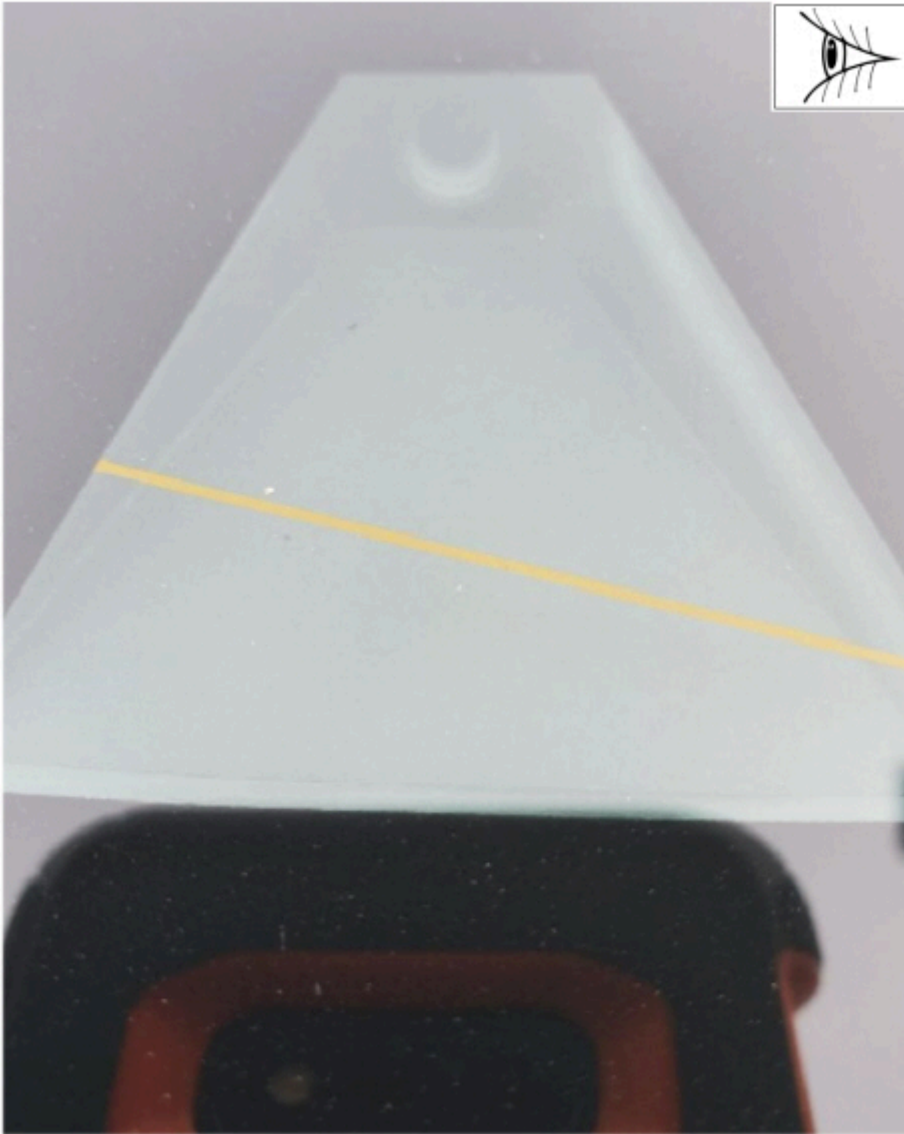
- (7). IPMA mounting and/or bracket off-center, not clocked properly or not secured to windshield (Figures 4-5)

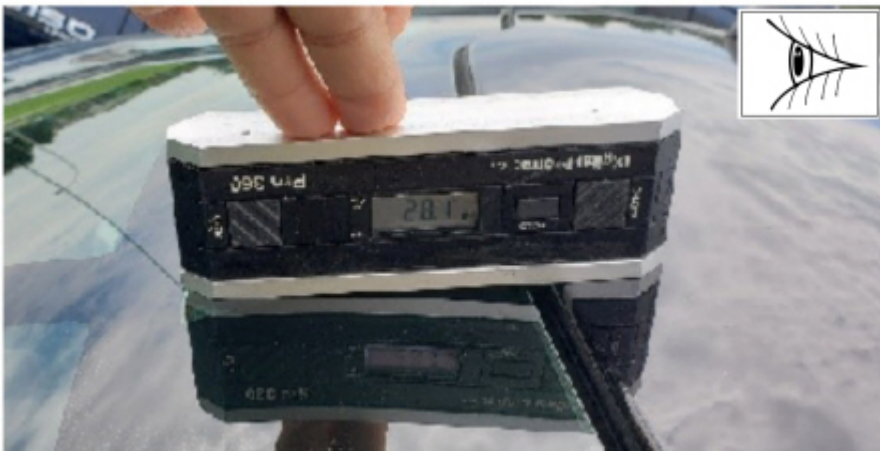
(8). Windshield not installed correctly. Figure 6 shows a windshield that is recessed near the vehicle's roof, causing the camera to be pitched upward.

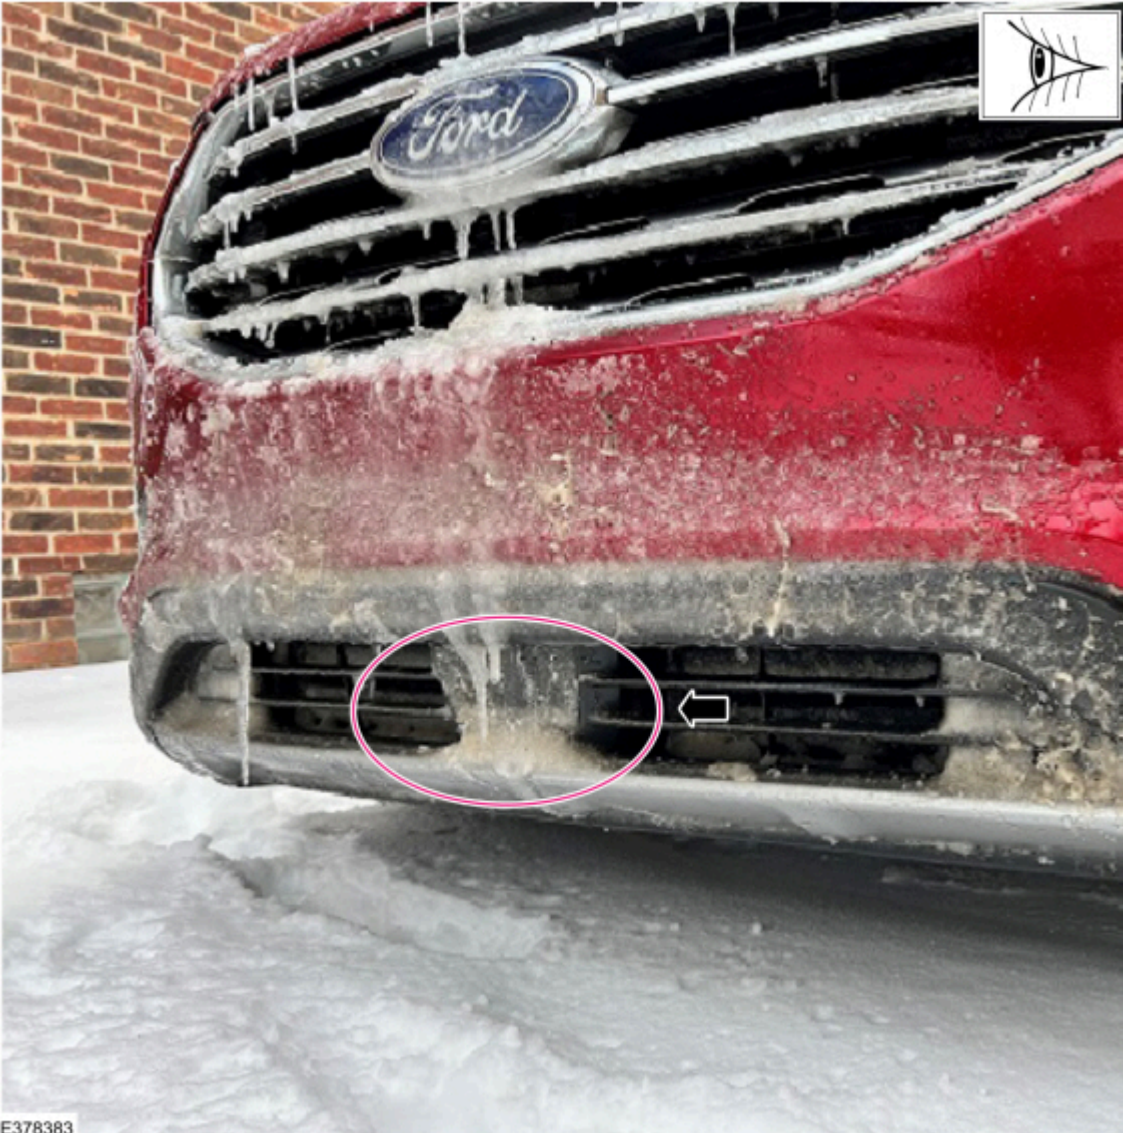
Figure 7

1. DTCs present in CCM or other modules
 - Repair all DTCs prior to diagnosing or attempting CCM alignment
2. Module or circuit concerns (usually DTCs would be present)
3. CCM radar blocked - may result in CCM DTC C1A67:97
 - Inspect the front bumper or CCM location for snow, ice, dust/dirt (Figure 7)

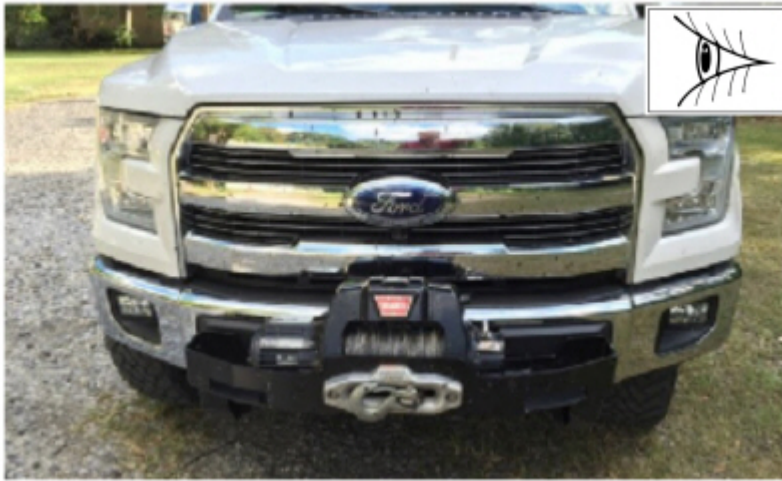
Figure 8

- (1). Incorrect front license plate/bracket mounting
- (2). Aftermarket or incorrect bumper or grille
- (3). Brush guard installed
- (4). Snow plow or snow plow mounting hardware installed
- (5). Other aftermarket accessories installed on front of vehicle (Figure 8)

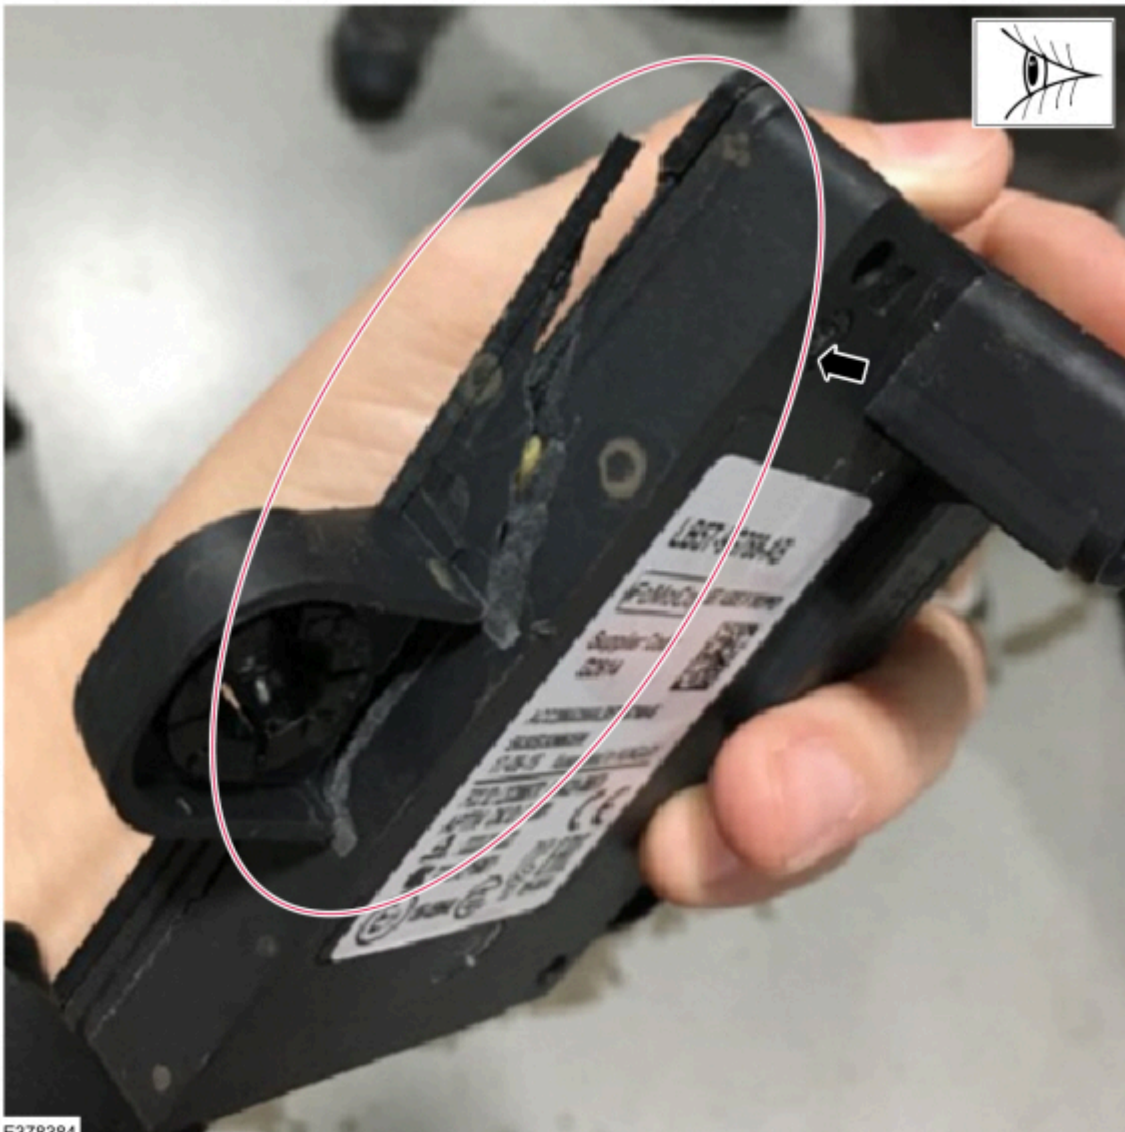
(6). CCM mounting hardware bent or damaged or improper CCM mounting (Figure 9)

NOTE: Improper CCM mounting may also result in DTCs B142E:78 or B1432:78 in the CCM
Figure 9

4. Using the FDRS tool, check the parameter identification (PID) for ALGN_OFF -CCM. A value greater than +/-3 degrees indicates a mounting issue with the CCM, not necessarily a defective module. Check for CCM or mounting

surface damage. If found repair damage as necessary. If no damage found, perform the CCM alignment procedure per WSM Section 419-03, Cruise Control Radar Alignment.
