# GENERAL SERVICE BULLETIN

## Adaptive Cruise, Pre-Collision And Collision Avoidance System Functionality Diagnostics

**23-7031**02 March  
2023

### Summary

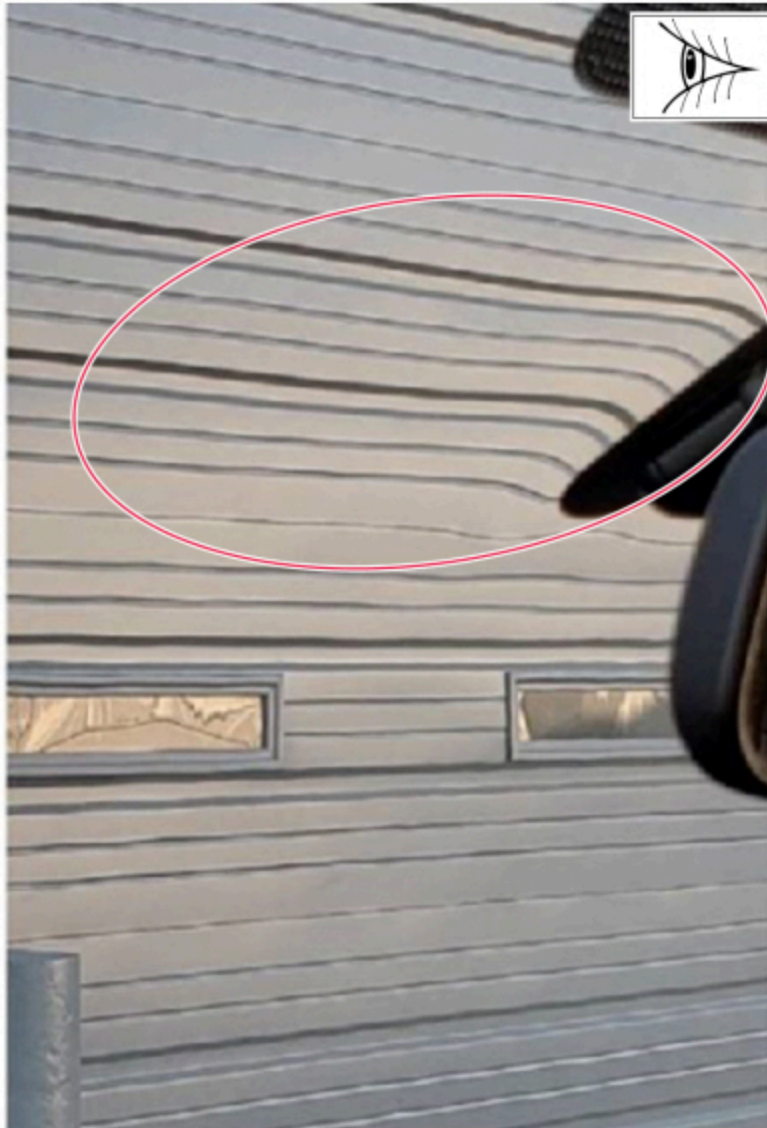
Figure 3

- (1). If this concern began after a recent windshield replacement, inspect the replacement windshield for imperfections and correct installation
- (2). Aftermarket windshield installed
  - Carlite replacement windshield recommended
- (3). Windshield clean of moisture, snow, ice, frost, and dust/dirt
- (4). IPMA lens clean
- (5). Aftermarket tinting or windshield banners/stickers
- (6). Glass distortion can distort the camera's view and prevent camera alignment and functionality (Figure 3)

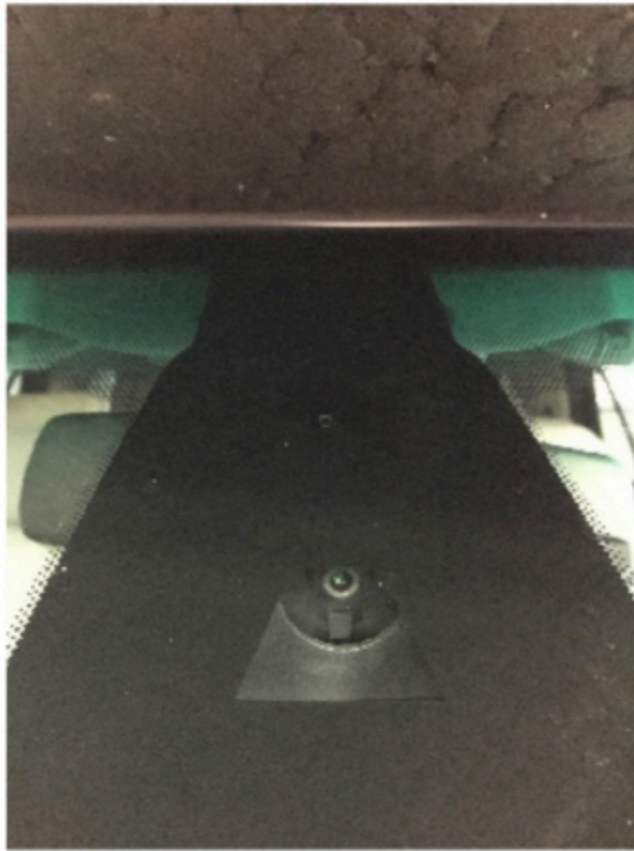
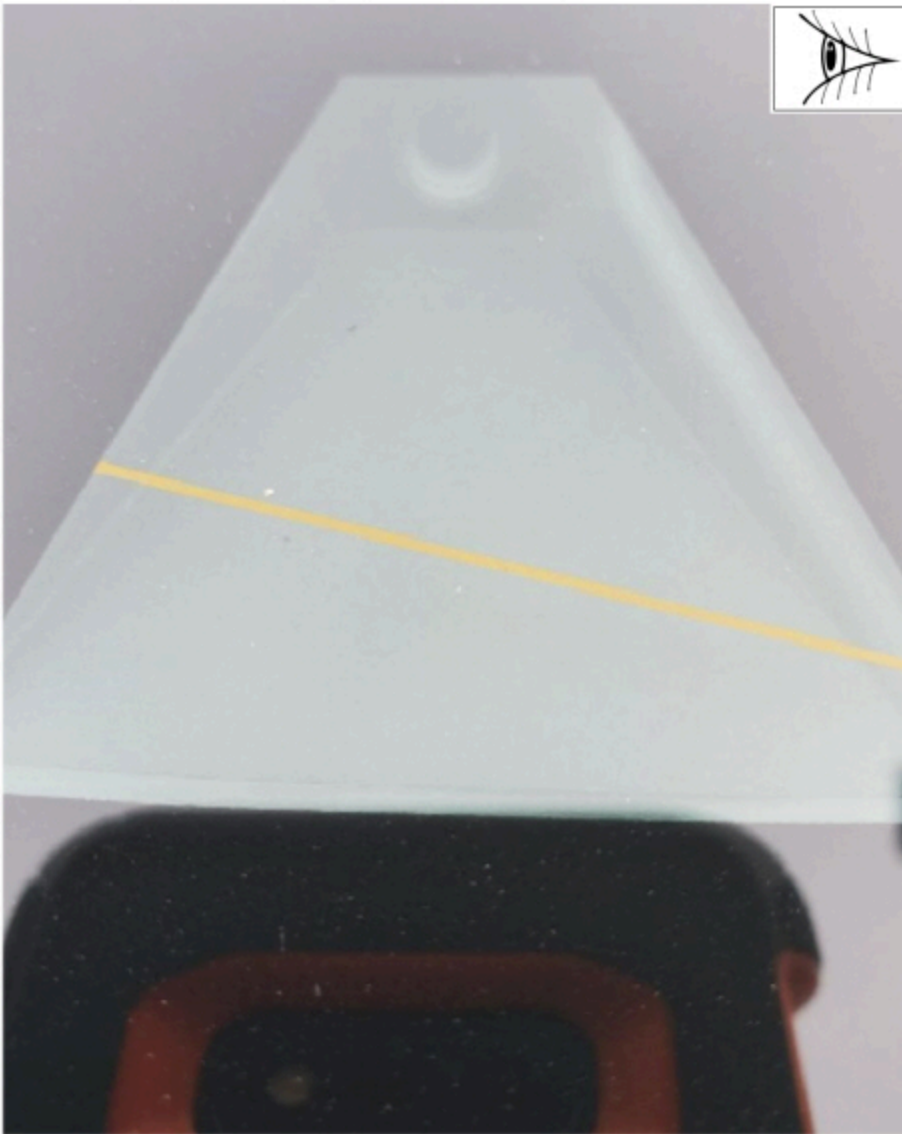
- (7). IPMA mounting and/or bracket off-center, not clocked properly or not secured to windshield (Figures 4-5)

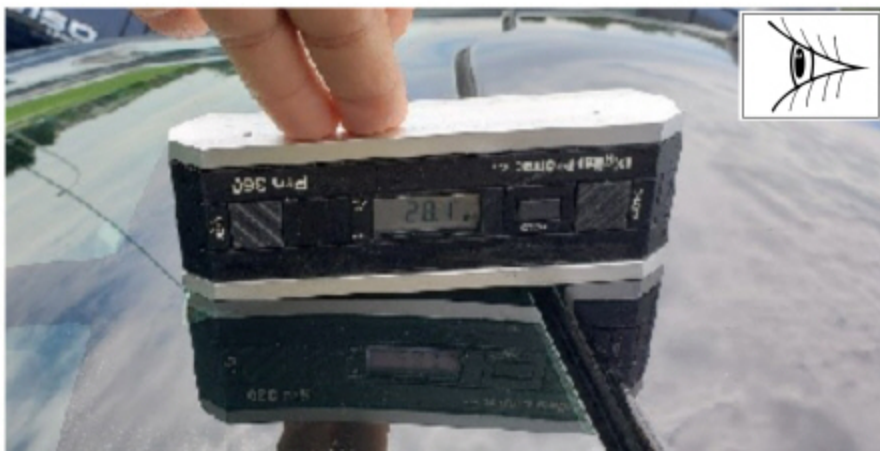
(8). Windshield not installed correctly. Figure 6 shows a windshield that is recessed near the vehicle's roof, causing the camera to be pitched upward.

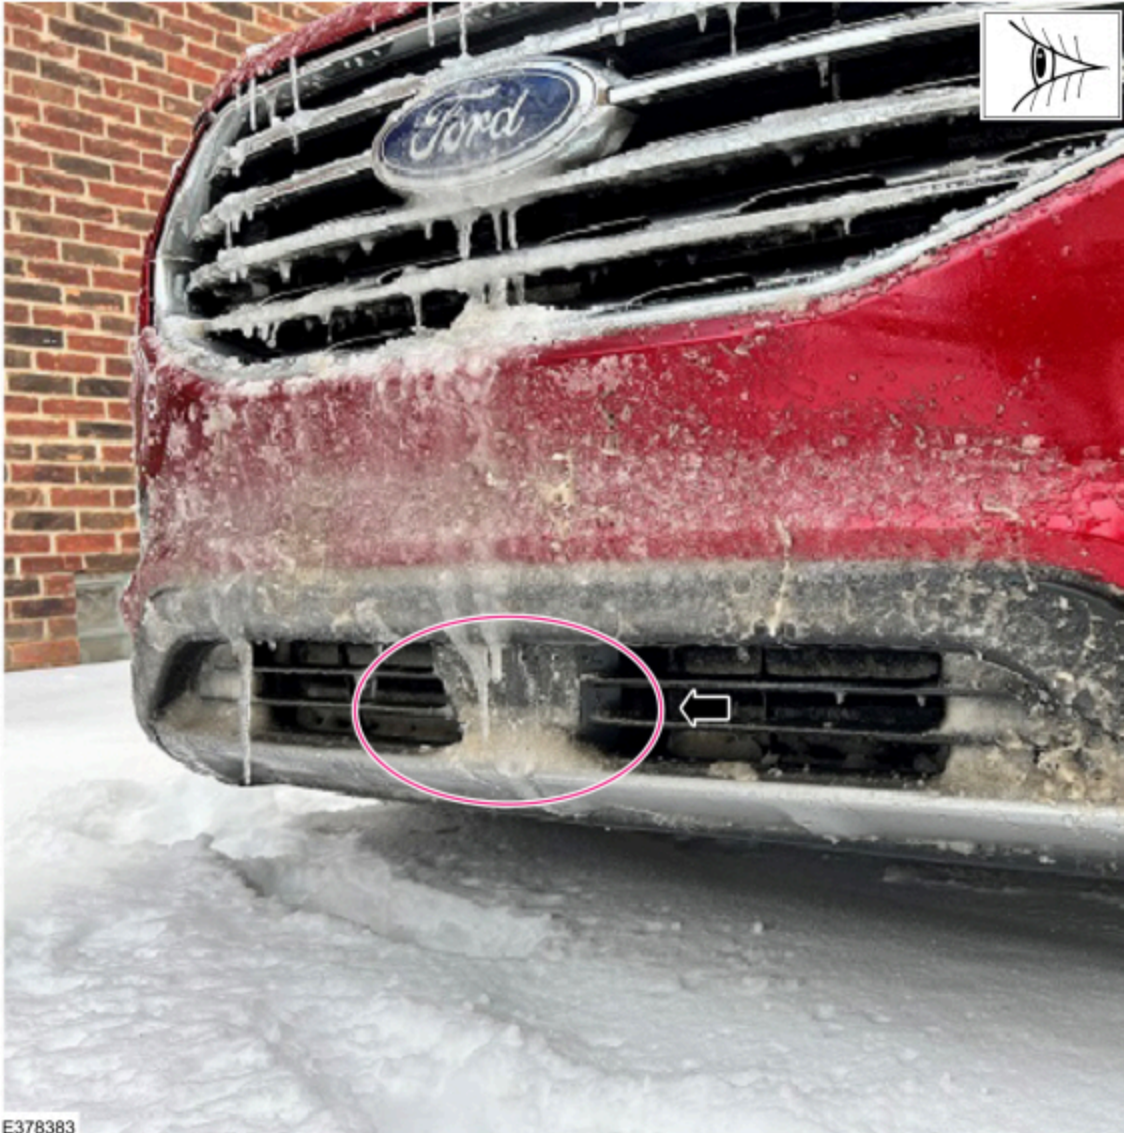
Figure 7

1. DTCs present in CCM or other modules
  - Repair all DTCs prior to diagnosing or attempting CCM alignment
2. Module or circuit concerns (usually DTCs would be present)
3. CCM radar blocked - may result in CCM DTC C1A67:97
  - Inspect the front bumper or CCM location for snow, ice, dust/dirt (Figure 7)

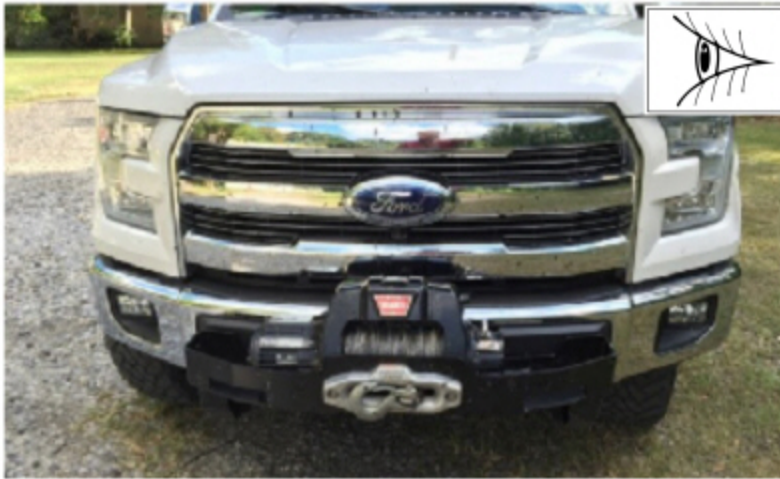
Figure 8

- (1). Incorrect front license plate/bracket mounting
- (2). Aftermarket or incorrect bumper or grille
- (3). Brush guard installed
- (4). Snow plow or snow plow mounting hardware installed
- (5). Other aftermarket accessories installed on front of vehicle (Figure 8)

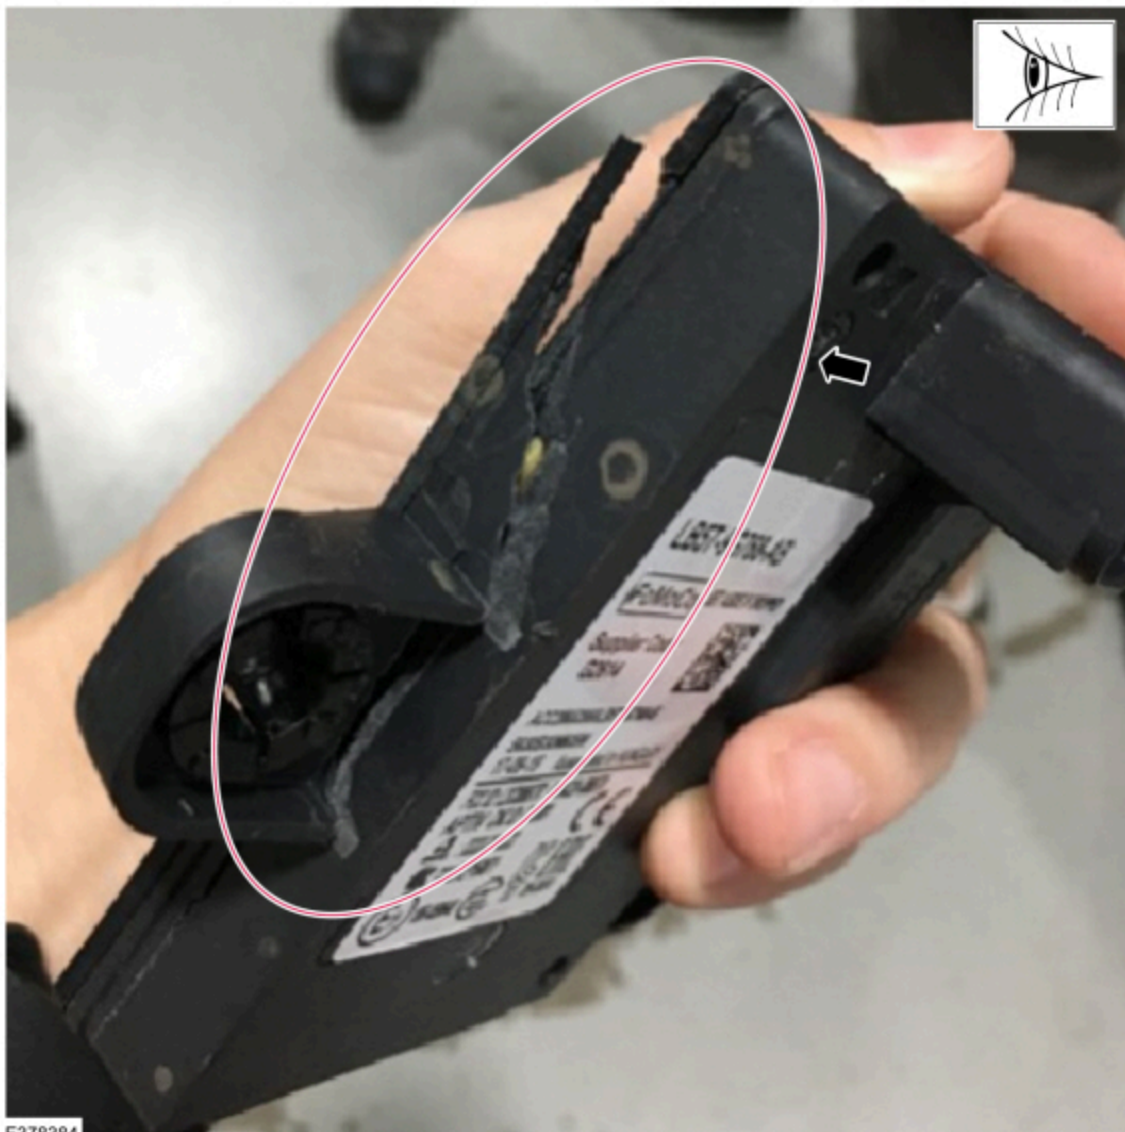
(6). CCM mounting hardware bent or damaged or improper CCM mounting (Figure 9)

**NOTE: Improper CCM mounting may also result in DTCs B142E:78 or B1432:78 in the CCM**  
Figure 9
