CERTAIN 2025 MODEL YEAR MACH-E VEHICLES — WIRE HARNESS INSPECTION

SERVICE PROCEDURE

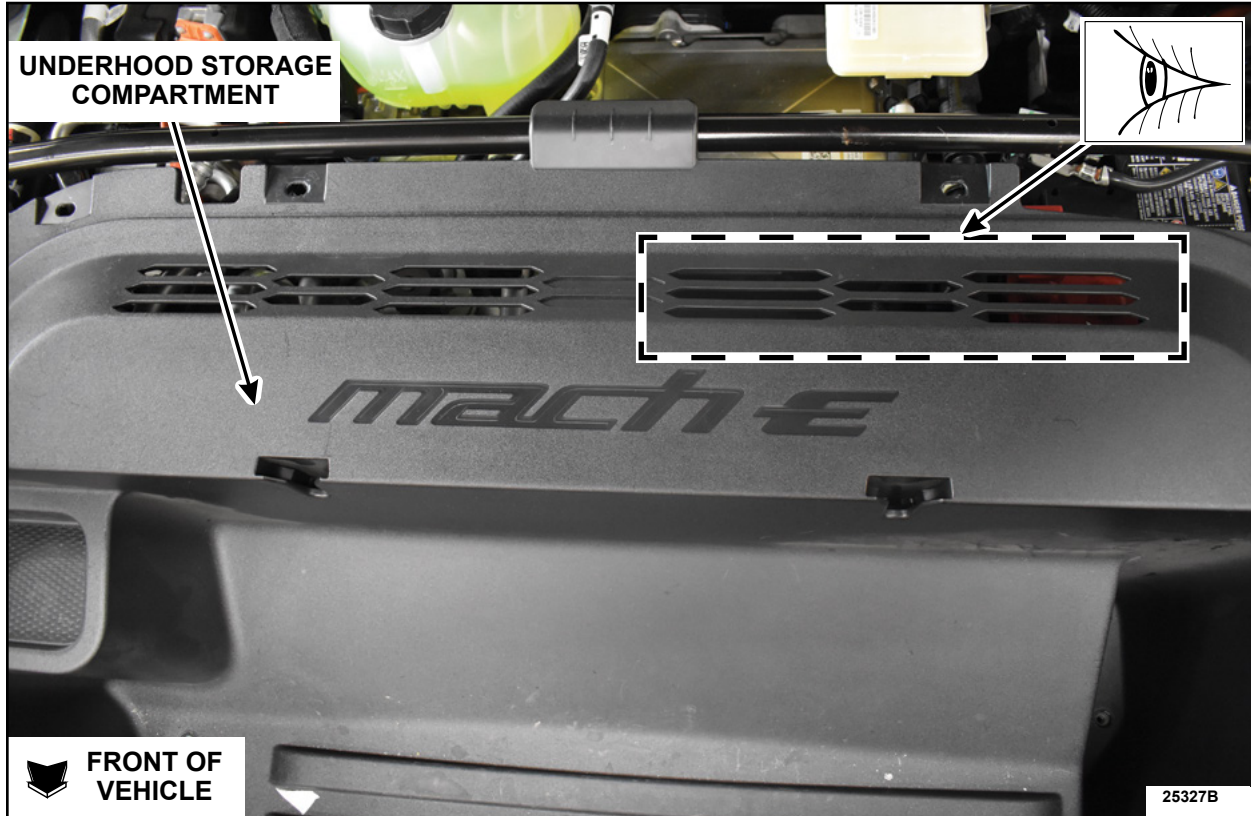
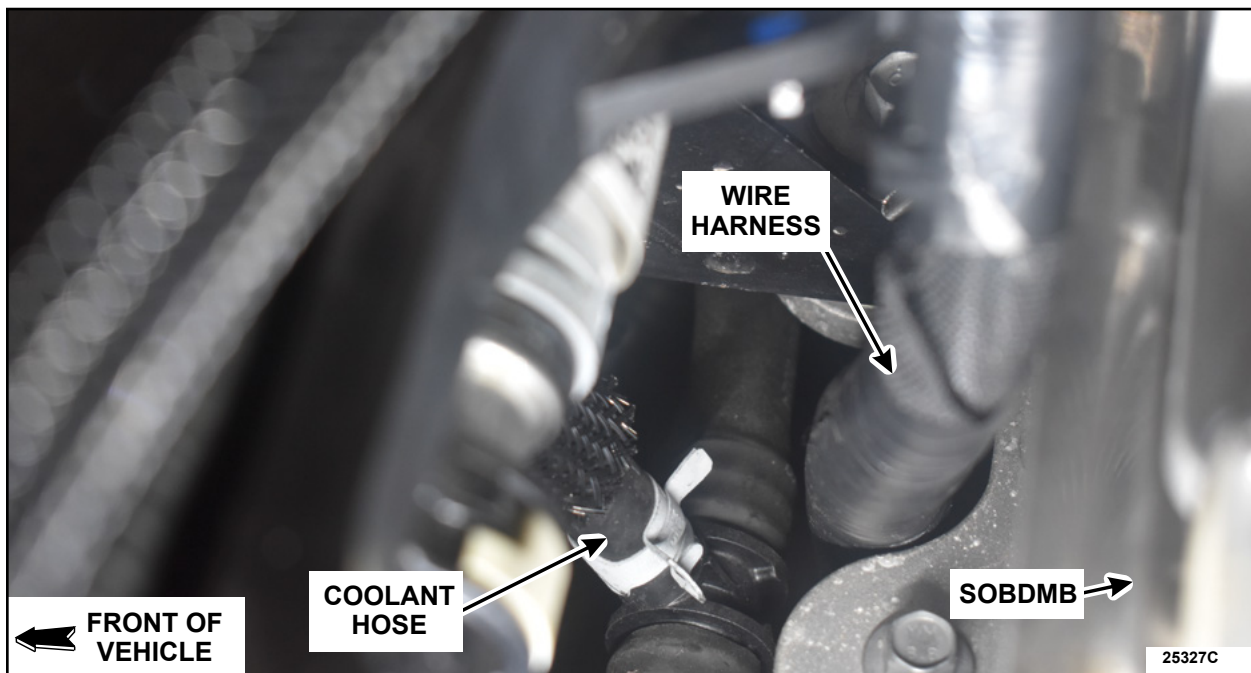
FIGURE 2

- Looking through the vents on the Left Hand (LH) side of the underhood storage compartment, locate and inspect the coolant hose and wiring harness in front of the Secondary On-Board Diagnostic Module B (SOBDMB). See Figures 2 and 3.

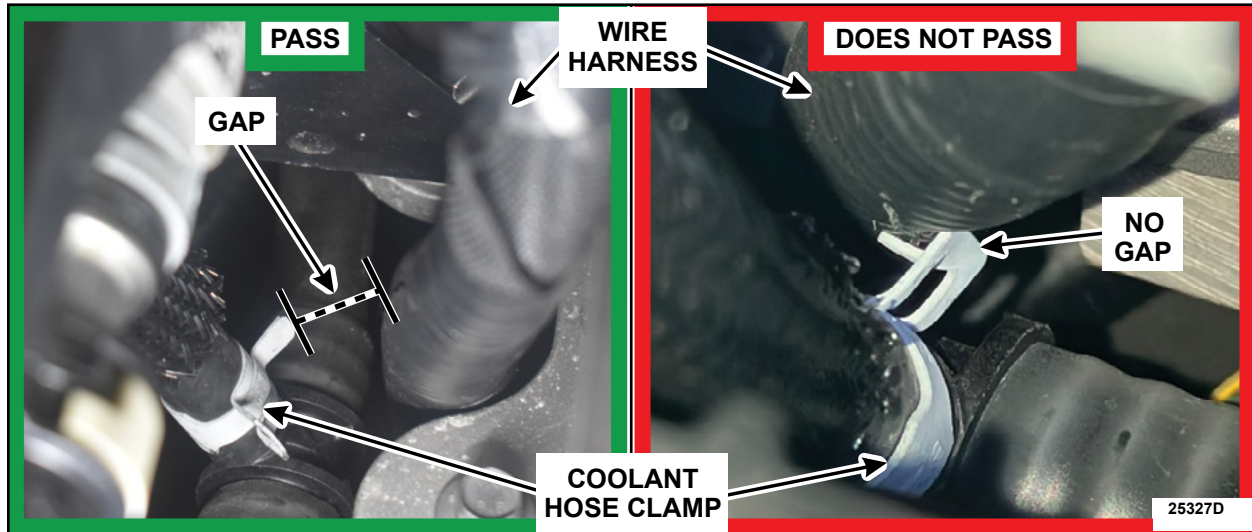
FIGURE 4

4. Visually check the gap between the coolant line clamp and the wire harness. See Figure 4.

- Is a gap of at least 6 mm (1/4 inch) present?

NO - Does not pass, Proceed to Step 5.

YES - Pass, reinstall the underhood center cover. This completes the FSA.
