TECHNICAL SERVICE BULLETIN

Unable To Update The APIM Or TCU With The FDRS And USB Drive - Module Recovery

22-2150
13 April 2022

Ford
2021 Bronco
2021 Edge
2021 F-150
2021 Mustang Mach-E
Lincoln
2021 Nautilus

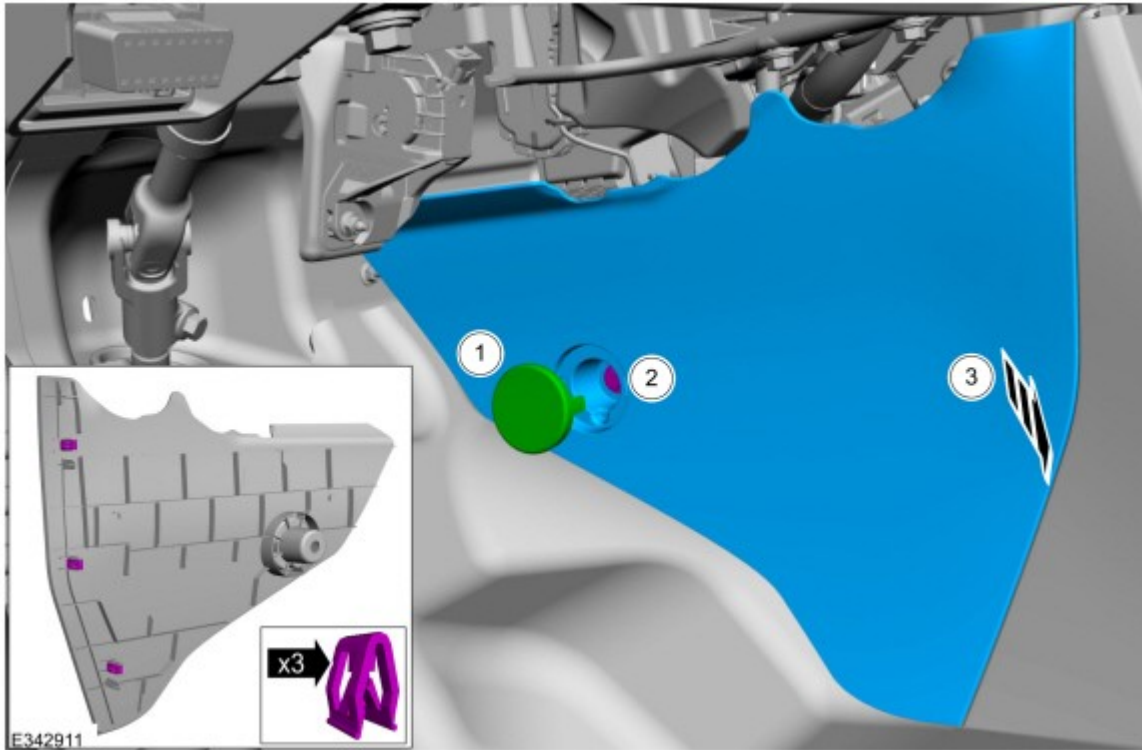
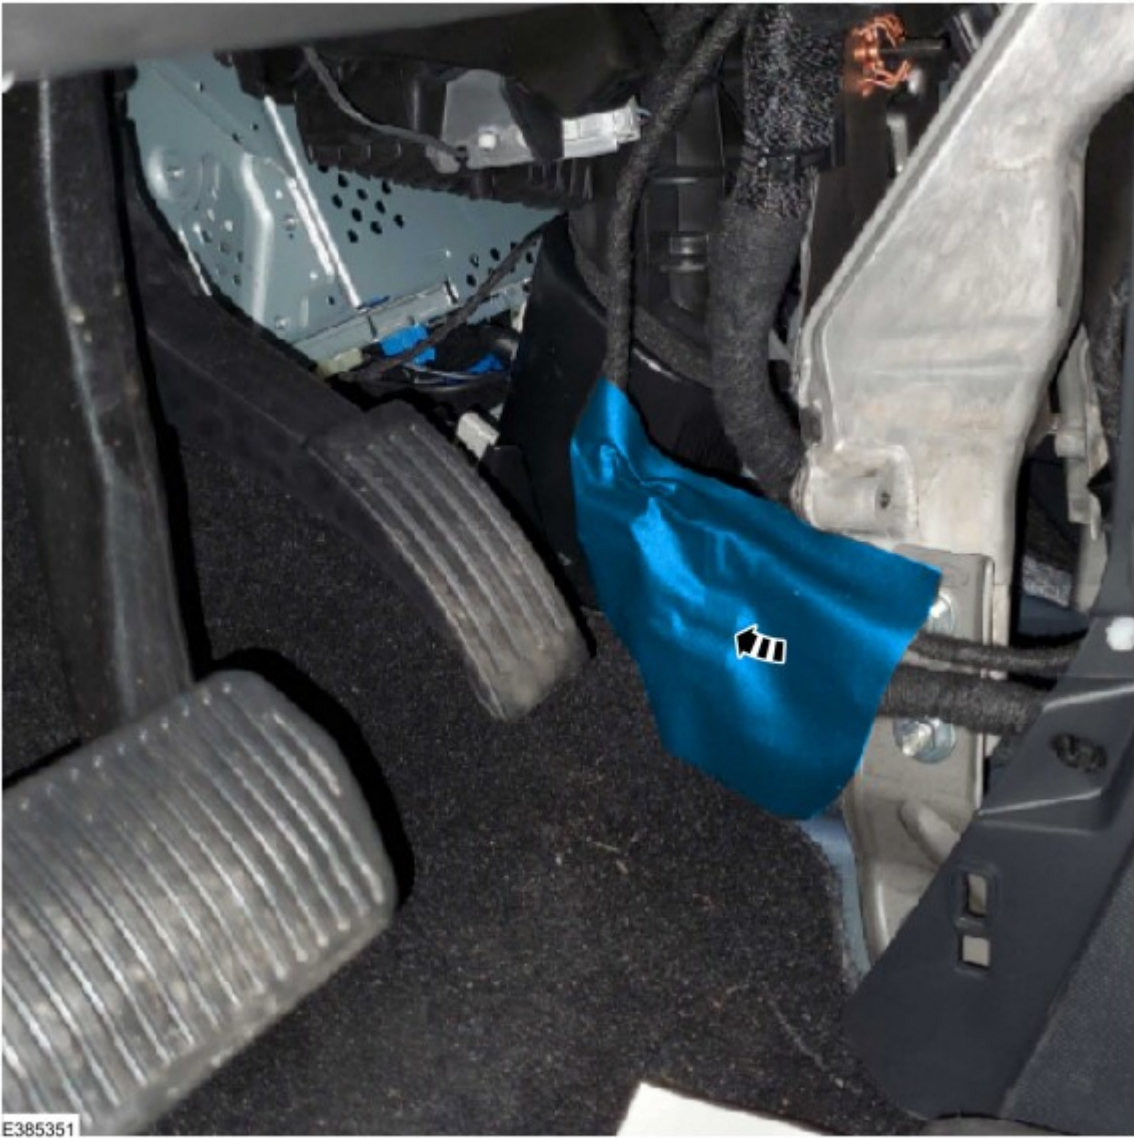
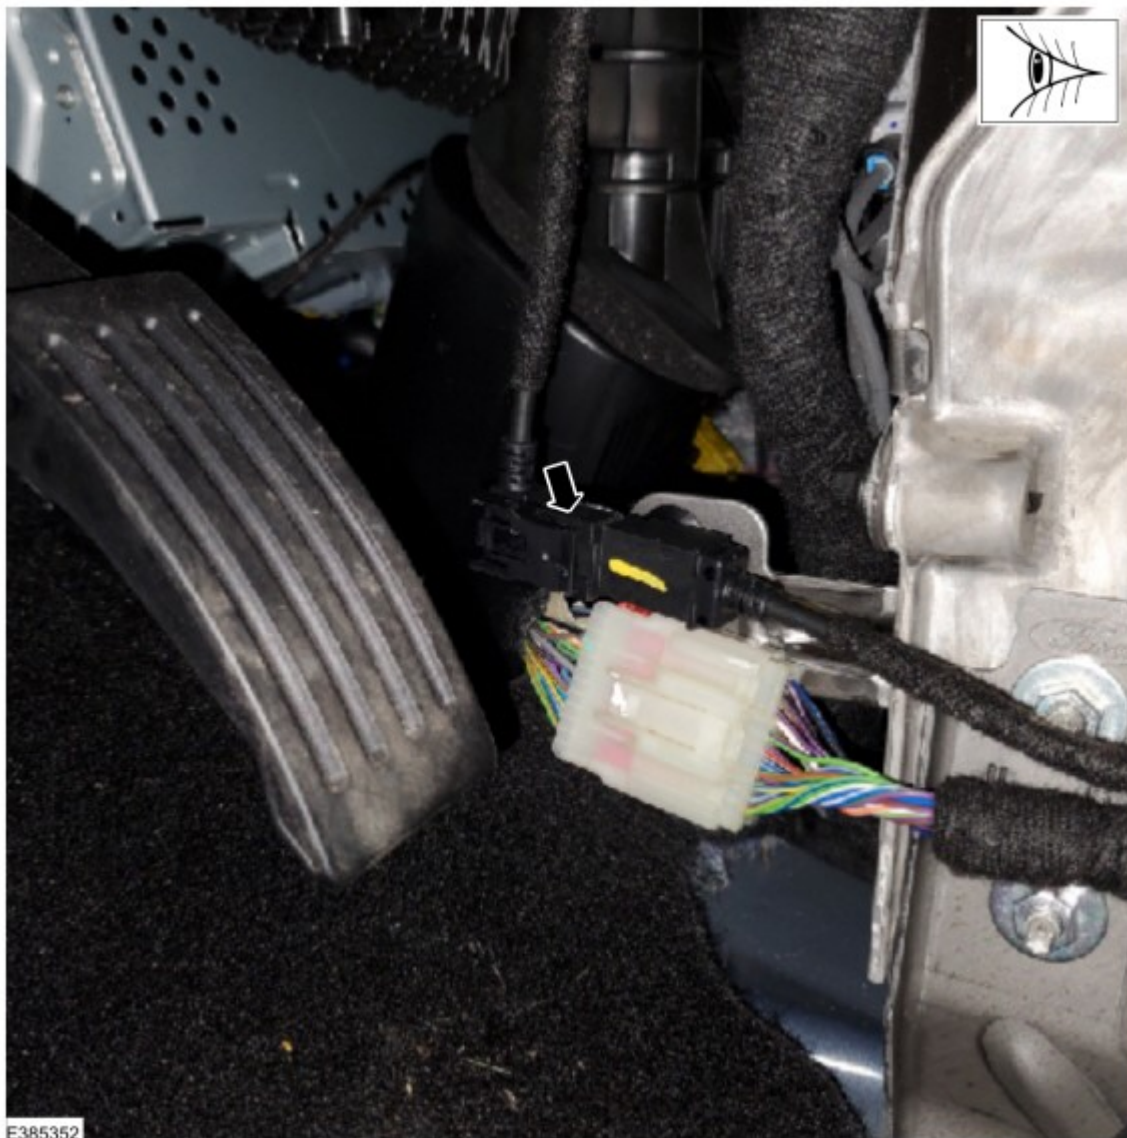
5. For Mustang Mach-E, Nautilus, and F-150 vehicles equipped with a SYNC media hub, access the APIM in-line USB connector.
 - (1). For Mustang Mach-E vehicles, remove the left side floor console front trim panel and disconnect the APIM in-line USB connector. The connector may be concealed by tape. Refer to Step 4 in the WSM Section 501-12 floor console removal. (Figures 1-3)

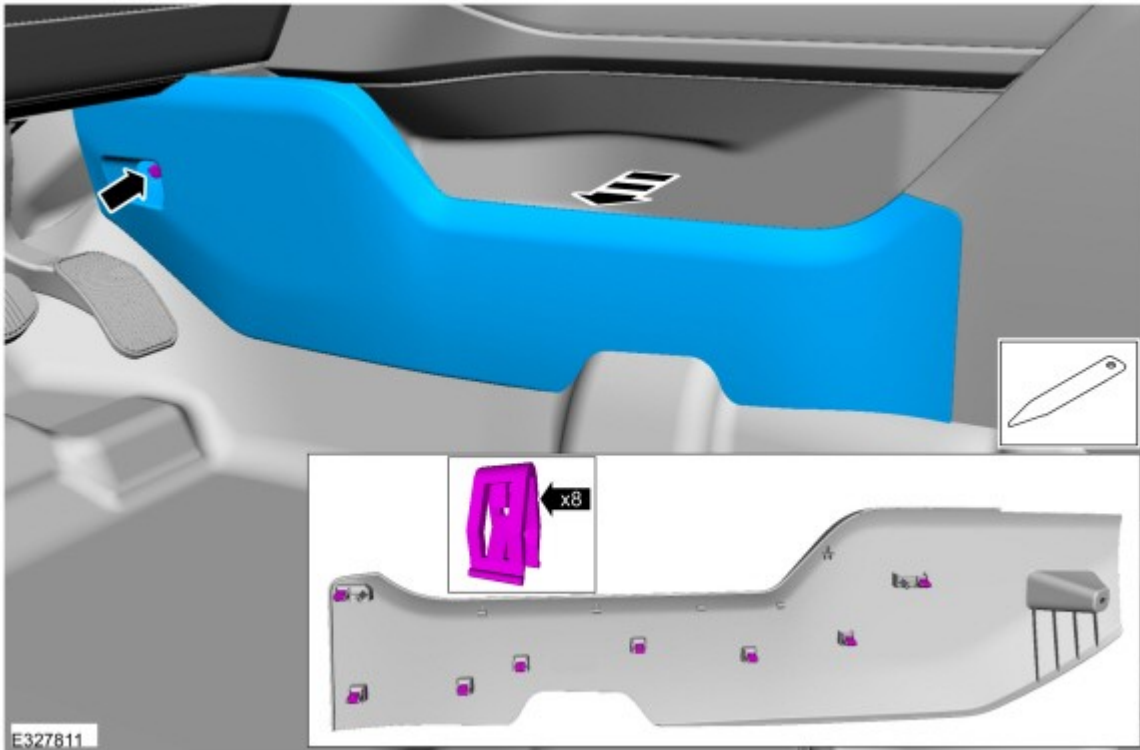
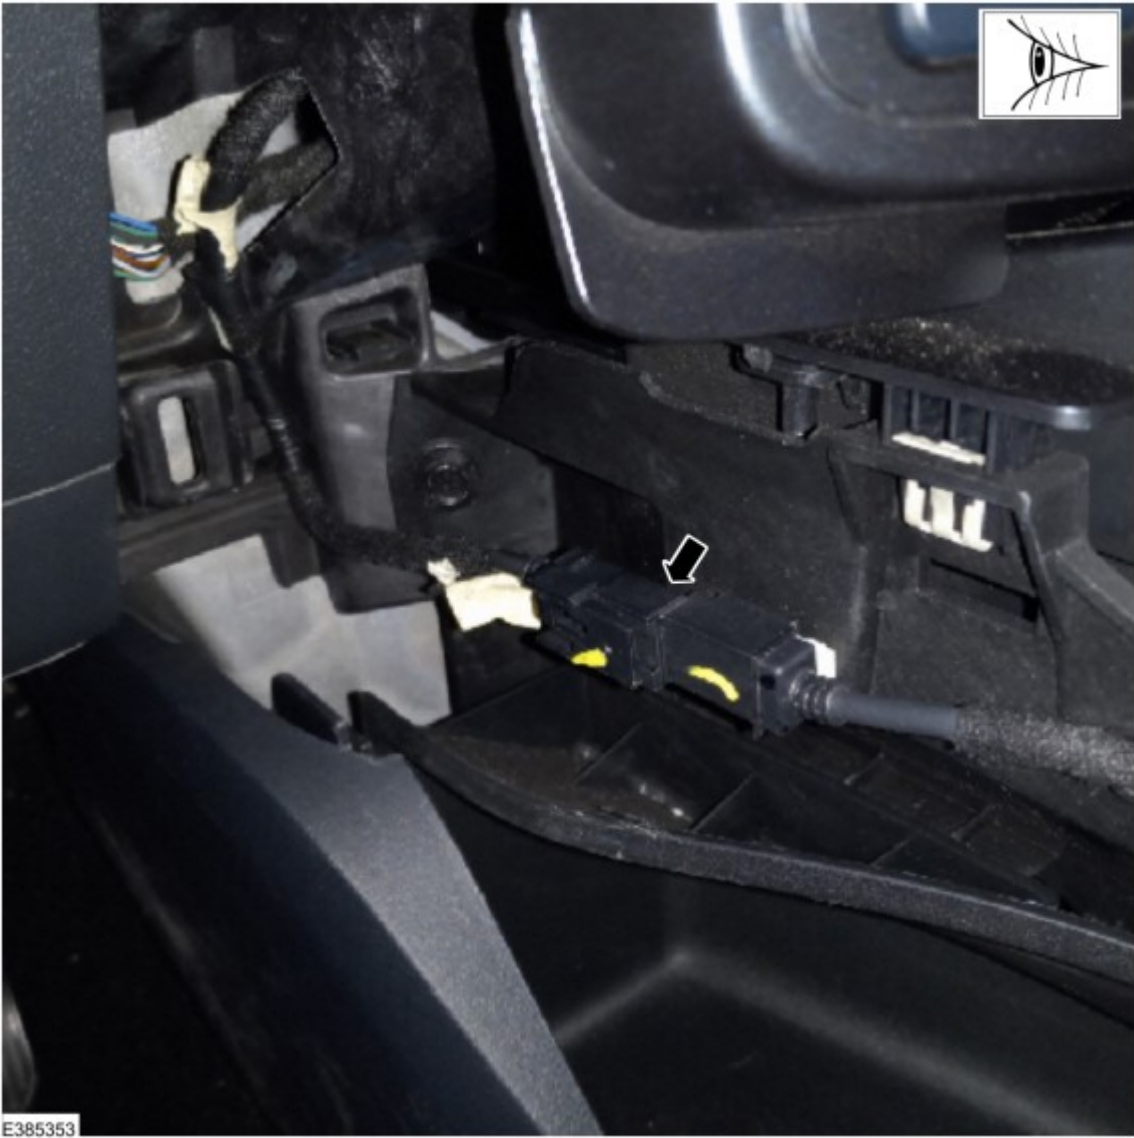
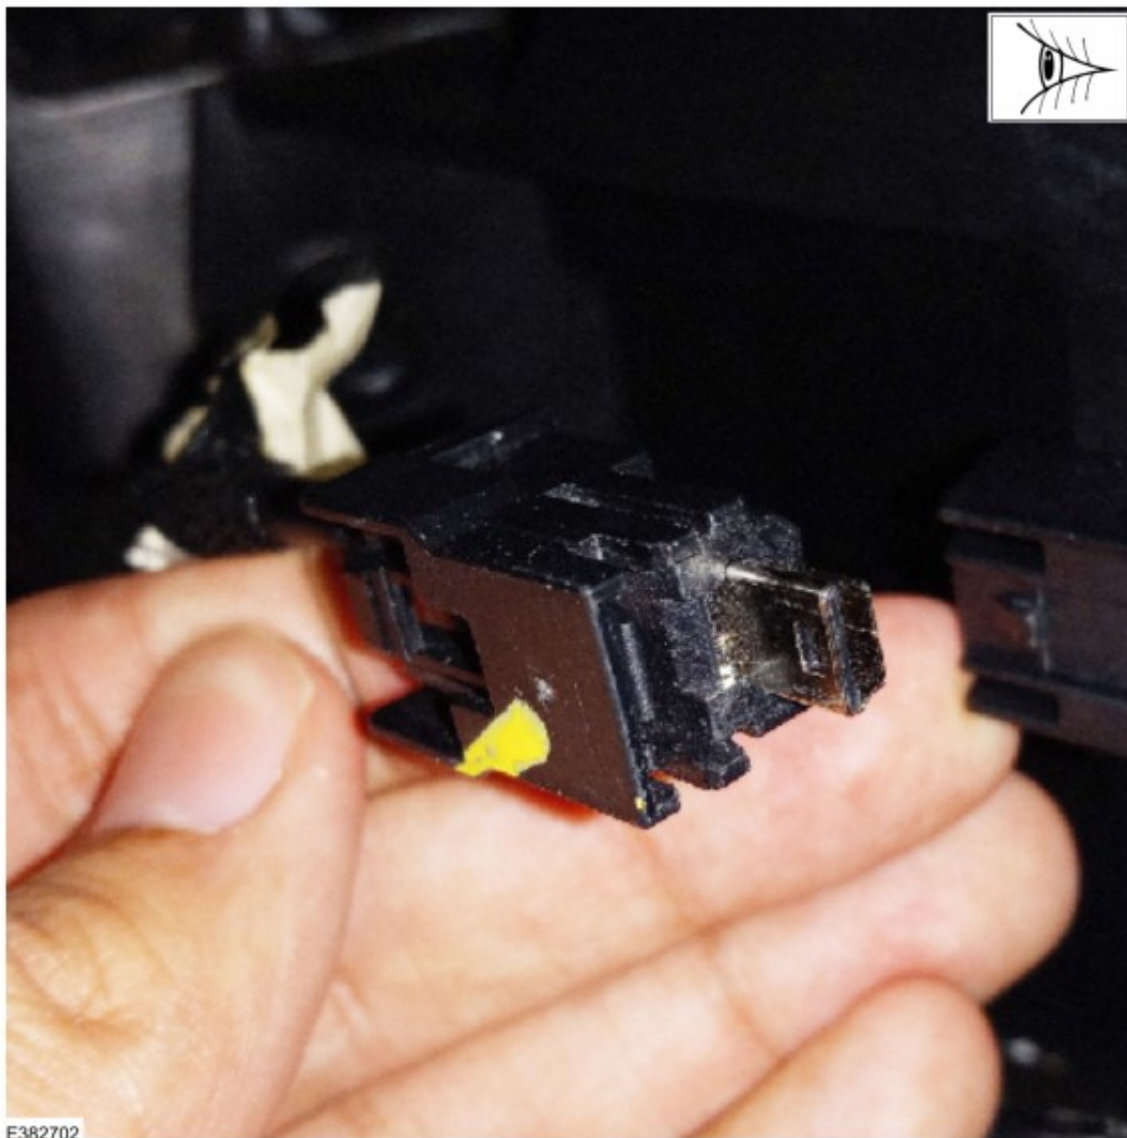
(2). For F-150 vehicles with a SYNC media hub and center console, remove the floor console lower left trim panel and disconnect the APIM in-line USB connector. Refer to Step 4 in WSM, Section 501-12 floor console removal. (Figures 4-6)

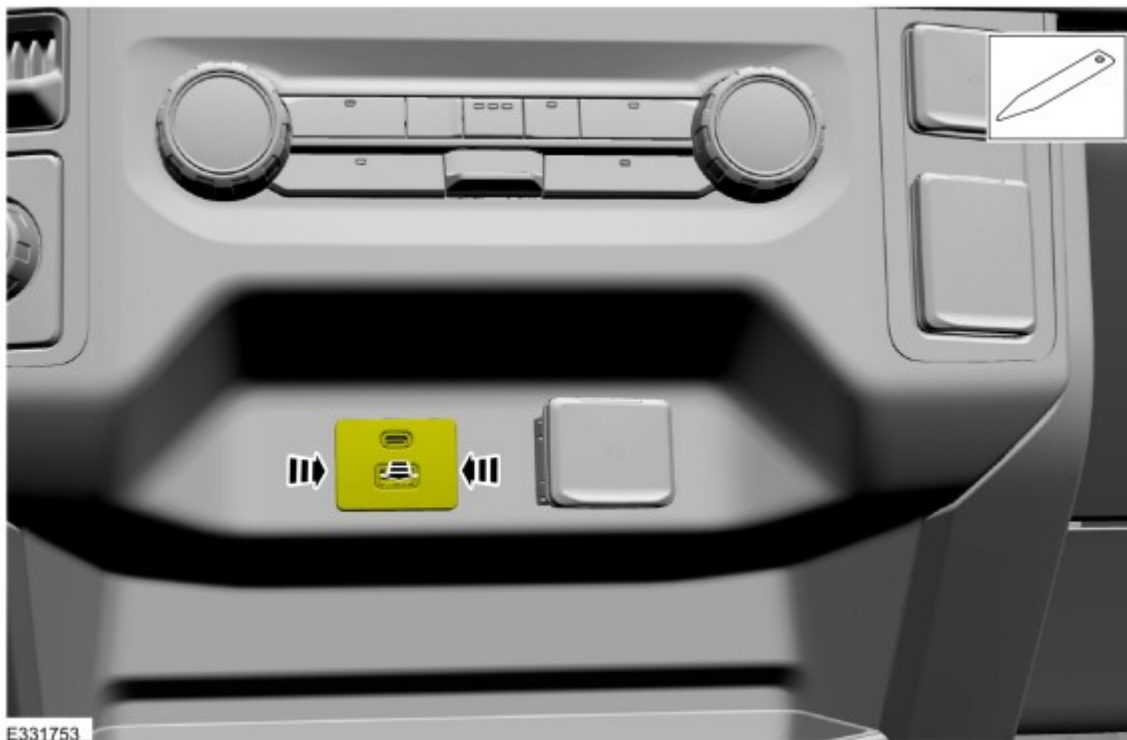
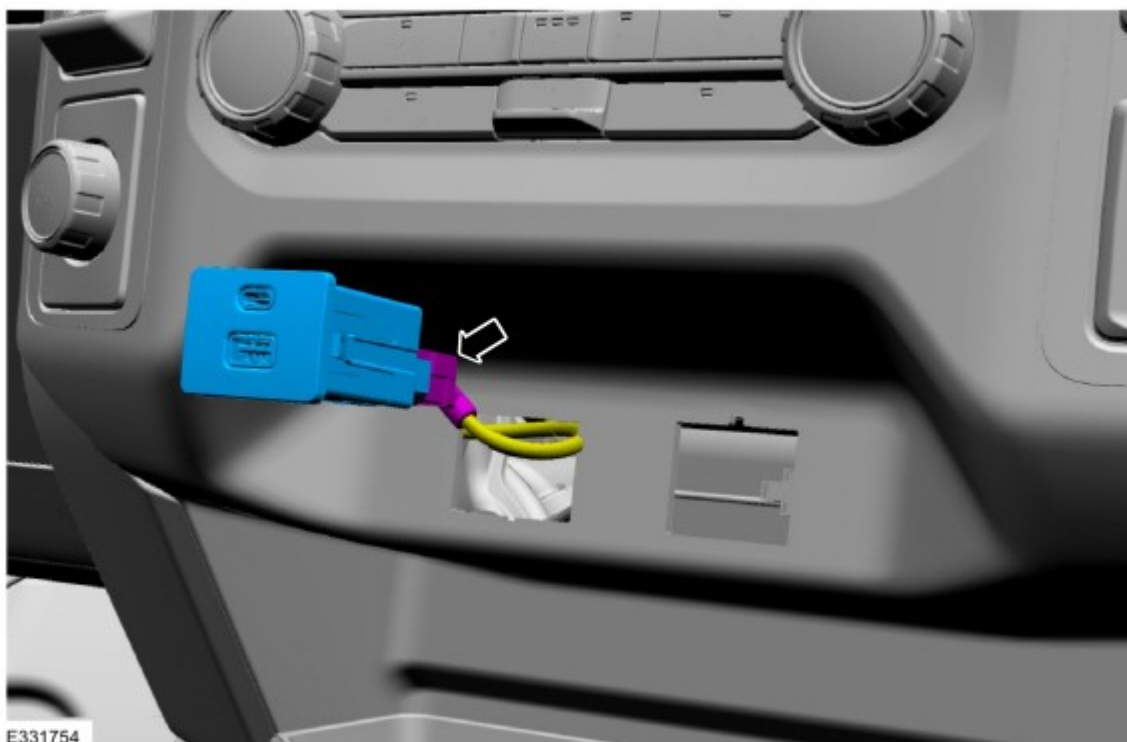
(3). For F-150 vehicles with the SYNC media hub and no center console, disconnect the SYNC media hub mini-USB connector from the back of the media hub. On some F-150 vehicles, media hub removal may not be required and the mini-USB connector can be accessed from the back of the instrument panel. Refer to Step 2 in WSM, Section 415-00 Universal Serial Bus (USB) Hub removal. (Figures 7-8)

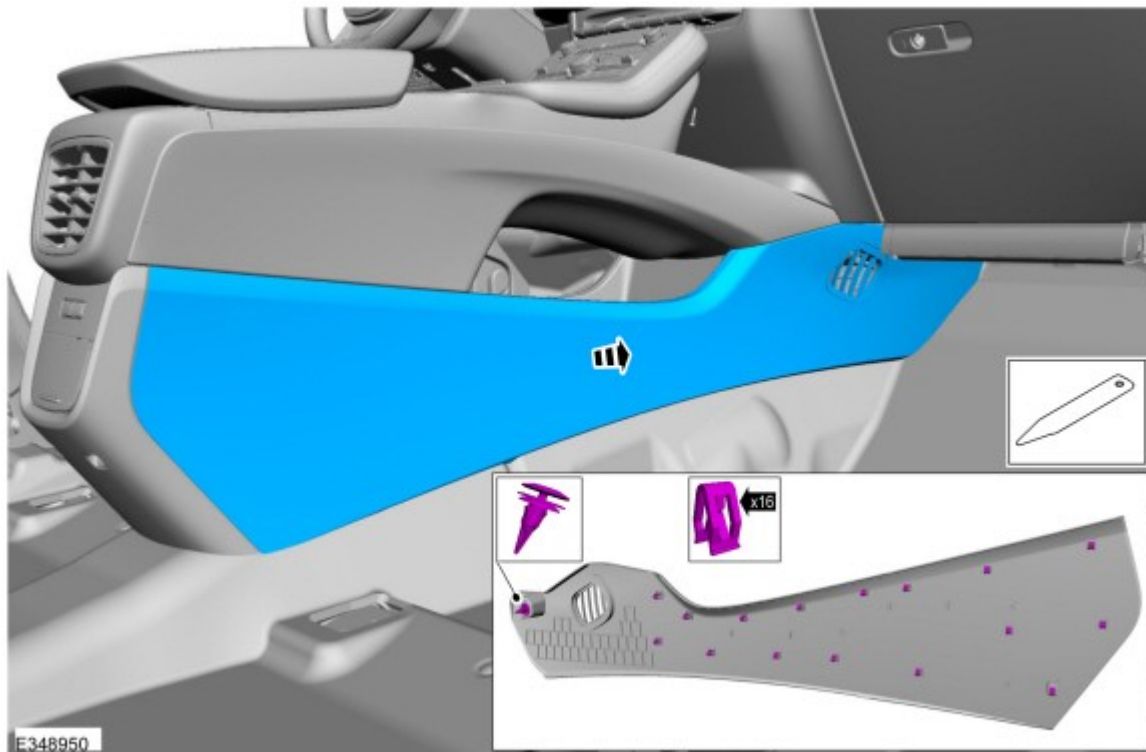
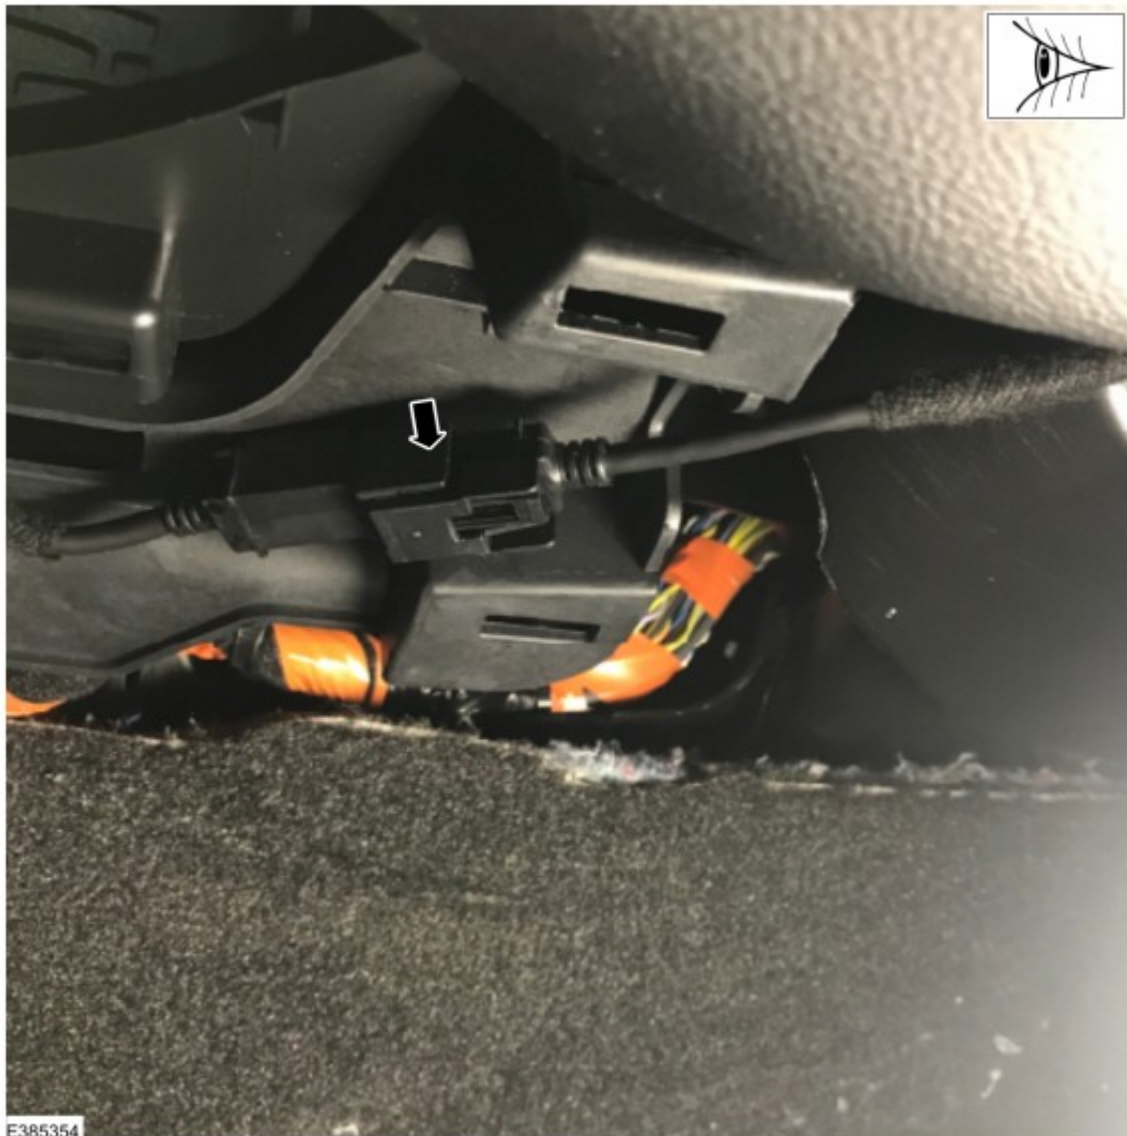
(4). For Nautilus vehicles, remove the floor console lower right trim panel and disconnect the APIM in-line USB connector. Refer to Step 1 in WSM, Section 501-12 floor console removal. (Figures 9-10)

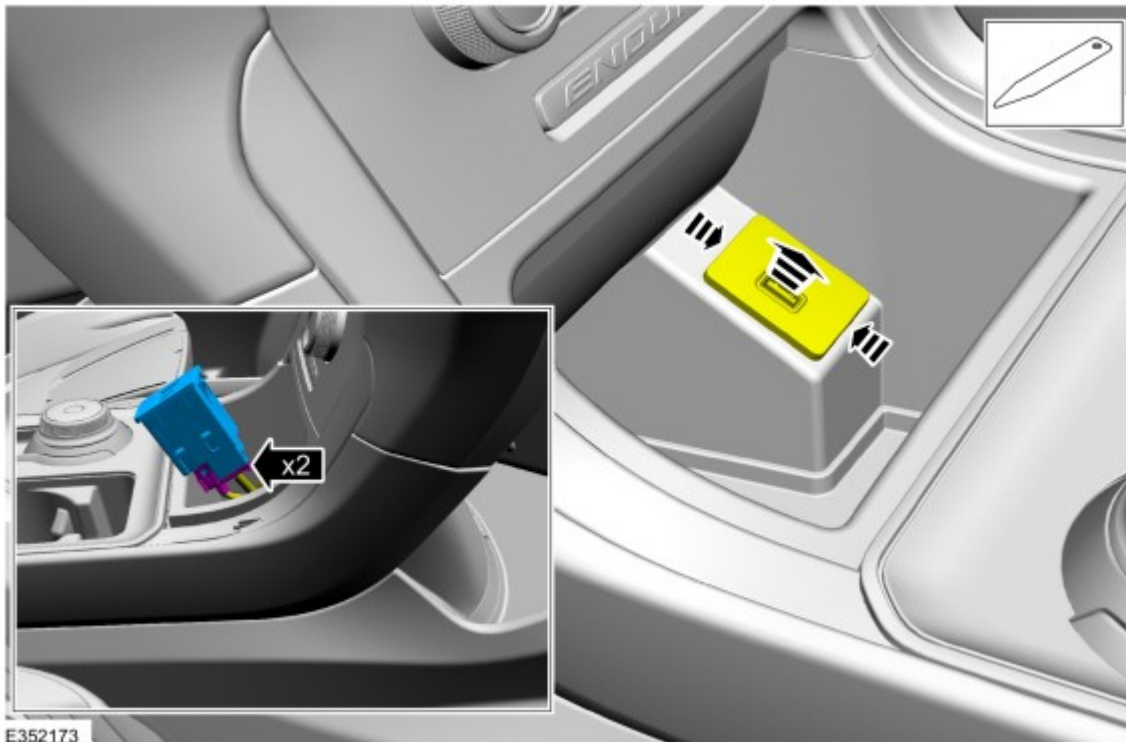
(5). For Edge vehicles, remove the SYNC media hub and disconnect the mini-USB connector on the back of the media hub. Refer to Step 1 in WSM, Section 415-00 Media Hub removal. (Figure 11)

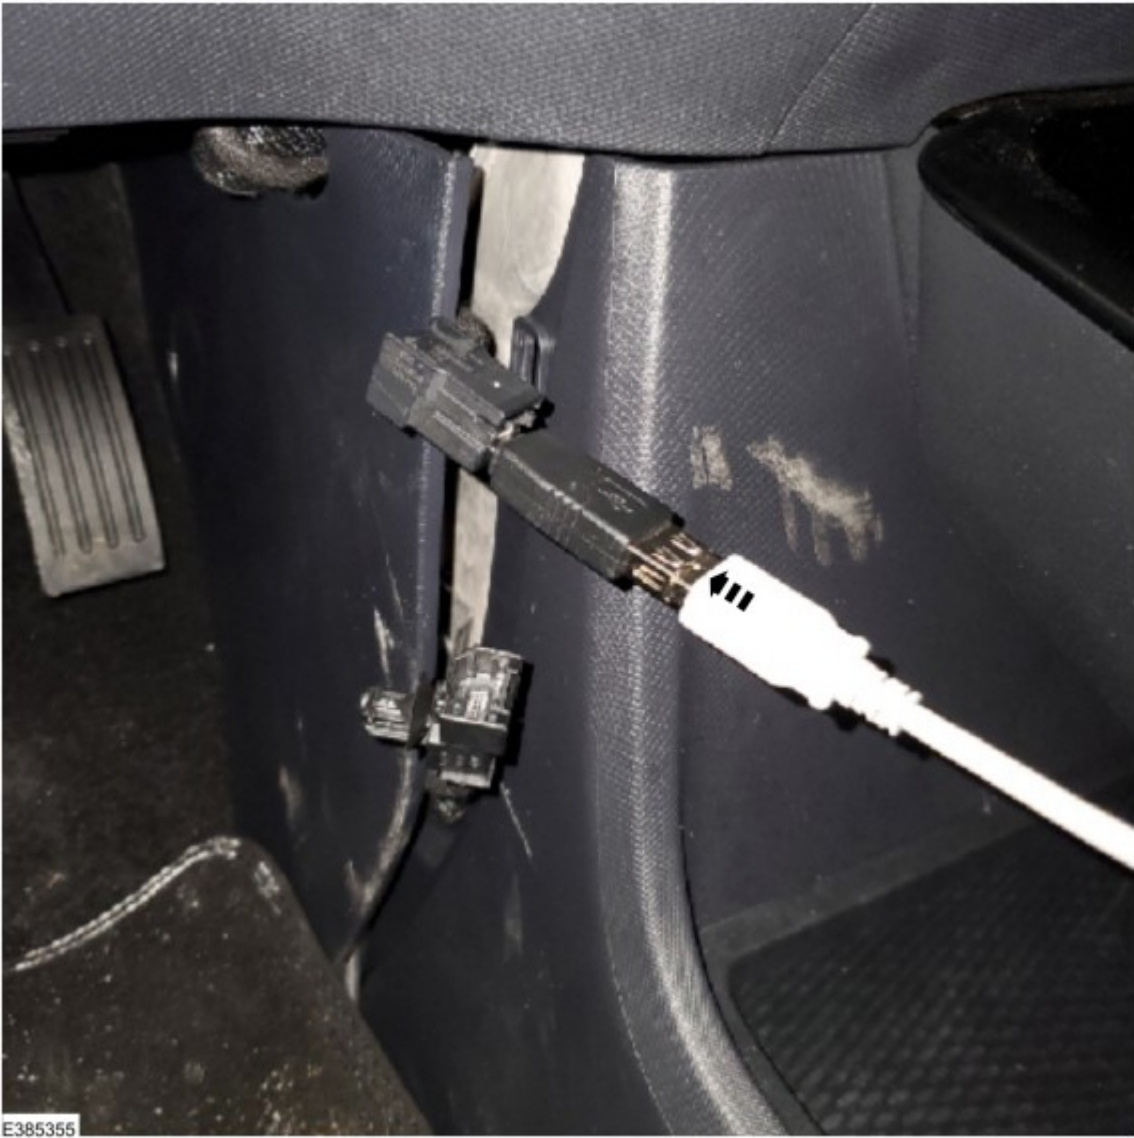
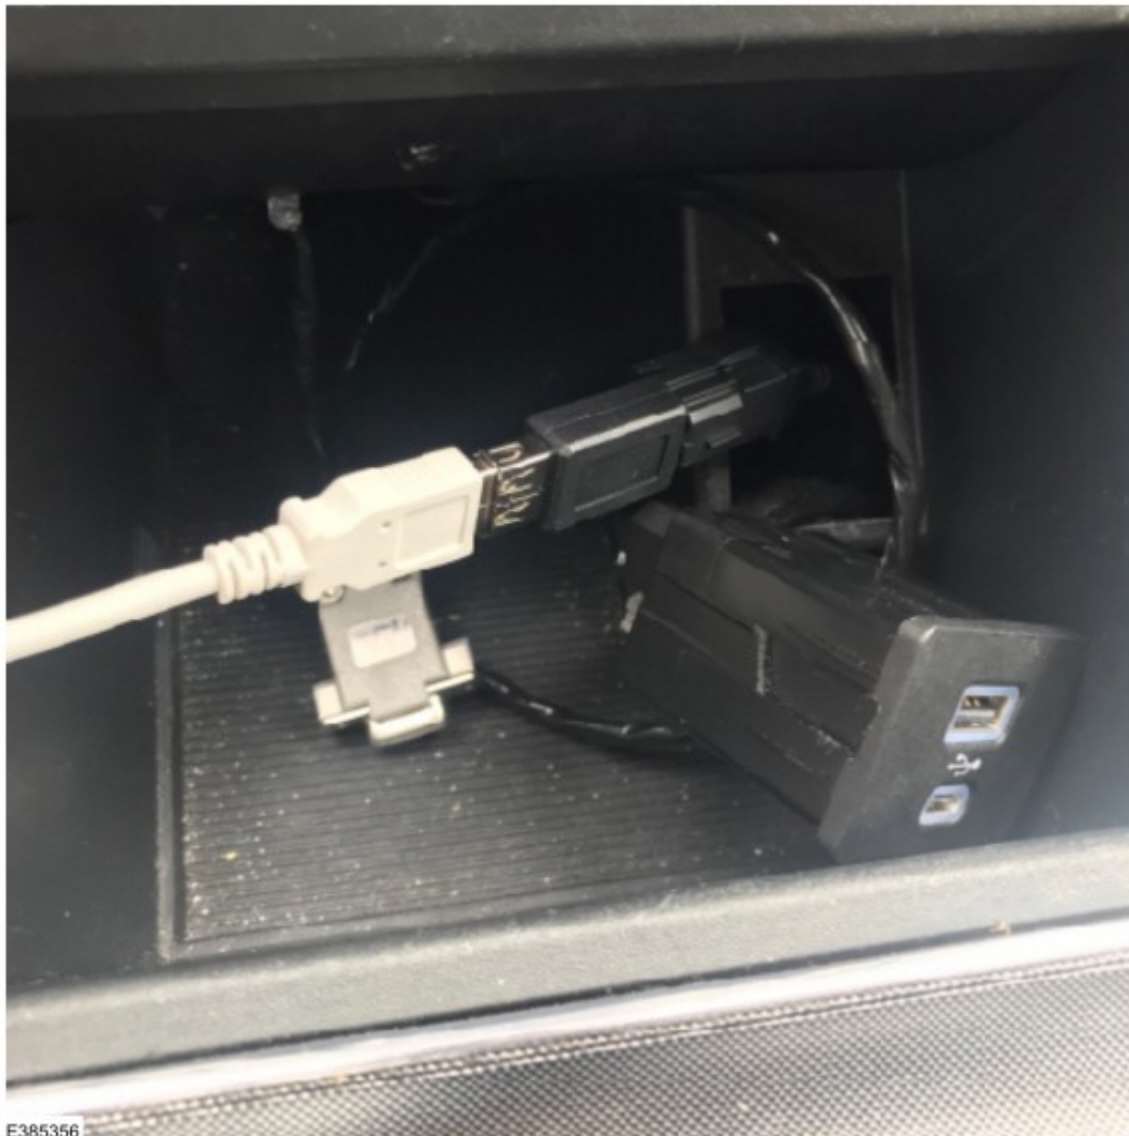
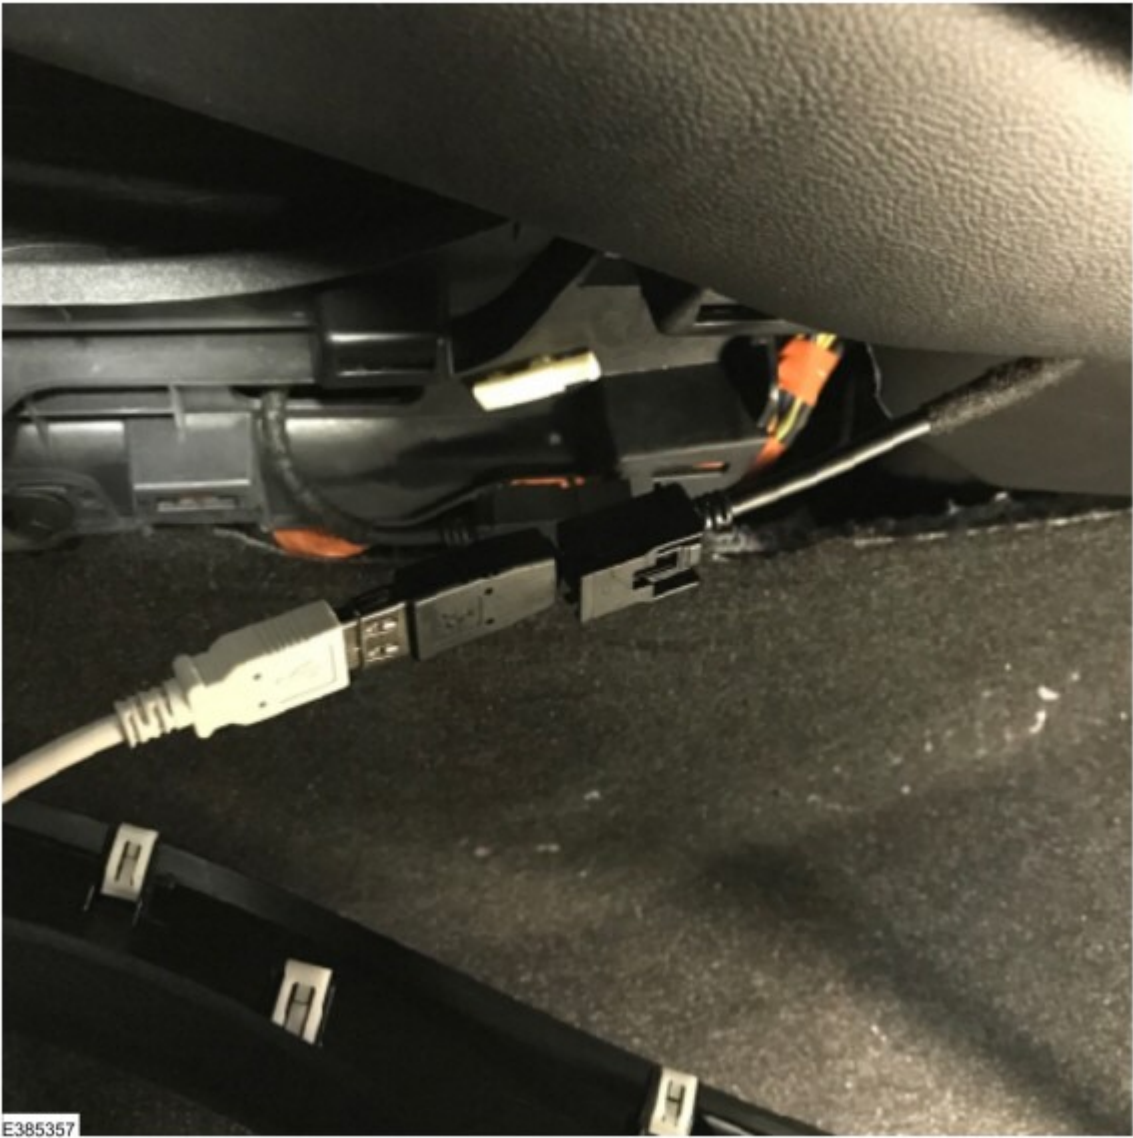
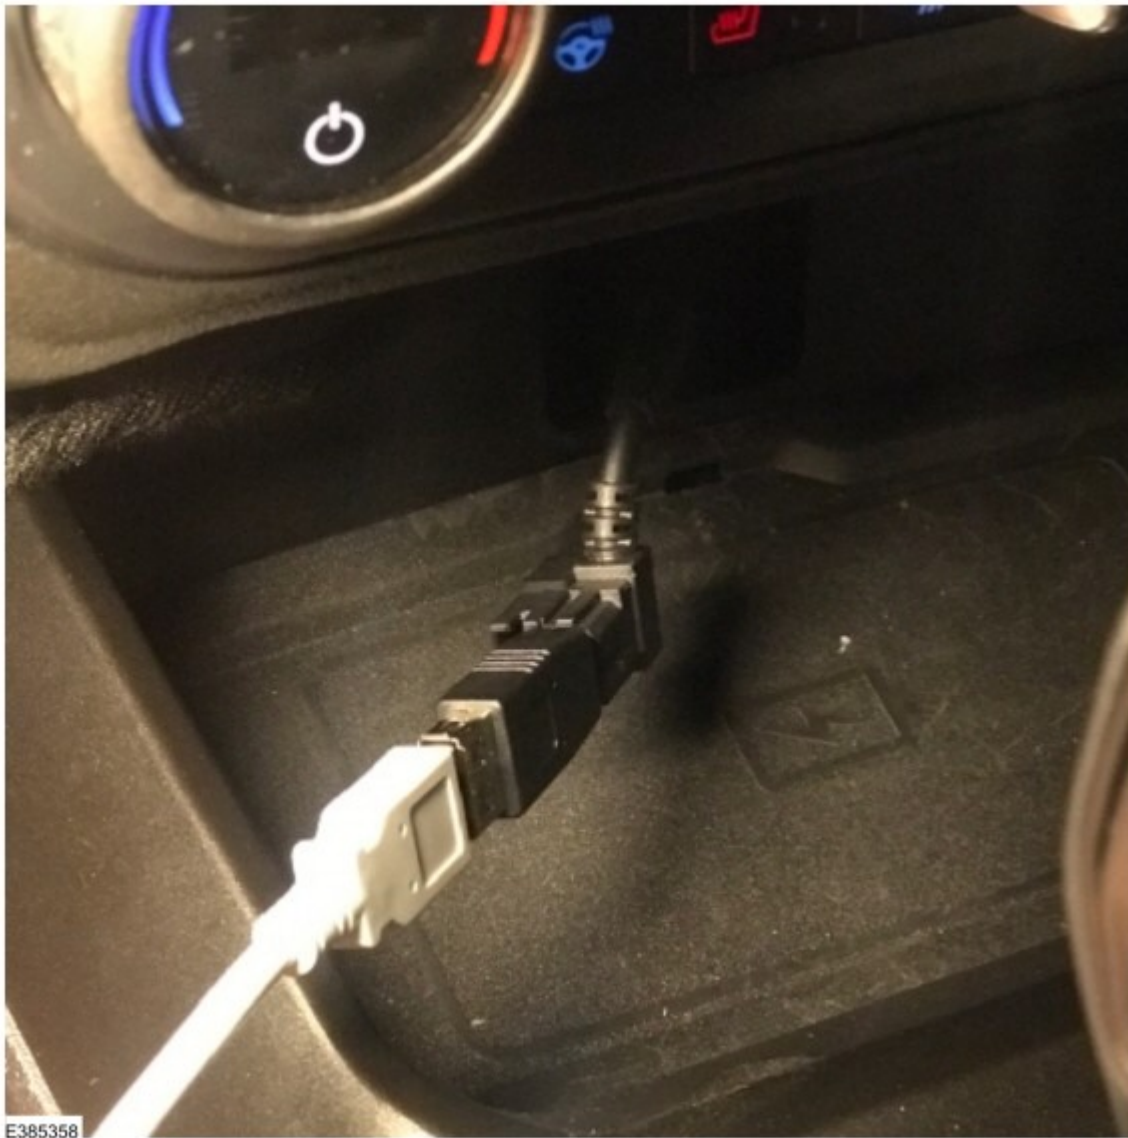
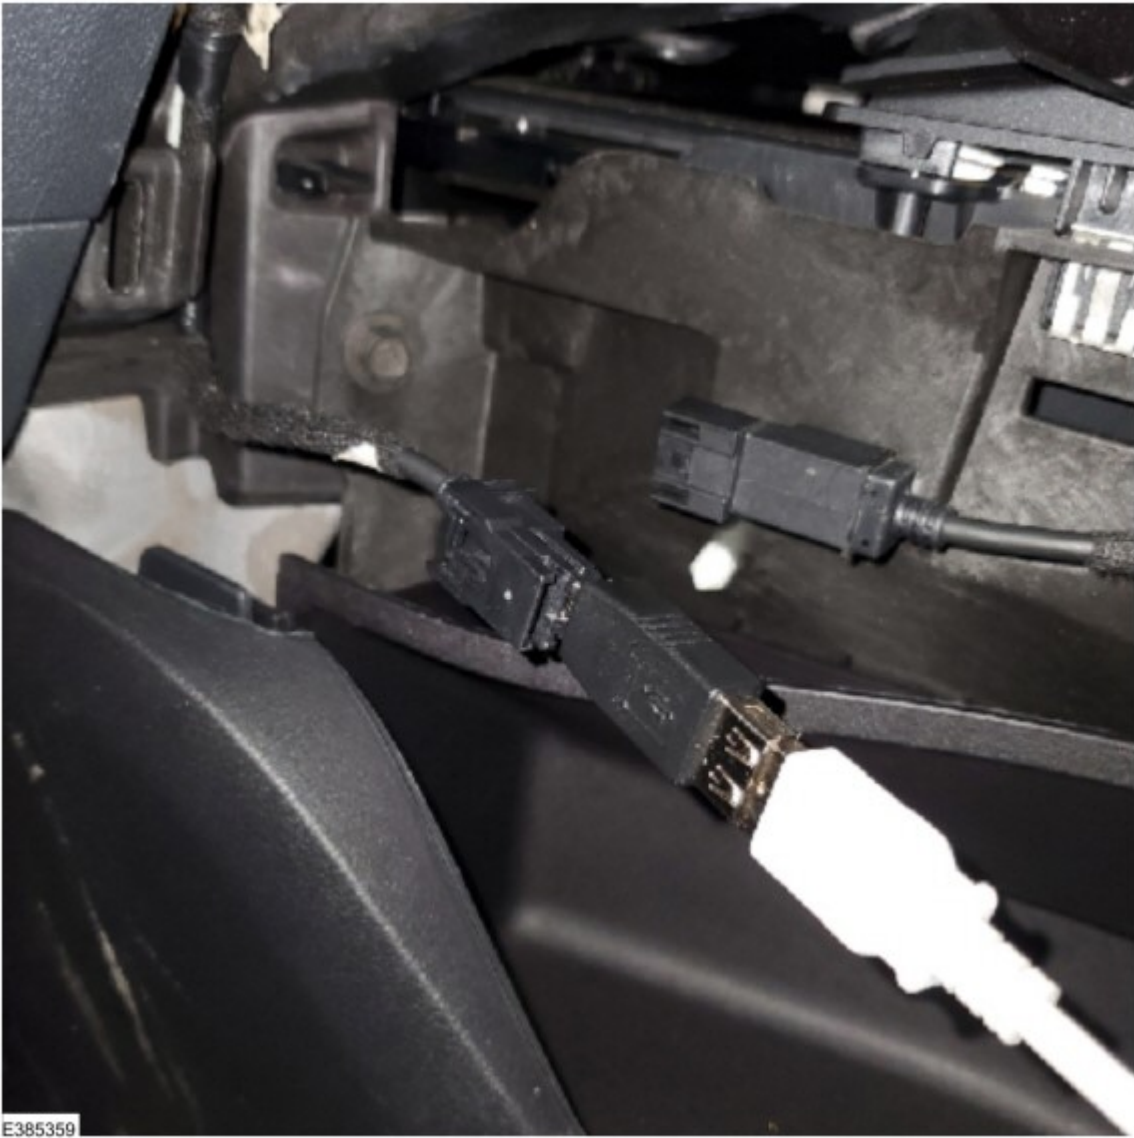
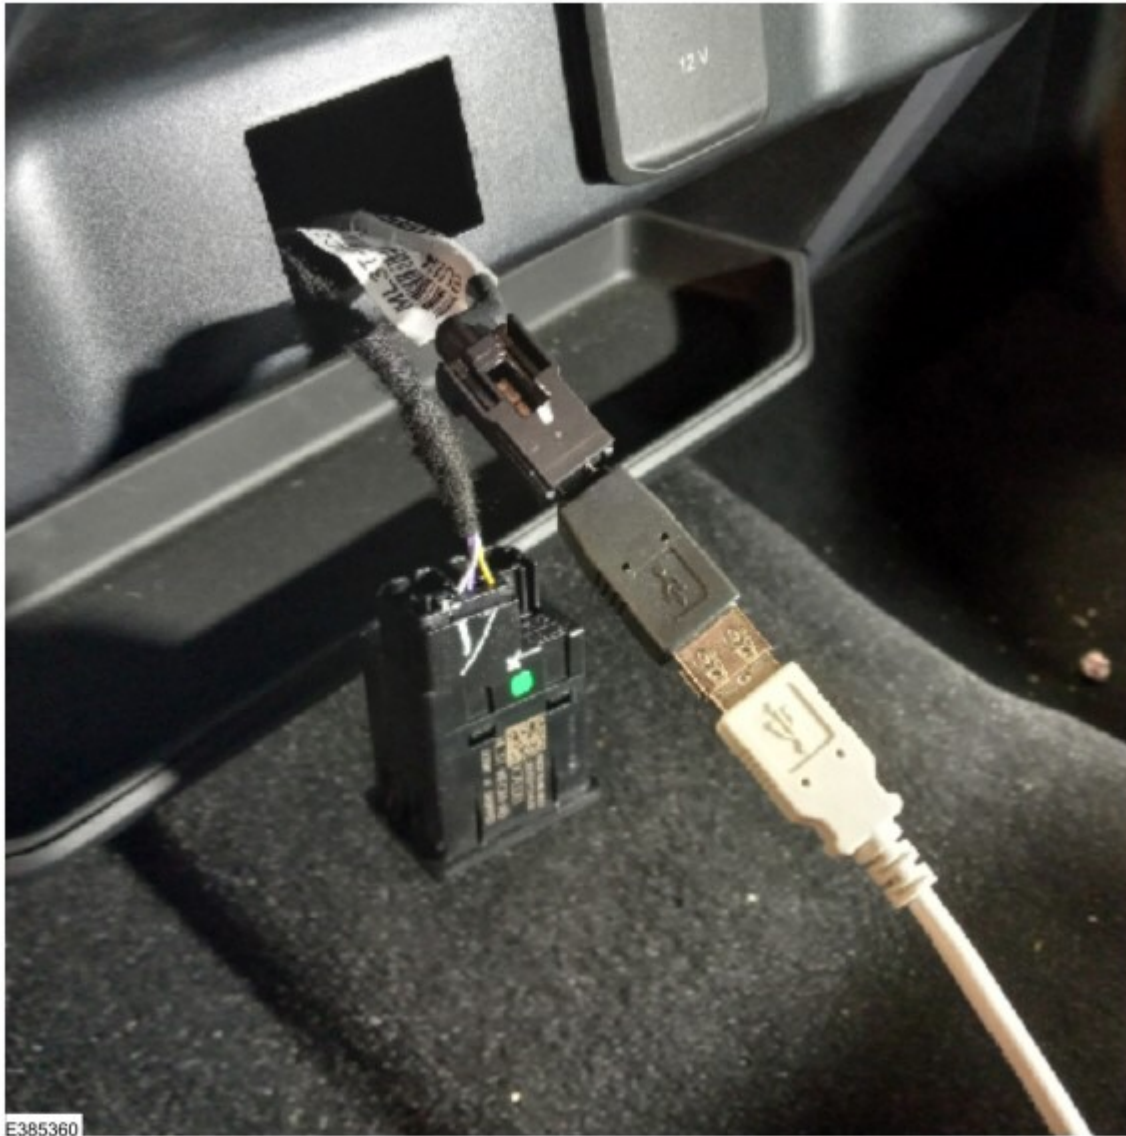
- Mustang Mach-E, Edge, Nautilus, Bronco and F-150 vehicles equipped with a SYNC Media hub:
 - Connect the Mini B 5-pin female adapter to the vehicle harness.
 - Connect the USB 2 Cable - male-to-male to the female adapter and the laptop USB port.

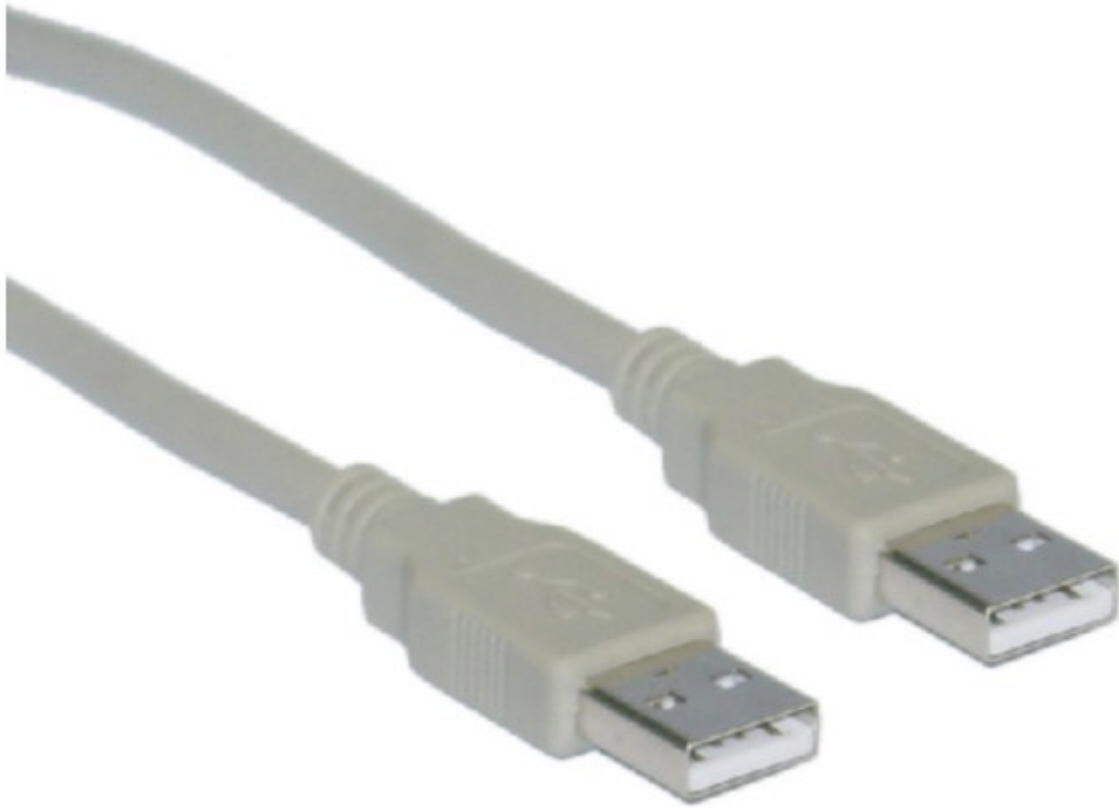
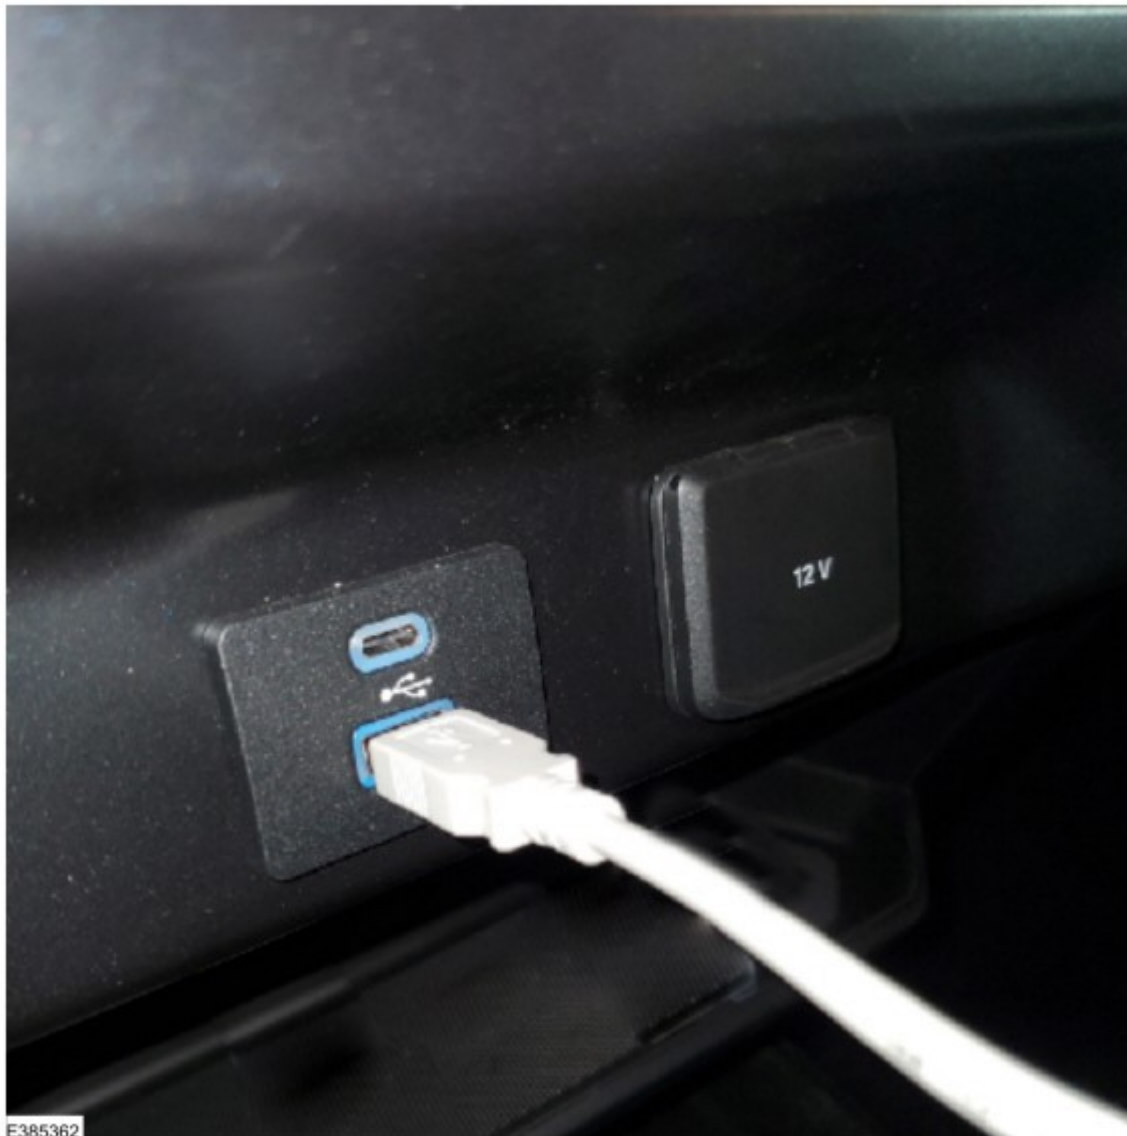
- F-150 vehicles without a SYNC media hub:
 - Connect the USB 2 Cable - male-to-male or equivalent to the vehicle USB port and the laptop USB port
