TECHNICAL SERVICE BULLETIN

Unable To Update The APIM Or TCU With The FDRS And USB Drive - Module Recovery

22-2150
13 April 2022

Ford
2021 Bronco
2021 Edge
2021 F-150
2021 Mustang Mach-E
Lincoln
2021 Nautilus

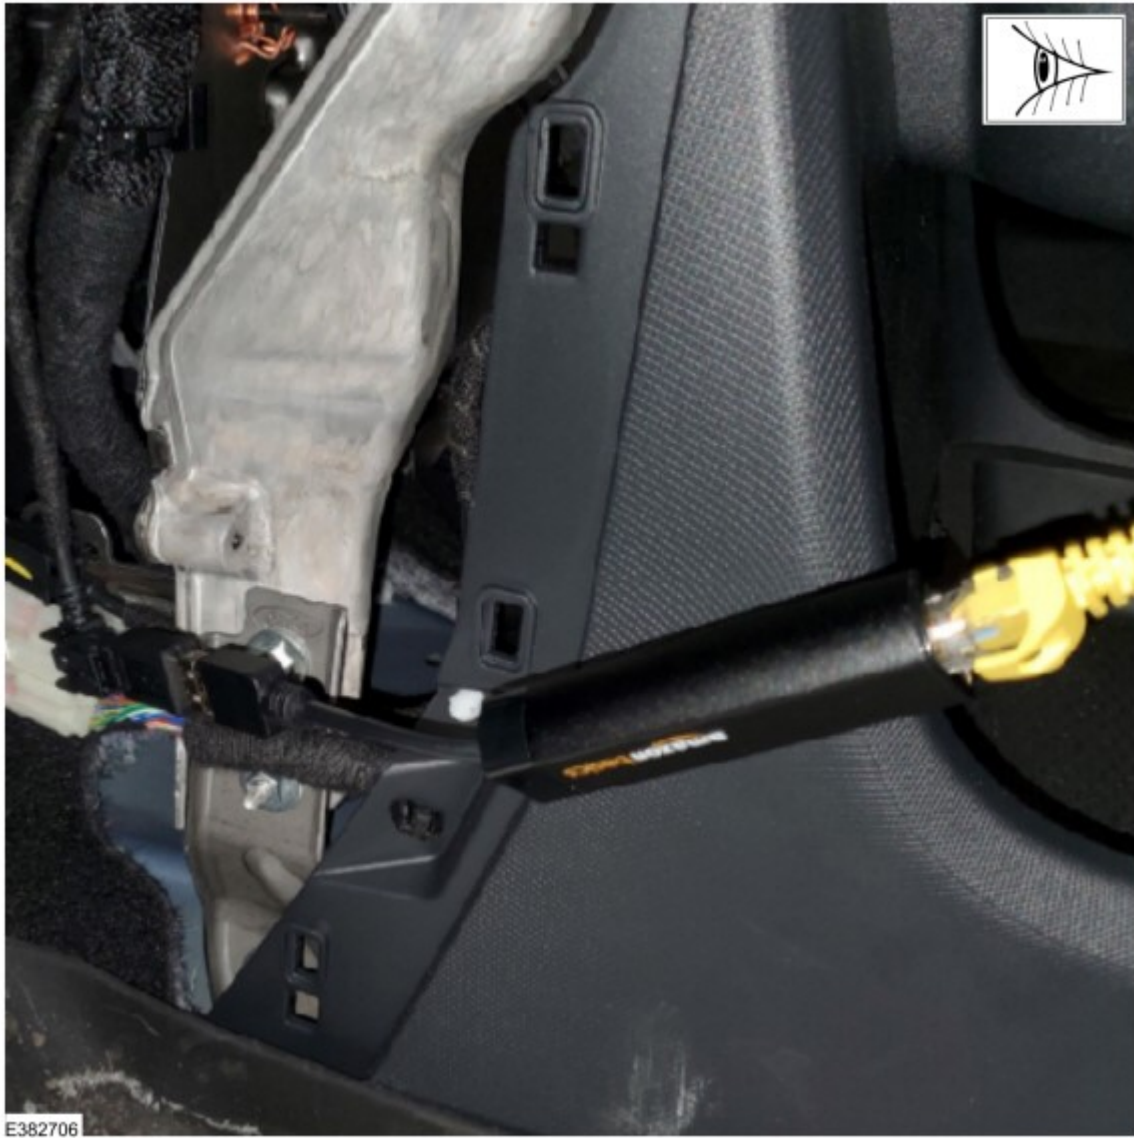
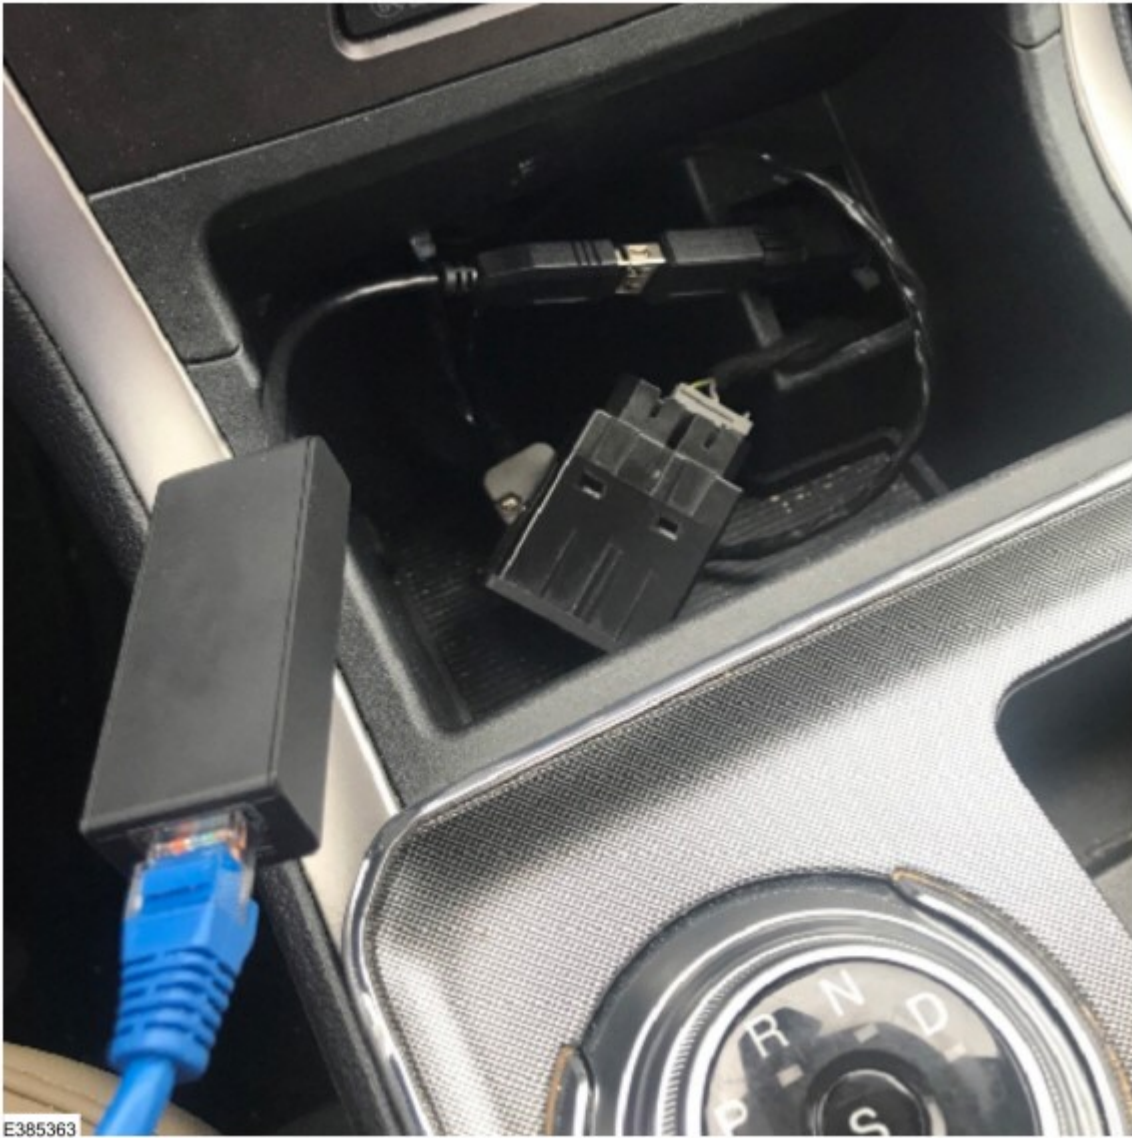
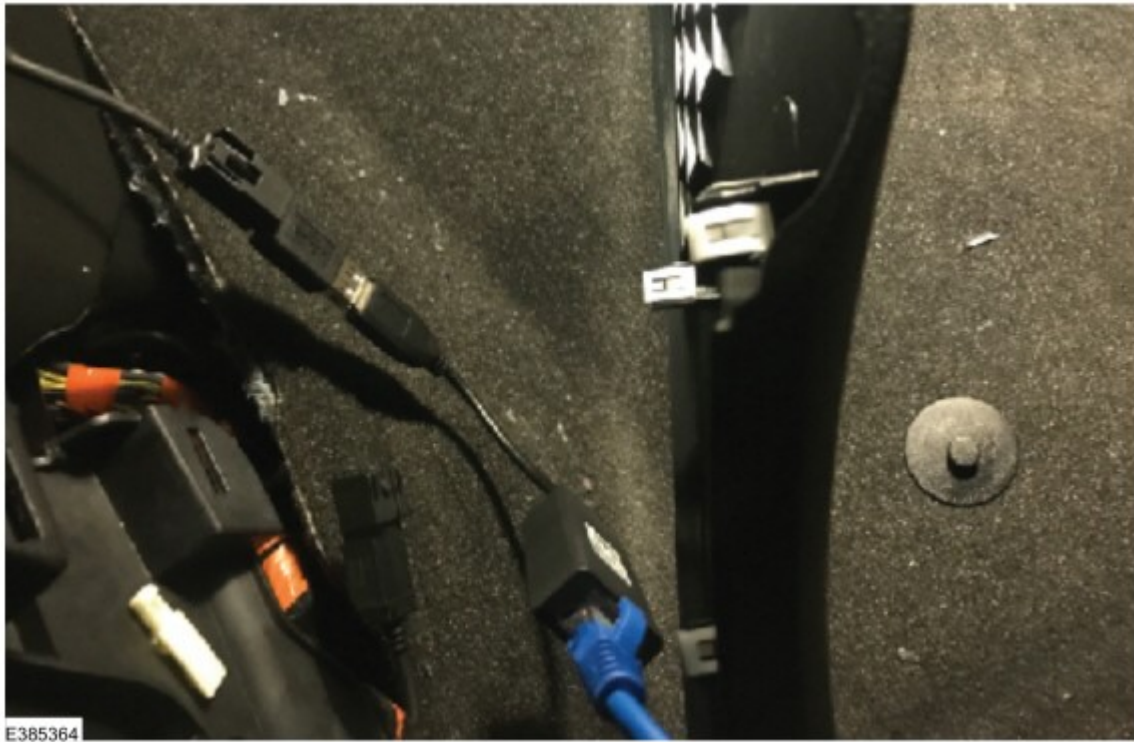
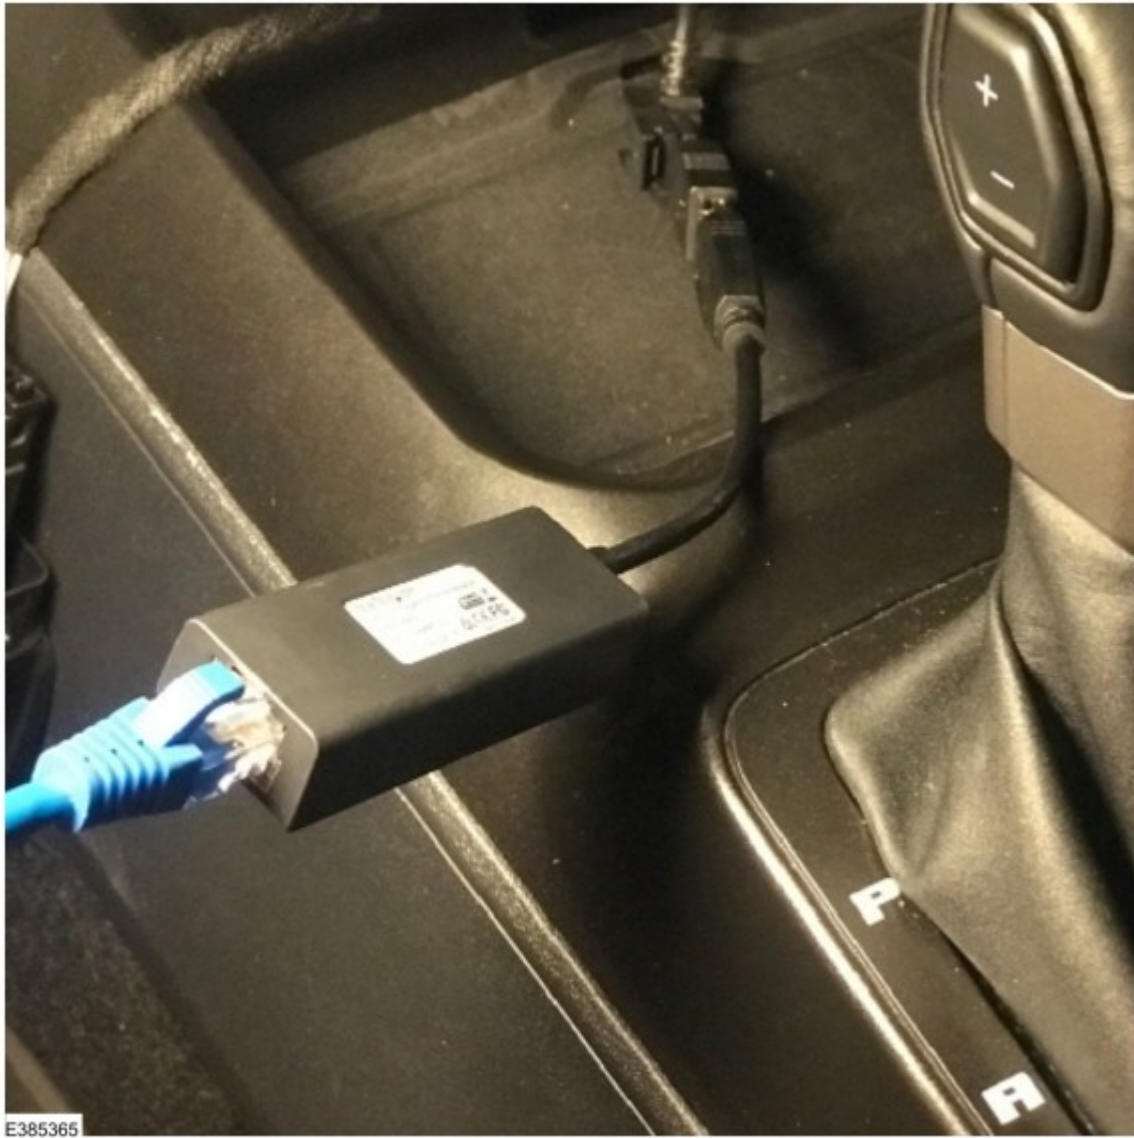
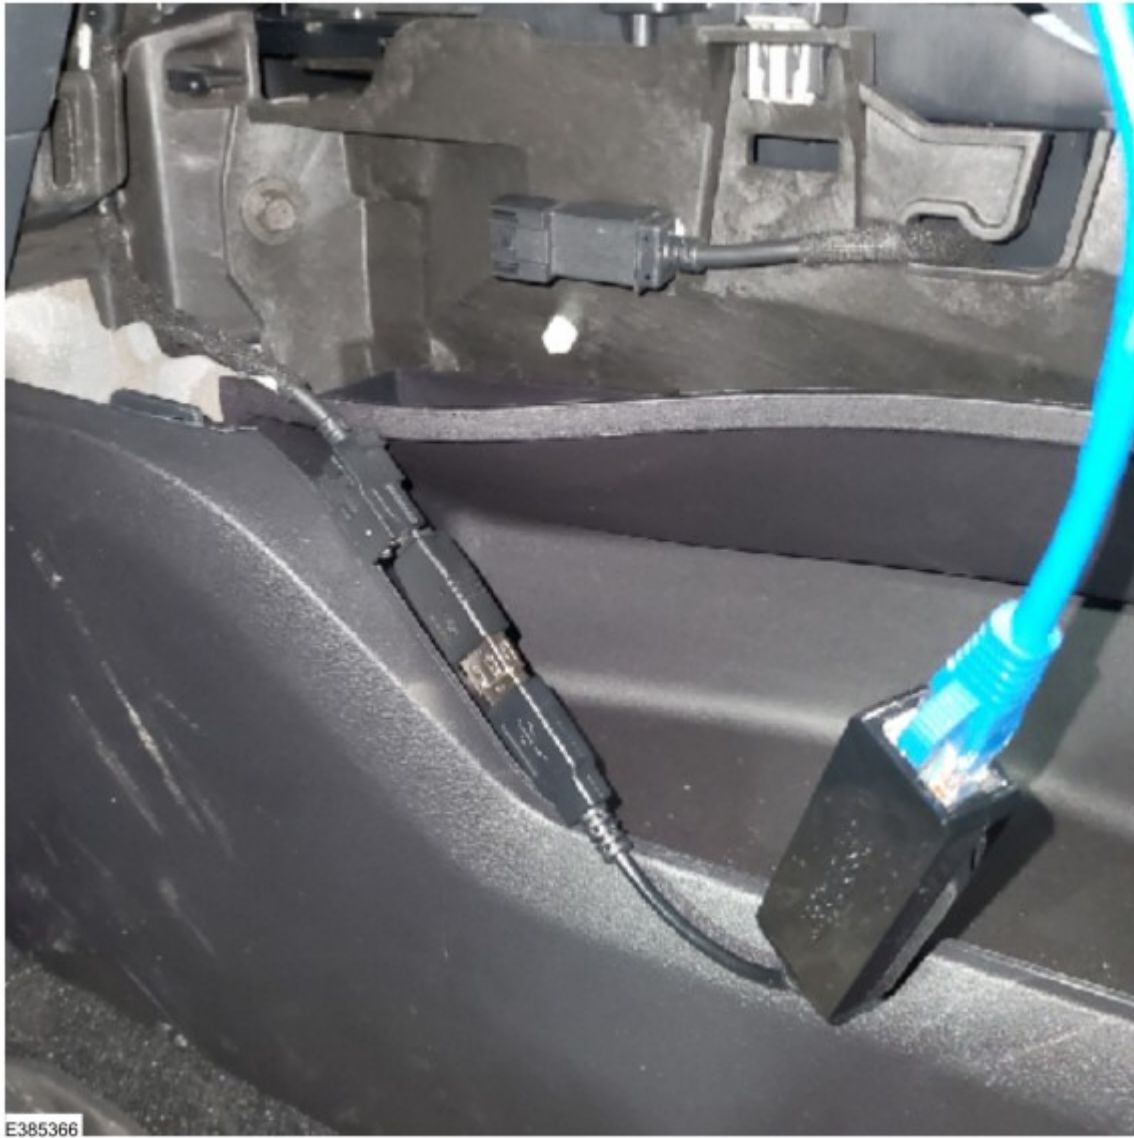
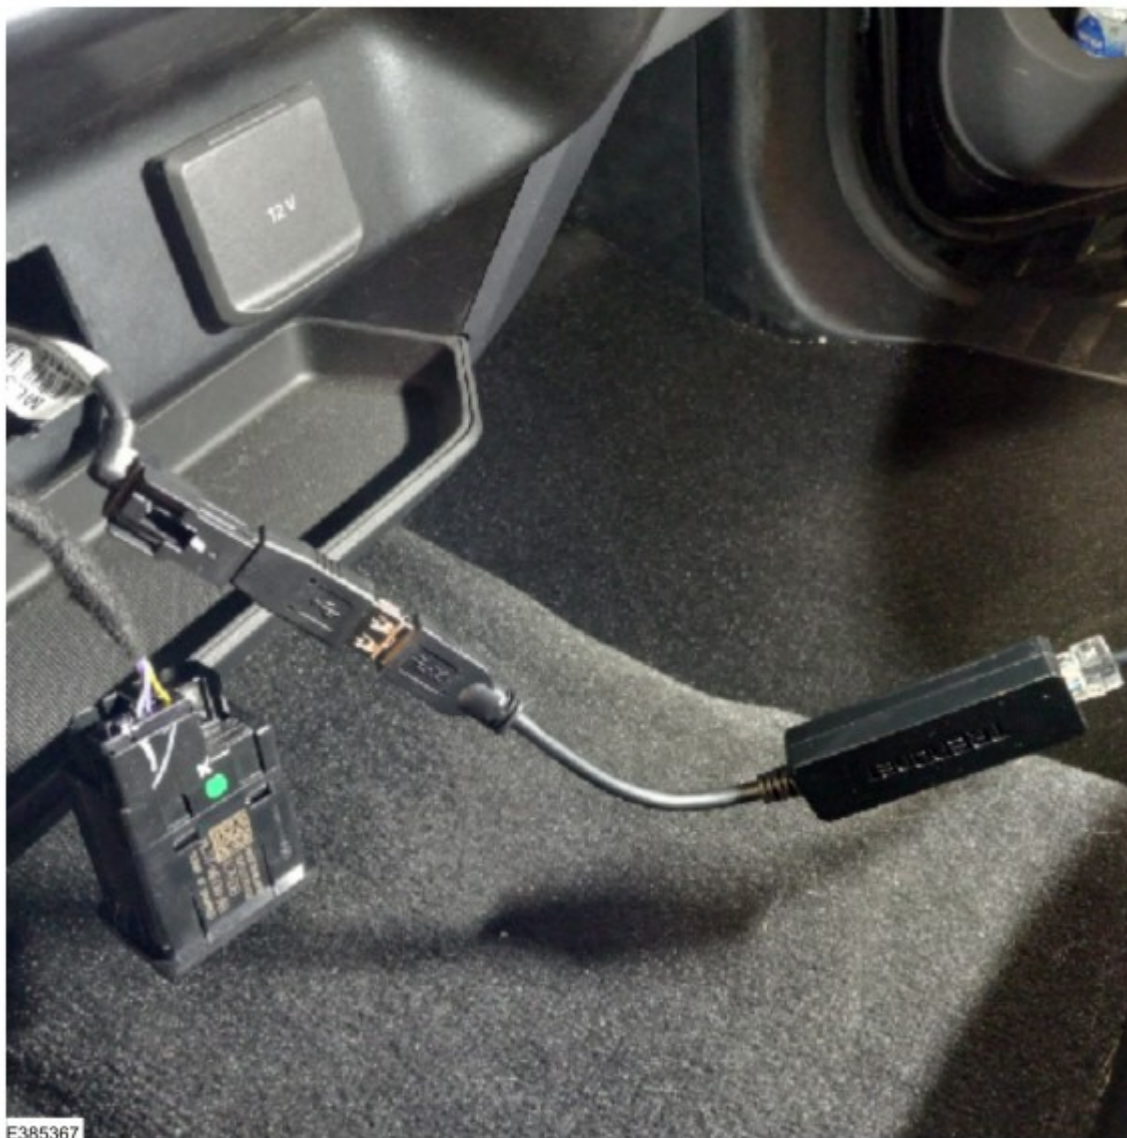
- Mustang Mach-E, Edge, Nautilus, Bronco and F-150 vehicles equipped with a SYNC media hub:
 - Connect the Mini B 5-pin female adapter to the vehicle harness.
 - Connect the USB-to-ethernet adapter to the female adapter.
 - Connect the ethernet cable to the USB-to-ethernet adapter and laptop ethernet port.

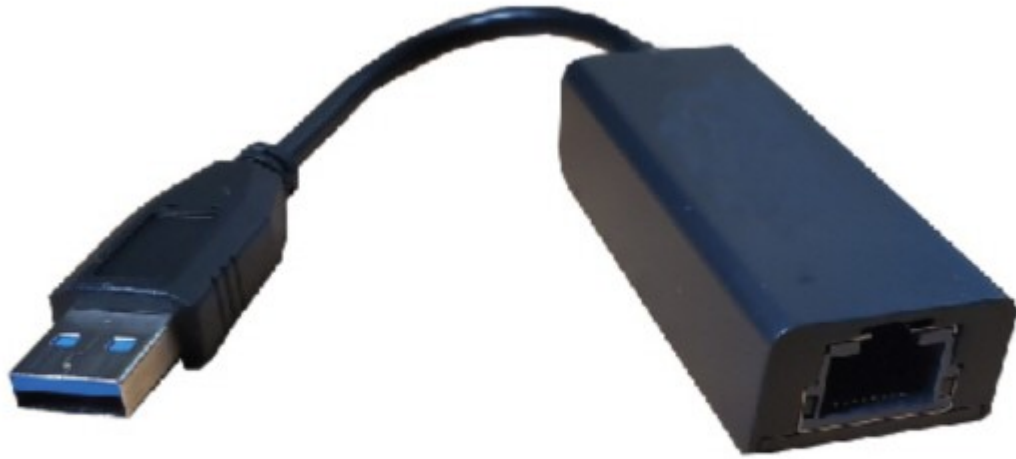
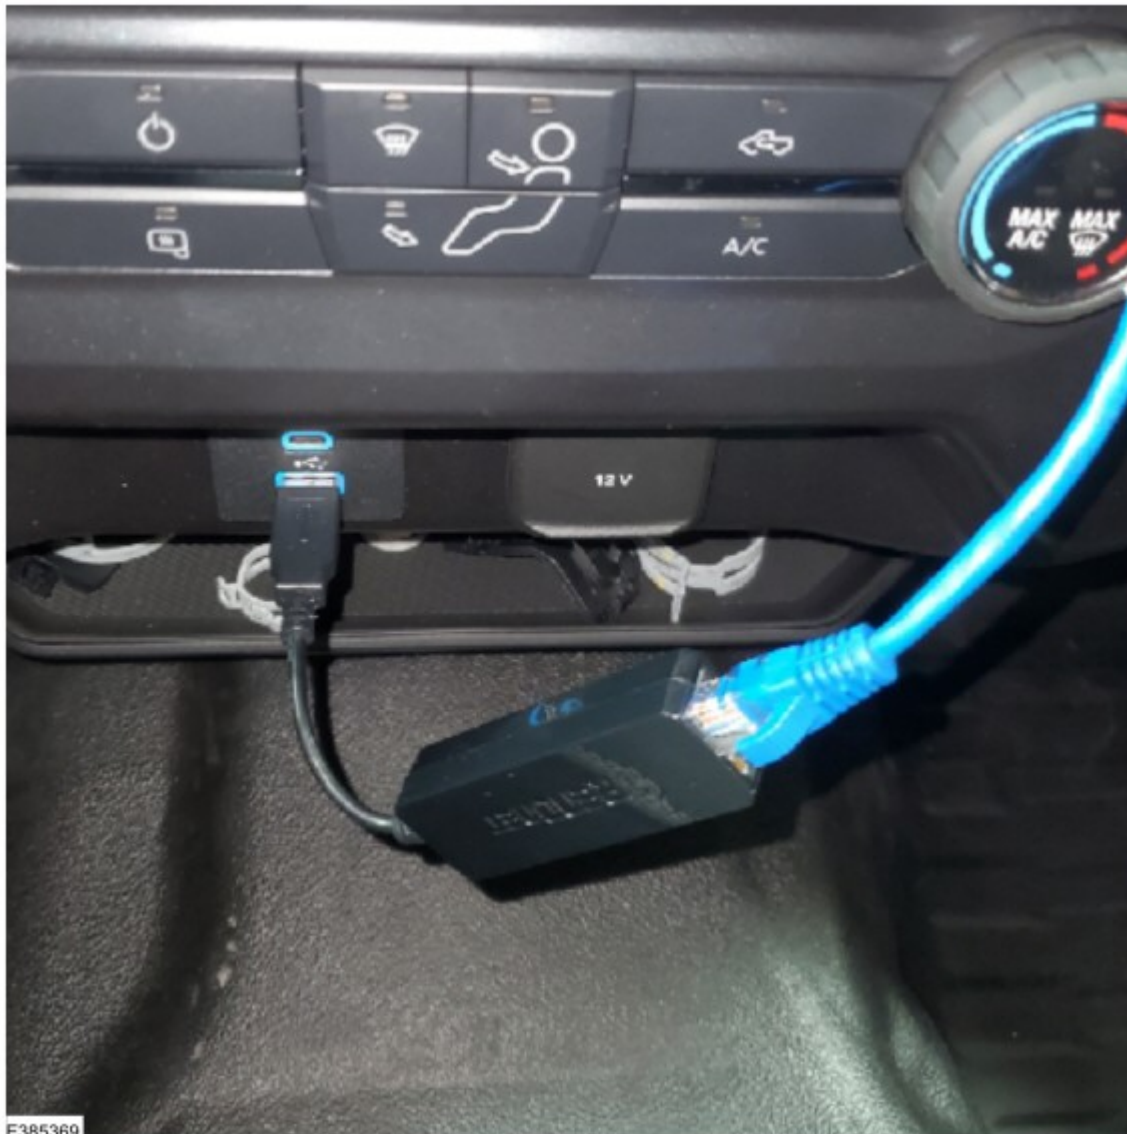
- Connect the USB-to-ethernet adapter to the vehicle USB port.
- Connect the ethernet cable to the USB-to-adapter and laptop ethernet port.
