TECHNICAL SERVICE BULLETIN

Unable to update the APIM or TCU with FDRS and USB Drive - Module Recovery

22-2166

2021 Mustang Mach-E - Battery Electric Vehicle (BEV) with High Voltage (HV) Technology | Assembly Plant: Cuautitlan (Mexico)

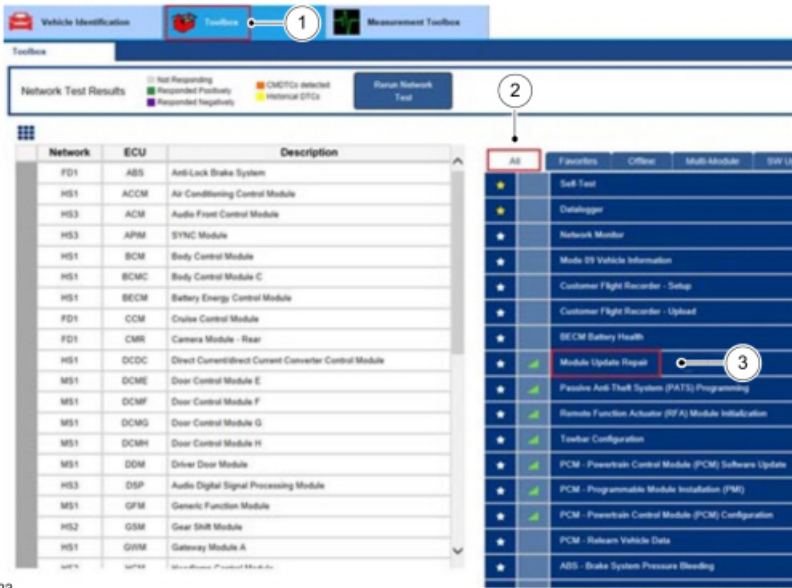
E384523

2. Navigate to the toolbox tab on FDRS then select the Multi Module tab. Under the Multi Module tab, download and run the Module Update Repair application.

- (1). Toolbox tab
- (2). Multi module
- (3). Module Update Repair application

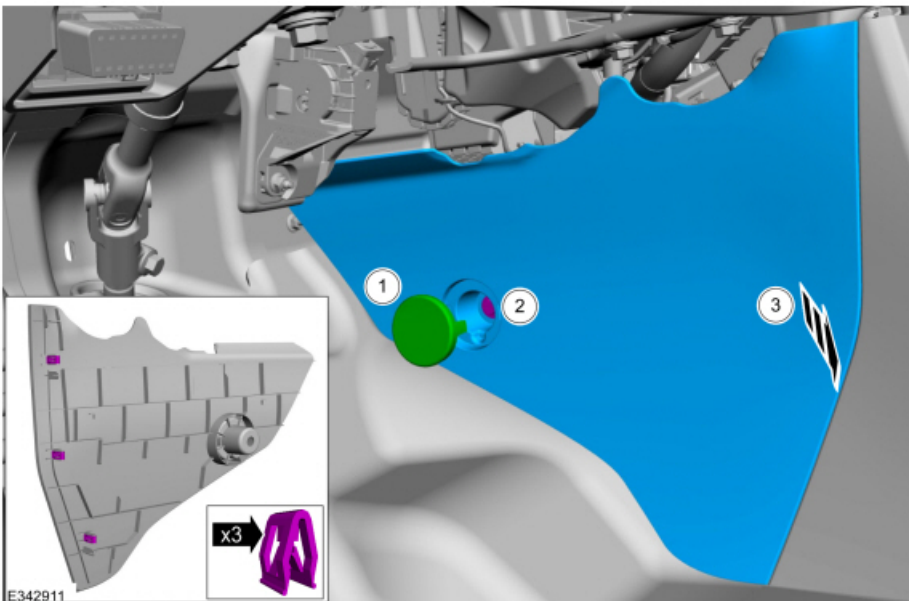
E342911

Gain access to the APIM in-line USB cable connector. For additional information, refer to Mustang Mach-E 2021 Workshop Manual Section 501-12.

- o Remove the left-hand side floor console front trim panel.

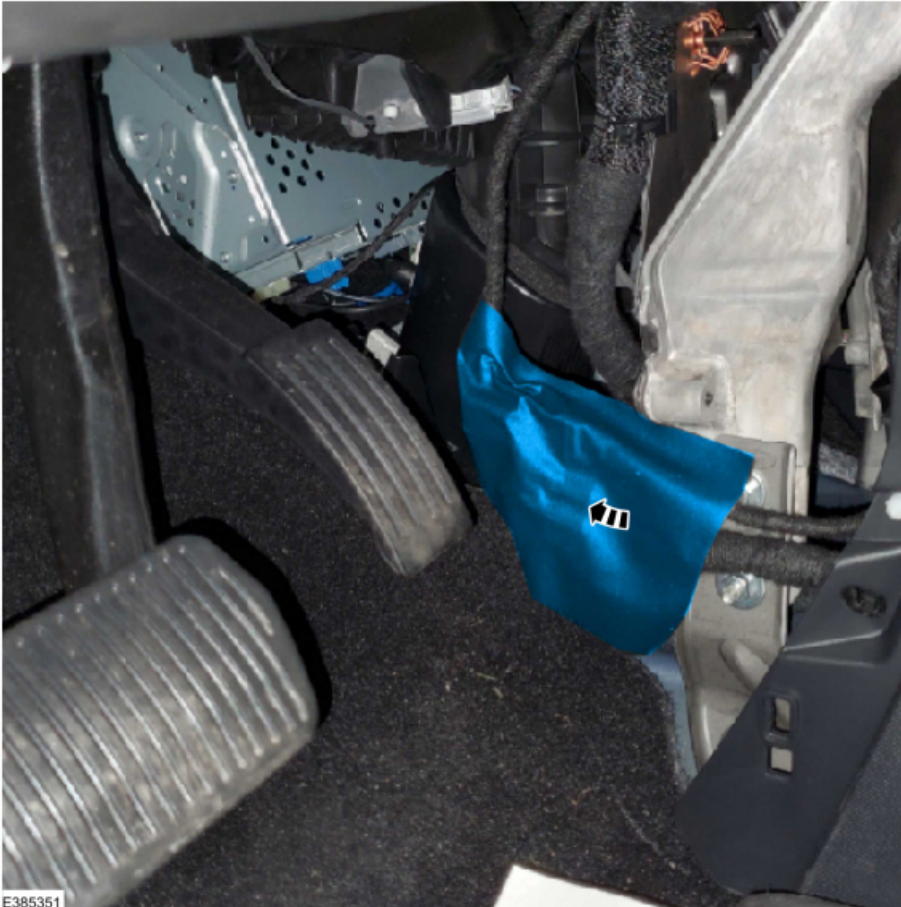
5. The electrical connector may be concealed by tape.

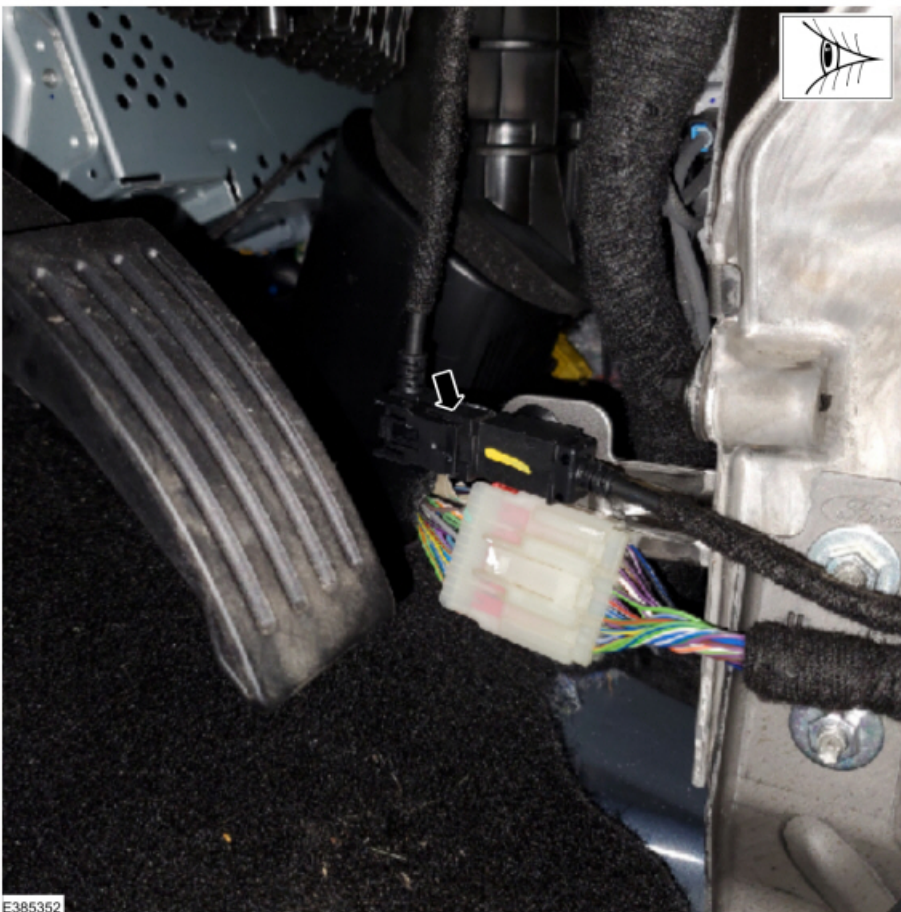
6. Disconnect the APIM in-line USB electrical connector.

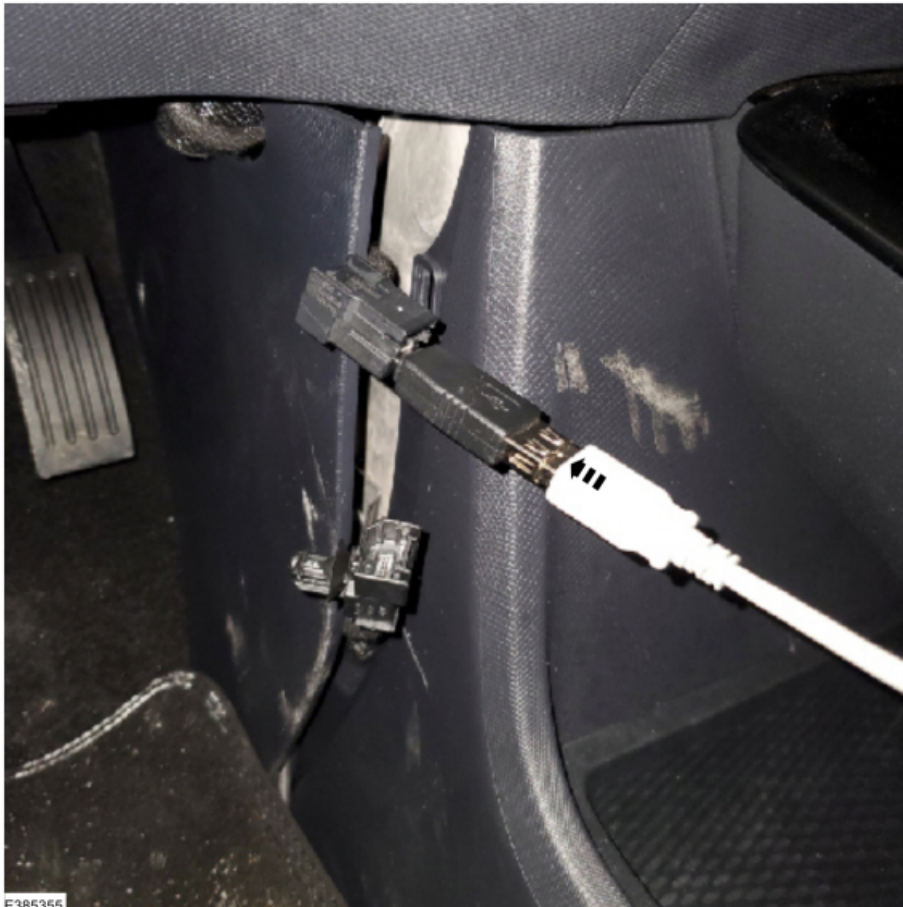
E385355

2. Required USB connections - A1 and A2:

- A1 - Connect the Adapter USB type A Female - Mini B 5 Pin Female, to the vehicle harness.
- A2 - Connect the Cable USB 2 Male – USB 2 Male, to the USB female adapter, and to the laptop computer USB port.

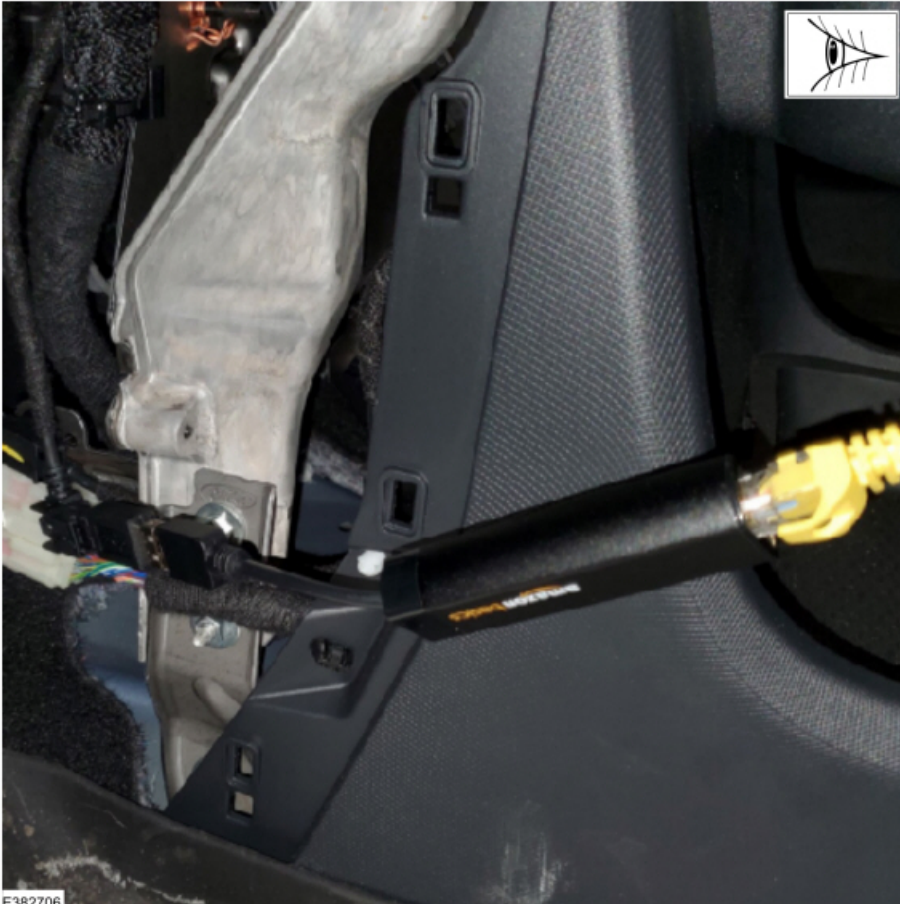
E382706

2. Required Ethernet connections - B1, B2, and B3:

- B1 - Connect the Adapter USB type A Female - Mini B 5 Pin Female, to the vehicle harness.
- B2 - Connect the Adapter USB male – Ethernet female, to the USB female adapter.
- B3 - Connect the Cable Ethernet male - Ethernet male, to the Ethernet female adapter, and to the laptop computer ethernet port.
