## TECHNICAL SERVICE BULLETIN

### Shift Knob Rotates Without Brake Pedal Depressed, Transmission Remains In Park (P)

22-2343

19 September 2022

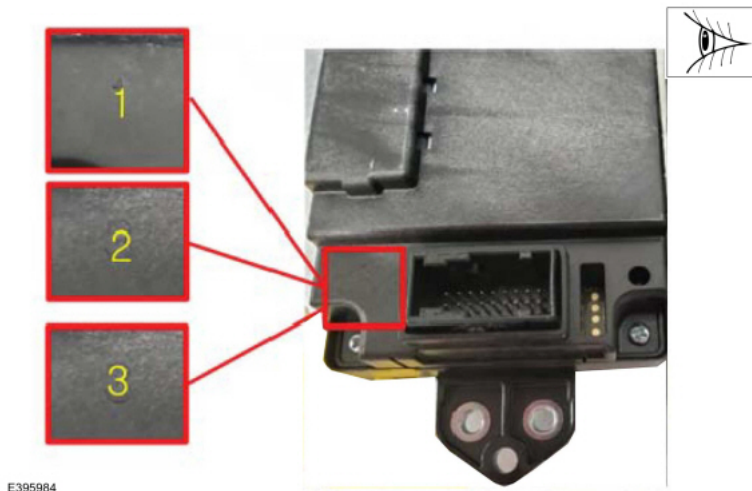
Figure 1

1. Remove center console trim. Refer to Workshop Manual (WSM) Section 307-05 Step 1.
2. Inspect the GSM at the location identified in Figure 1.

- (1). If the GSM is marked with numbers 1, 2, or 3, proceed to Step 4.
  - (2). If the GSM is marked with number 4 or blank, re-install GSM and proceed to Step 3.
3. Reprogram the GSM using the latest software level of the Ford Diagnostic and Repair System (FDRS). Repair is complete.
  4. Replace the GSM. Follow the WSM Section 307-05.
