**TECHNICAL SERVICE BULLETIN****Parking Brake Fault Service Now Message In IPC - DTCs C2008, C2007,C1034, U0293 And/Or U0100
- Built On Or Before 15-Mar-2022****22-2143**

21 April 2022

Ford 2021-2022 Mustang Mach-E	Built on or before 15-Mar-2022
---	--------------------------------

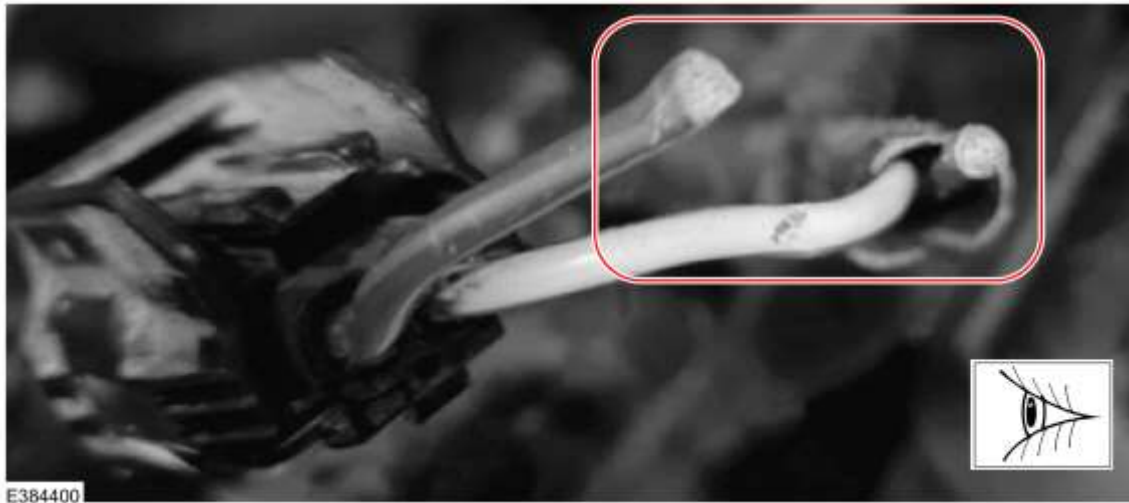
Figure 1

1. Remove both rear tires. Refer to Workshop Manual (WSM), Section 204-04A.
2. Remove the tape and the conduit on the wiring harness to both the left/right rear brake calipers.
3. Inspect the wiring for damage or open circuit. Is there a damaged or open circuit? (Figure 1)
 - (1). Yes - proceed to Step 4.
 - (2). No - proceed to Step 9.
