TECHNICAL SERVICE BULLETIN

22-2404

Unable To Update The APIM, TCU Or GWM With The FDRS And USB Drive - Module Recovery

31 October 2022

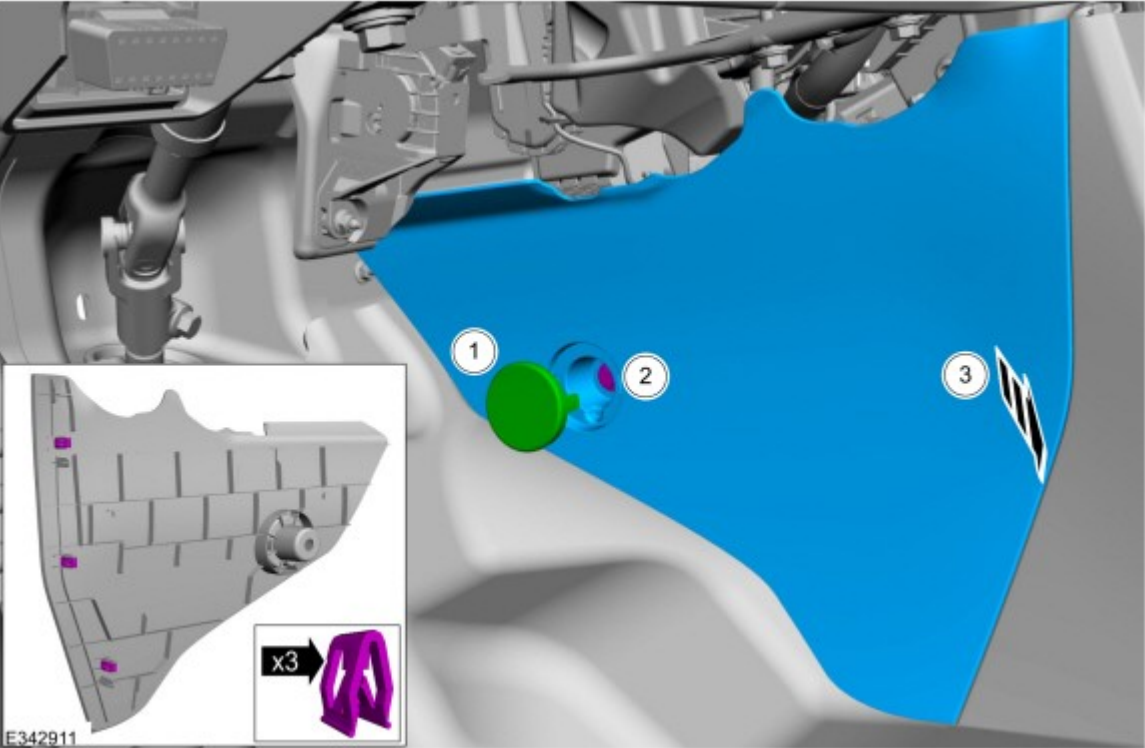
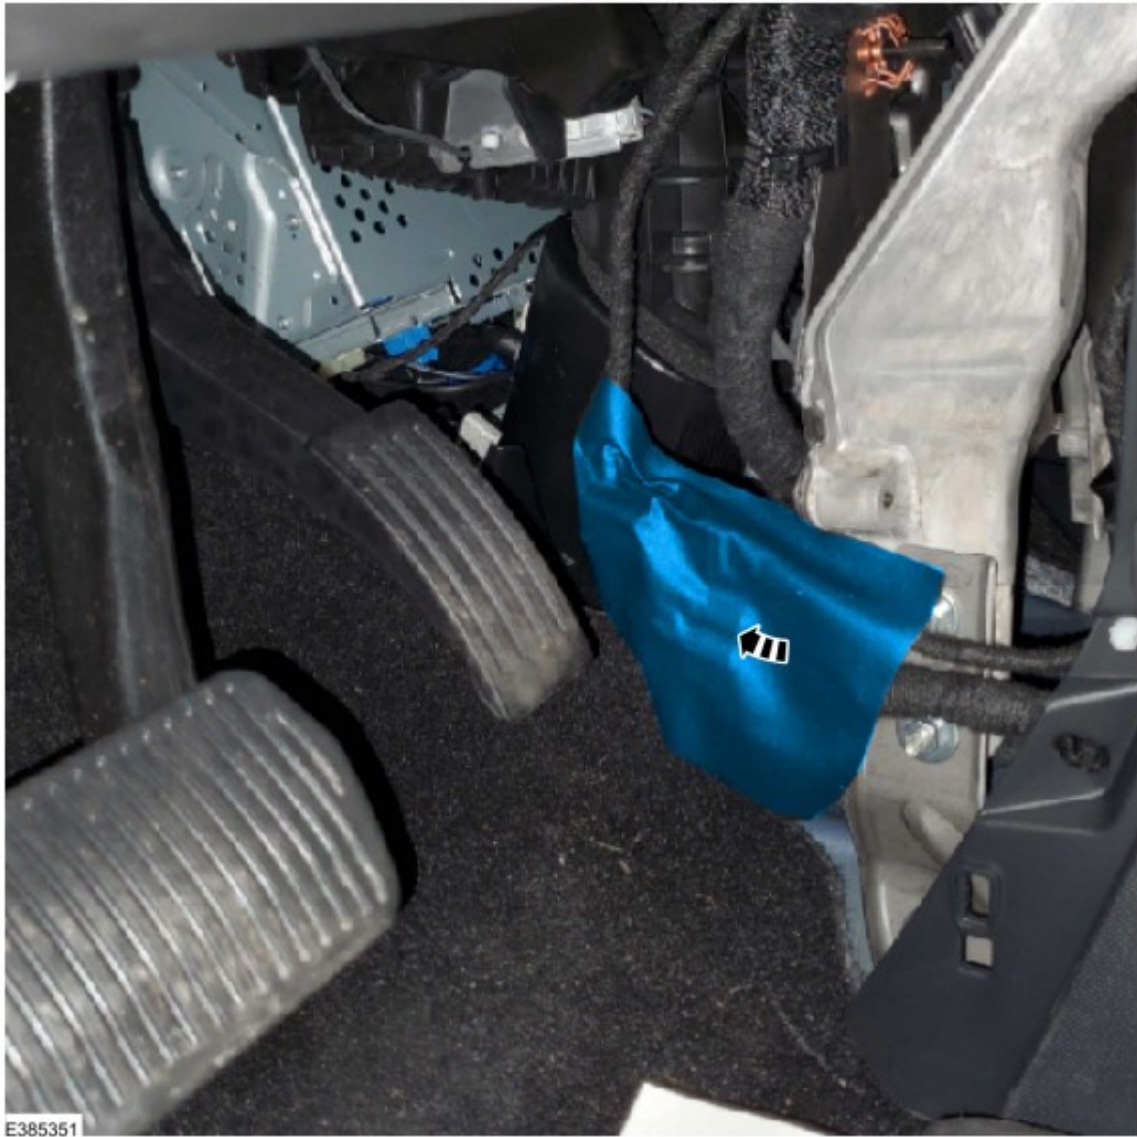
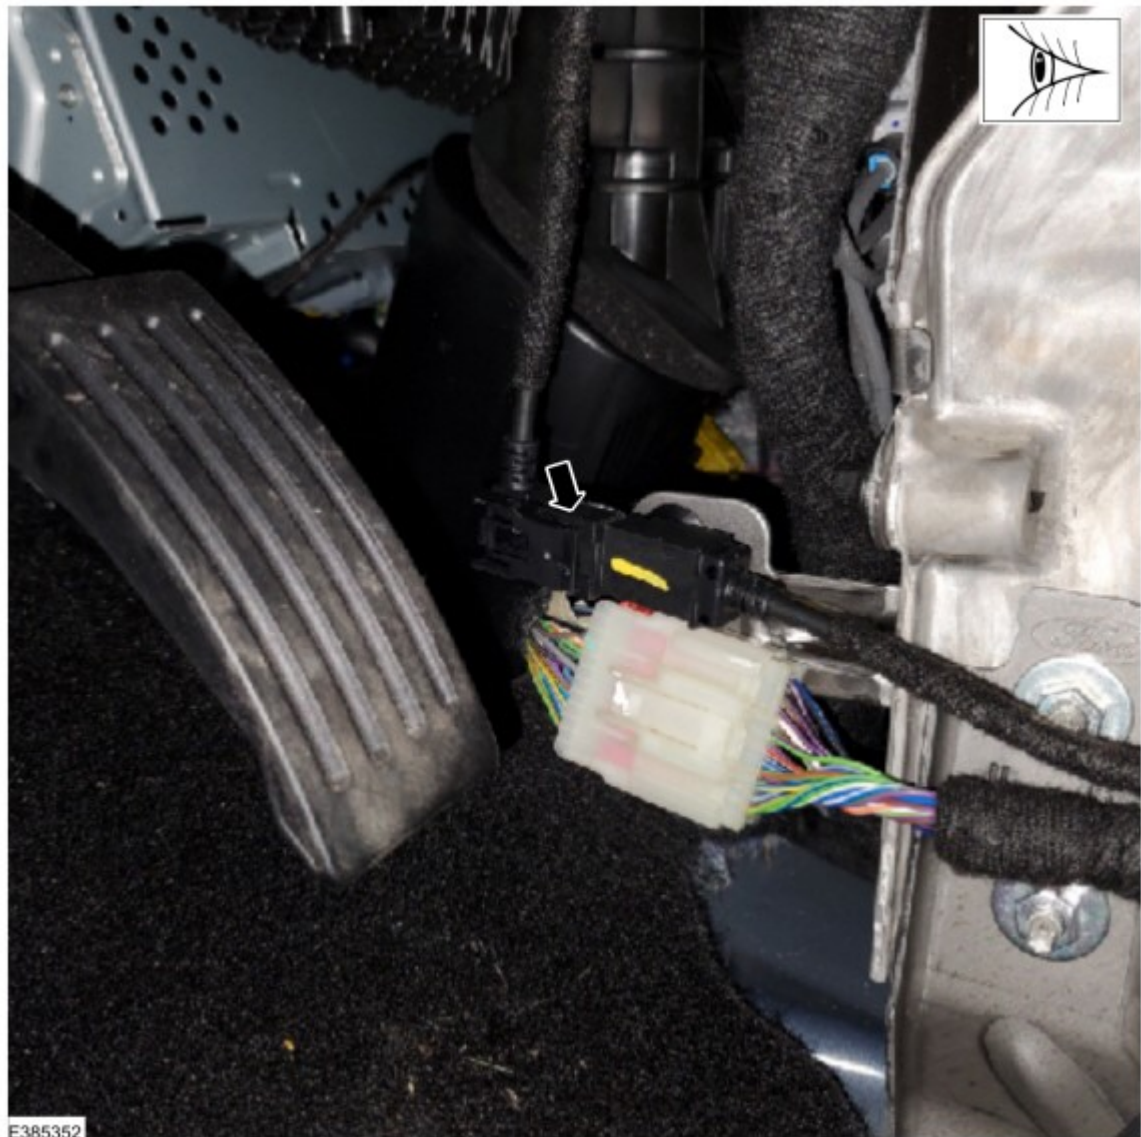
(1). For Mustang Mach-E vehicles, remove the left-hand side floor console front trim panel and disconnect the APIM in-line USB connector. The connector may be concealed by tape. Refer to Step 4 in the WSM Section 501-12 floor console removal. (Figures 1-3)

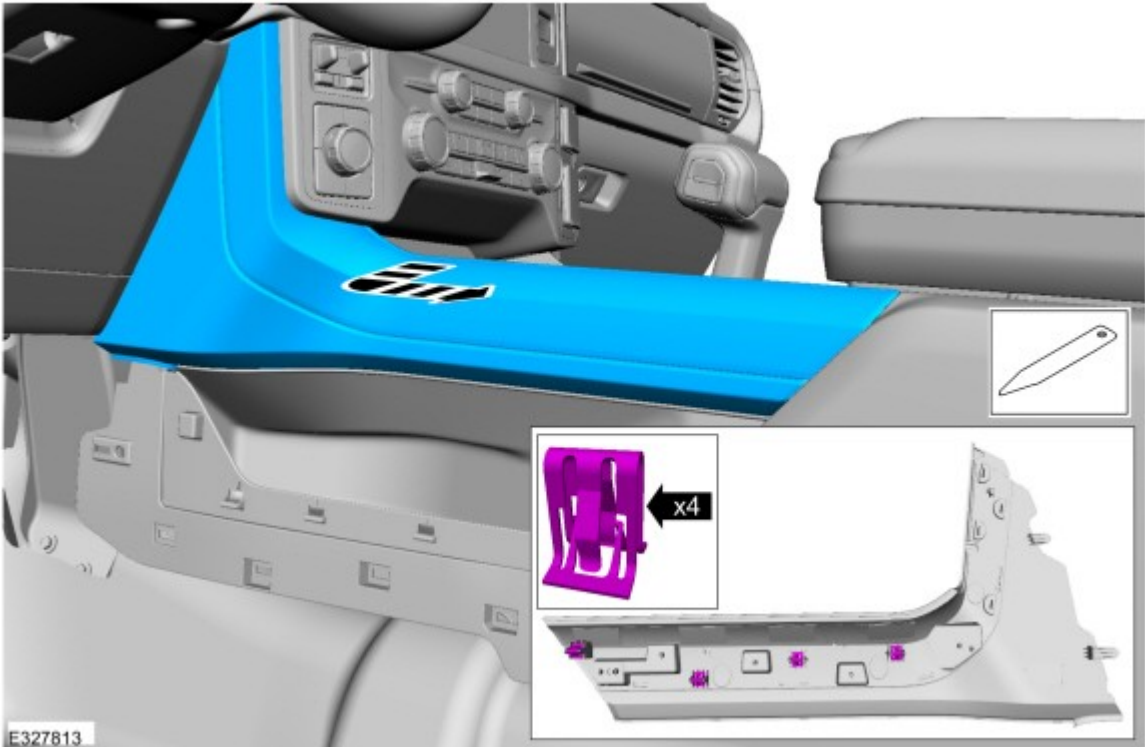
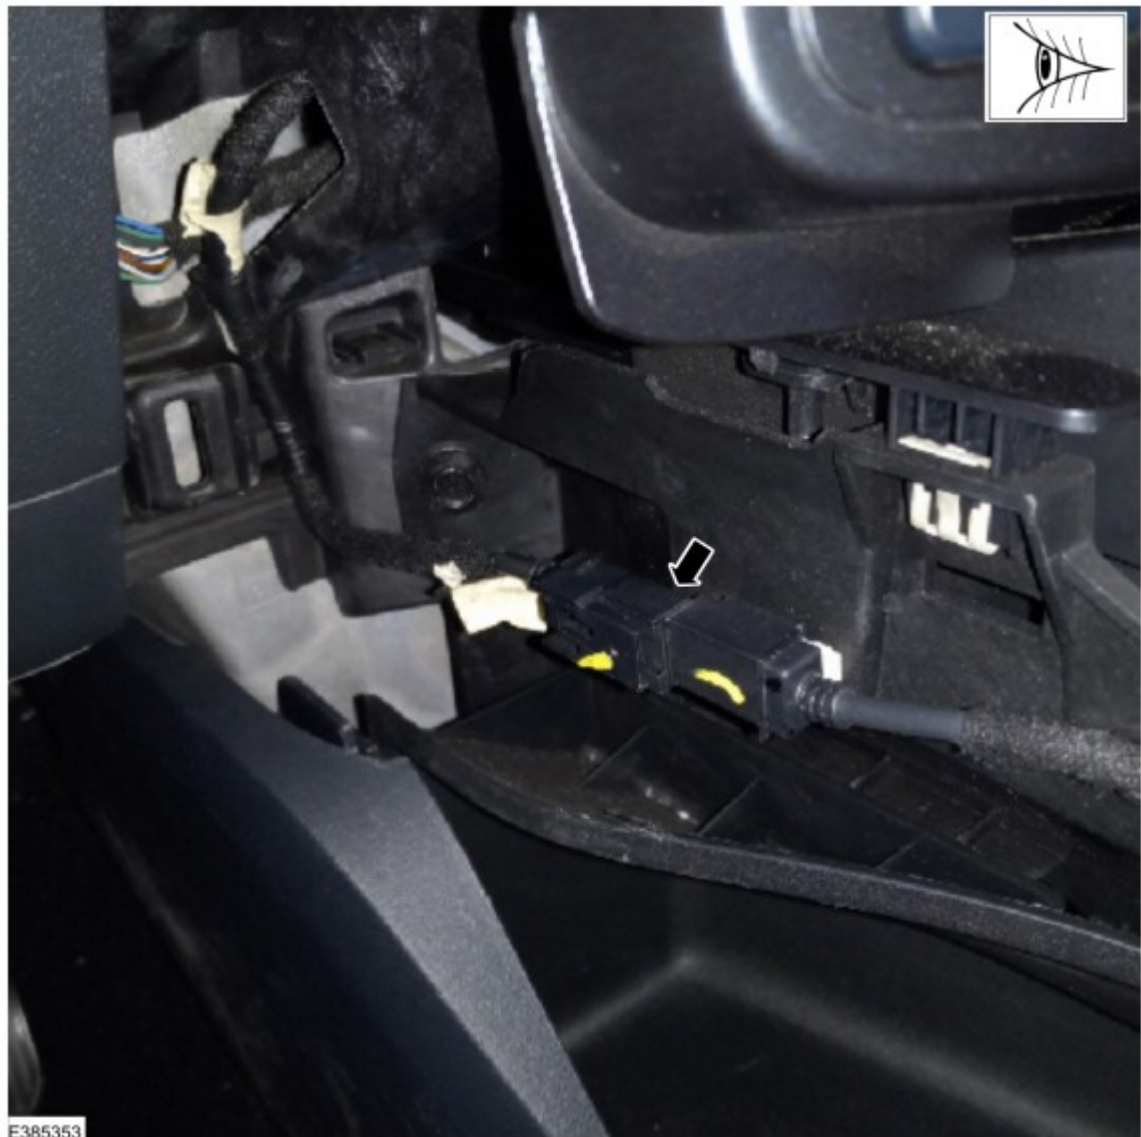
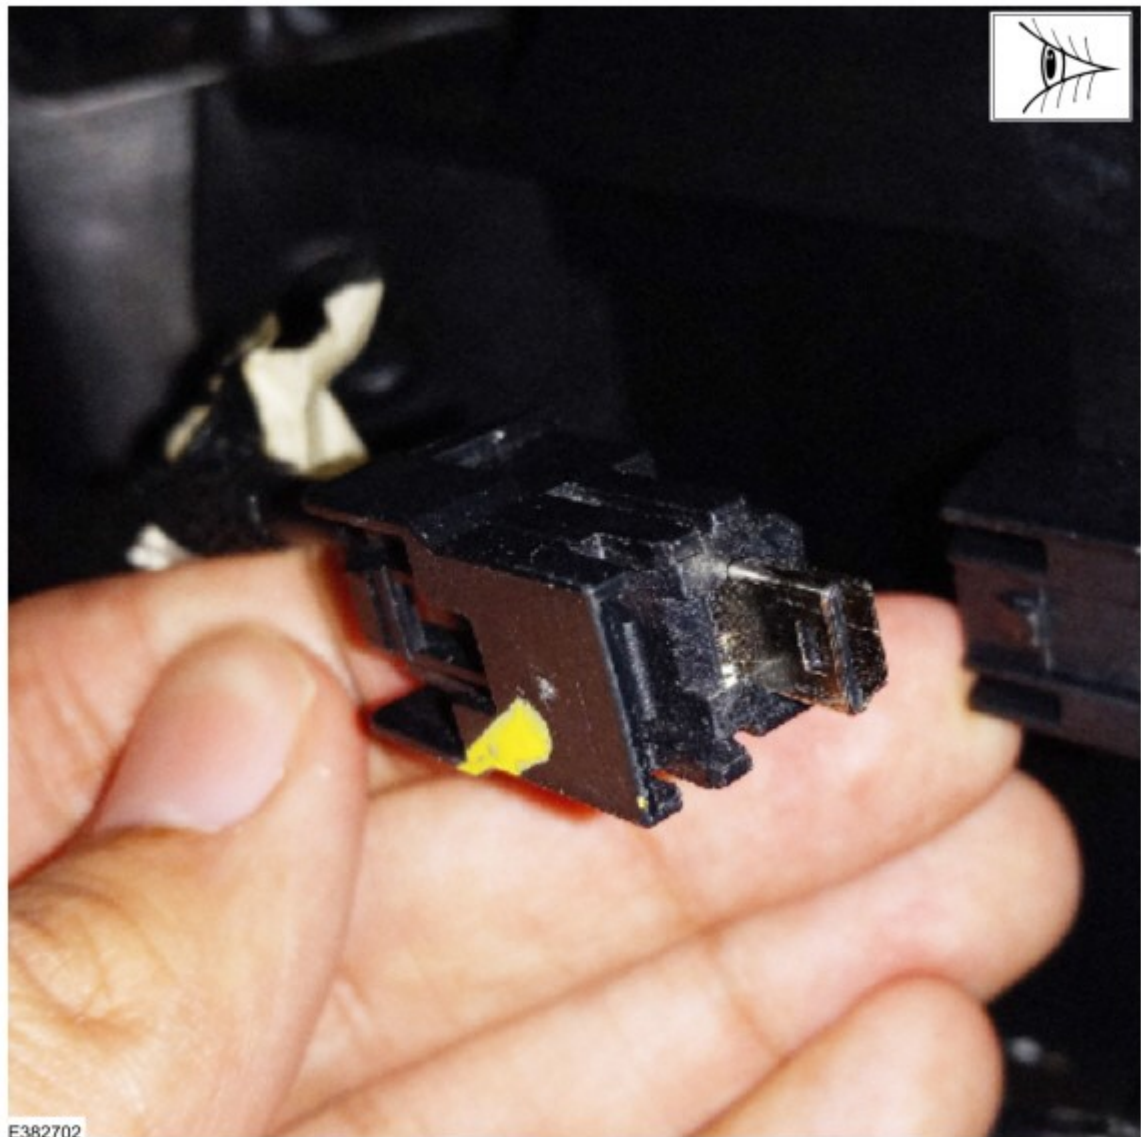
(2). For F-150 vehicles with a SYNC media hub and center console, remove the floor console lower left hand trim panel and disconnect the APIM in-line USB connector. Refer to Step 5 in Workshop Manual (WSM), Section 501-12 floor console removal. (Figures 4-6)

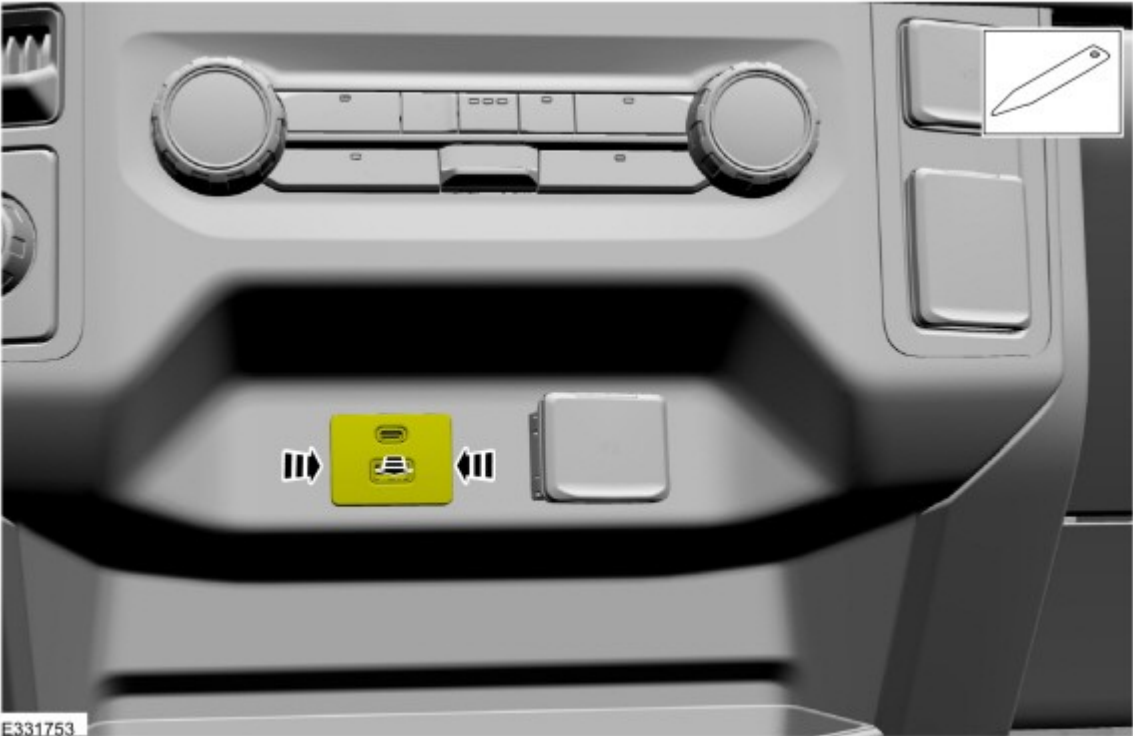
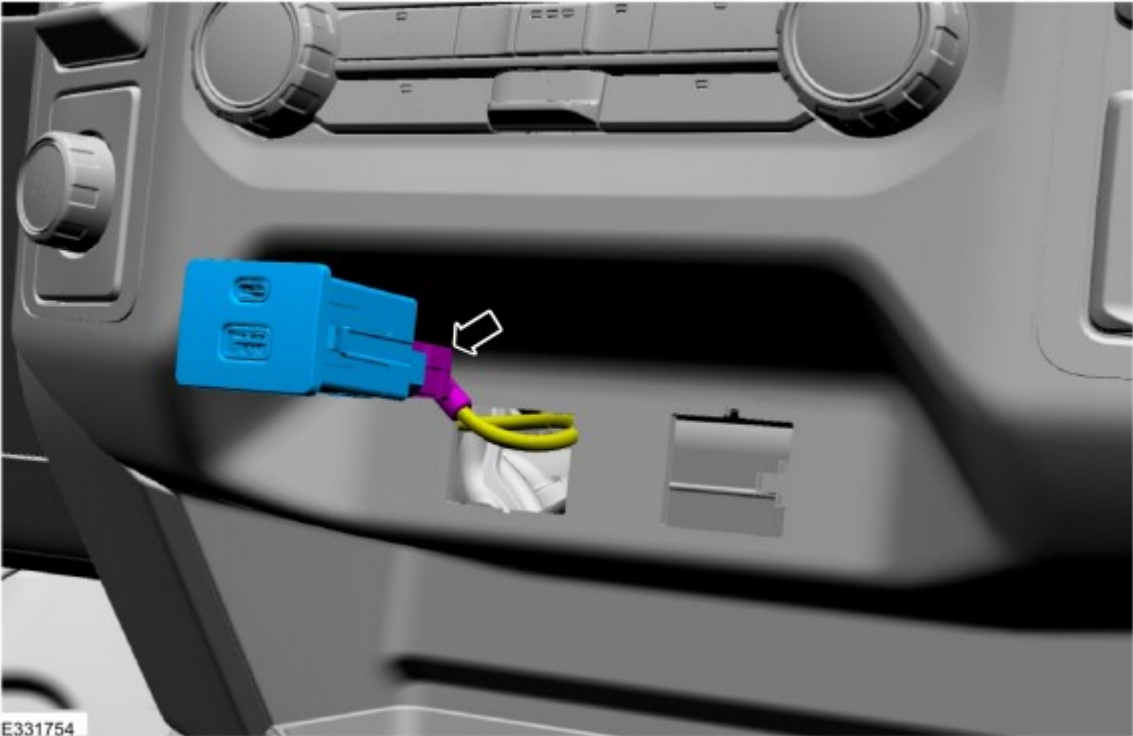
(3). For F-150 vehicles with the SYNC media hub and no center console, disconnect the SYNC media hub mini-USB connector from the back of the media hub. On some F-150 vehicles, media hub removal may not be required and the mini-USB connector can be accessed from the back of the instrument panel. Refer to Step 2 in Workshop Manual (WSM), Section 415-00 Universal Serial Bus (USB) Hub removal. (Figures 7-8)

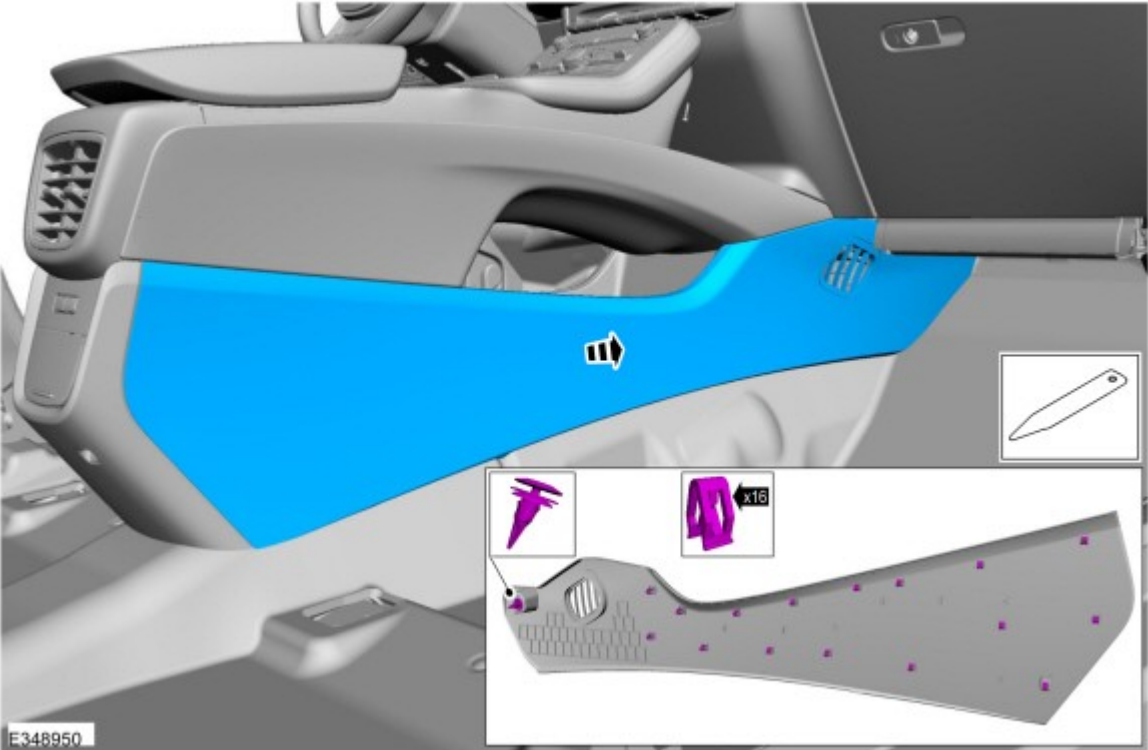
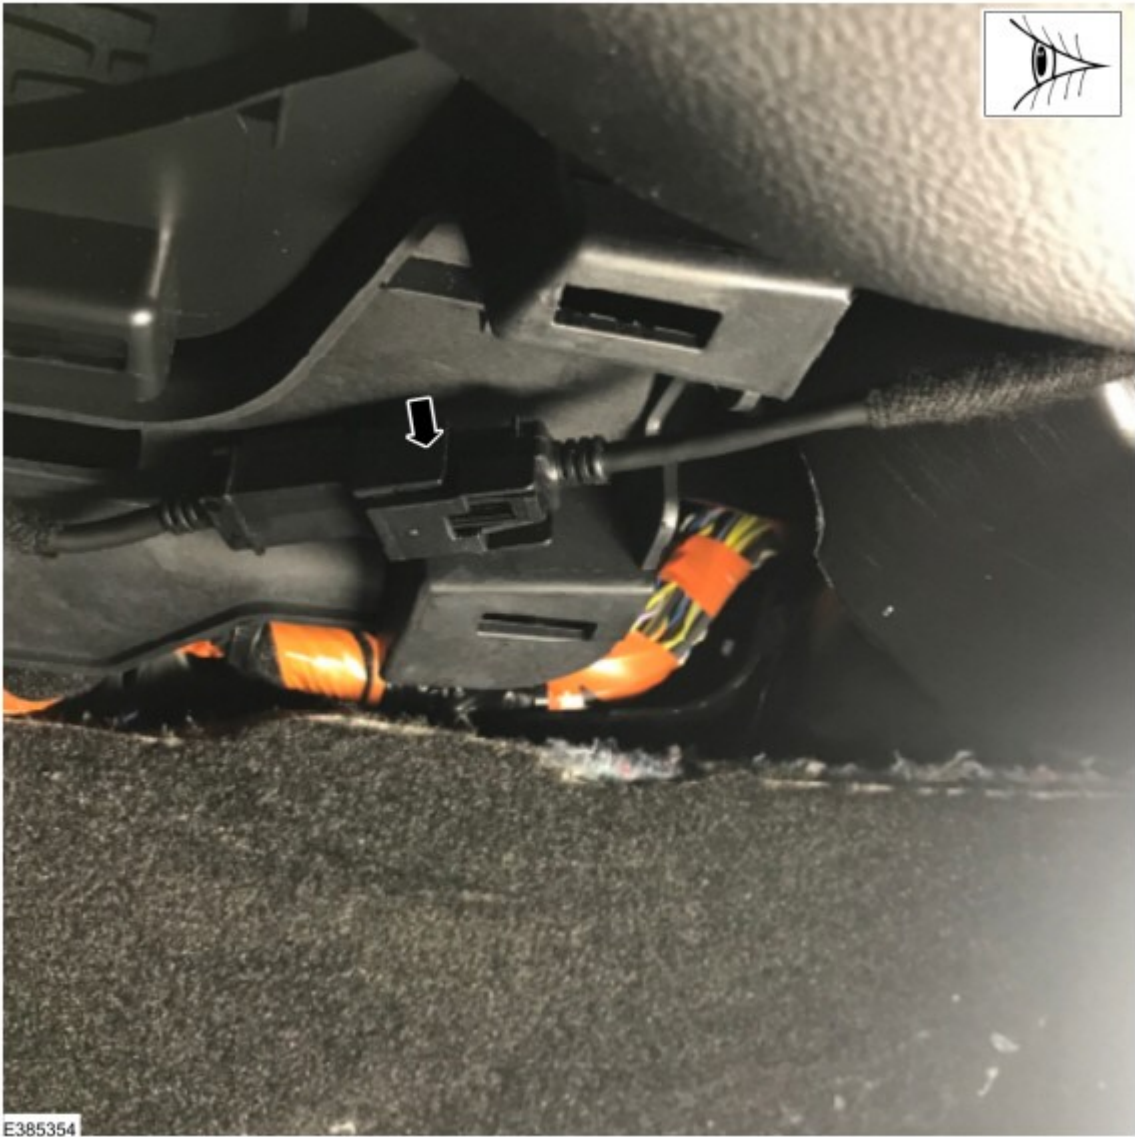
(4). For Nautilus vehicles, remove the floor console lower right hand trim panel and disconnect the APIM in-line USB connector. Refer to Step 1 in Workshop Manual (WSM), Section 501-12 floor console removal. (Figures 9-10)

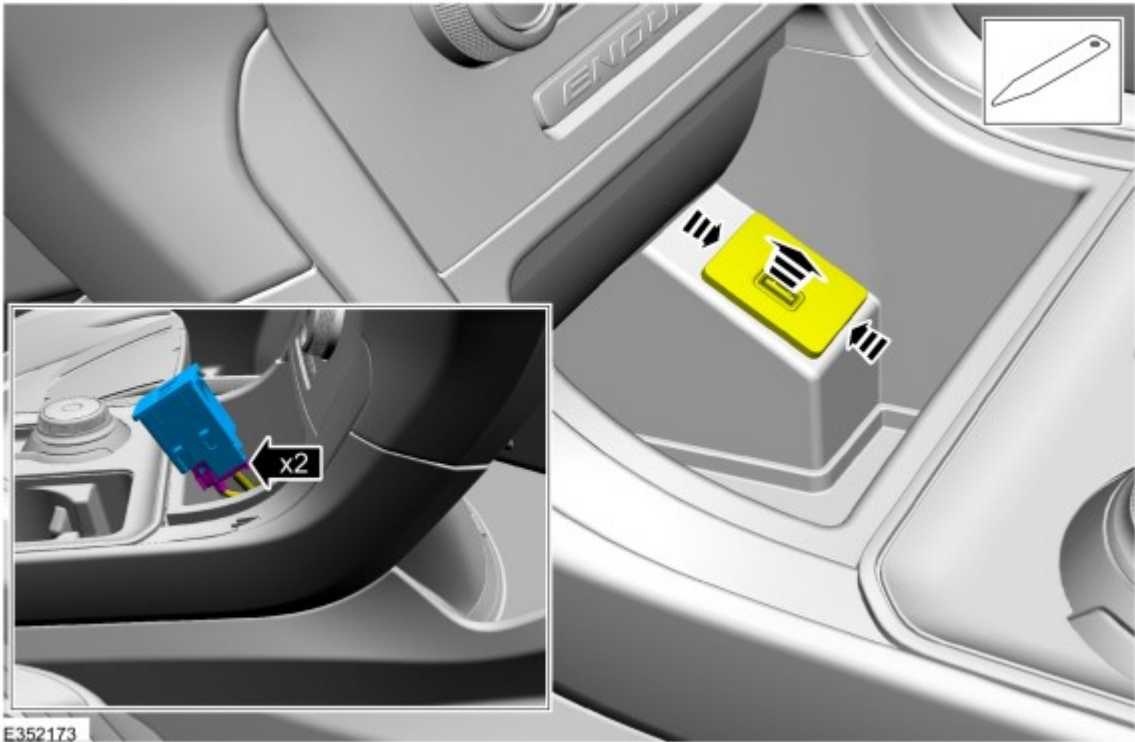
Figure 11

(5). For Edge vehicles, remove the SYNC media hub and disconnect the mini-USB connector on the back of the media hub. Refer to Step 1 in Workshop Manual (WSM), Section 415-00 Media Hub removal. (Figure 11)
