## CERTAIN 2021-2022 MODEL YEAR MUSTANG MACH-E — ELECTRIC PARKING BRAKE WIRE REPAIR

### SERVICE PROCEDURE

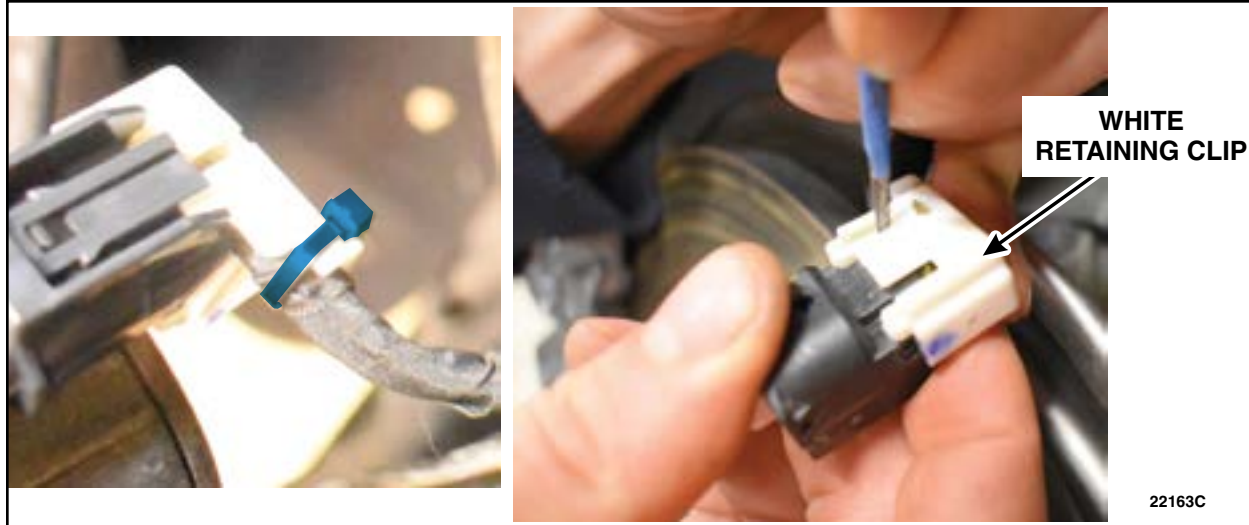
**FIGURE 3**

6. Remove the tie strap connecting the retaining clip to the harness. Then, using a small screwdriver, remove the white retaining clip from the connector. See Figure 3.

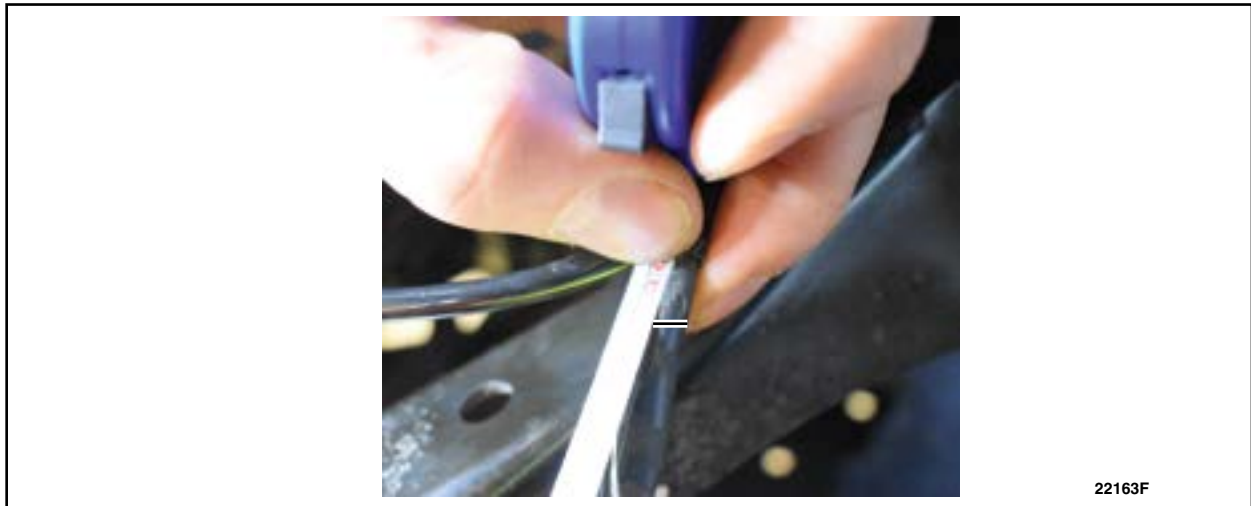
**FIGURE 6**

9. Starting at the connector, measure 300mm (11.8 in) back and mark the wires. See Figure 6.

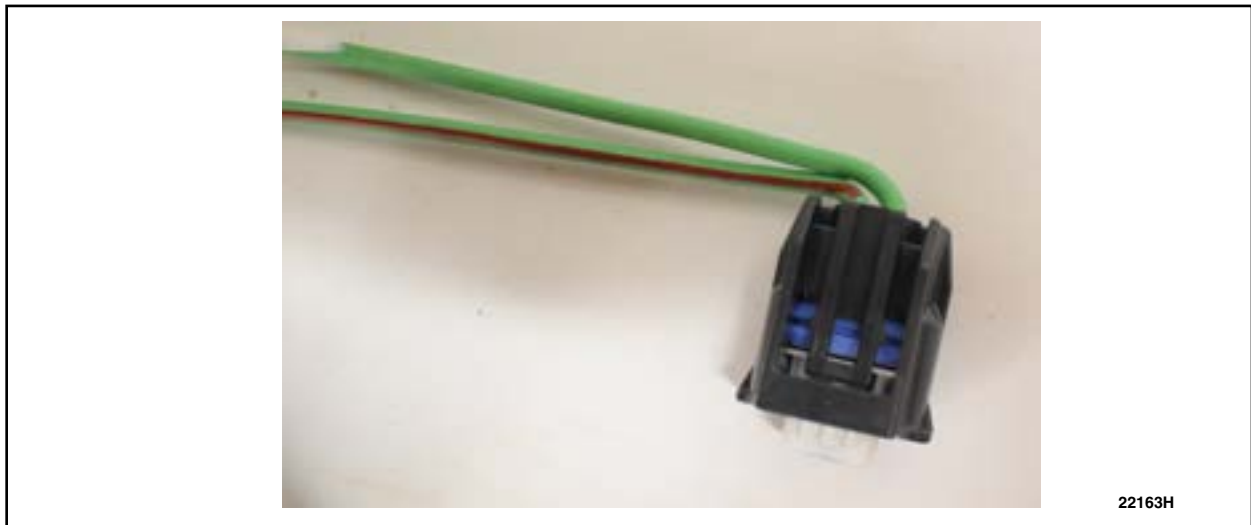
**FIGURE 8**

11. Before installing the *new* connector, it is recommended to bend the wires at the connector so that the clip will seat better to the *new* connector. See Figure 8.

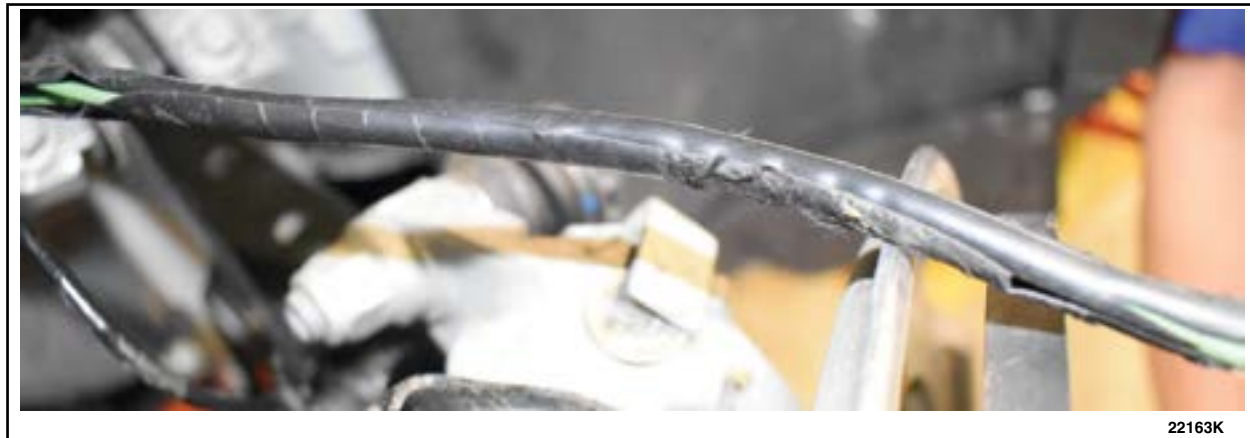
**FIGURE 10**

13. Reinstall the conduit and trim back 10mm (0.4in) from the connector. See Figure 10.

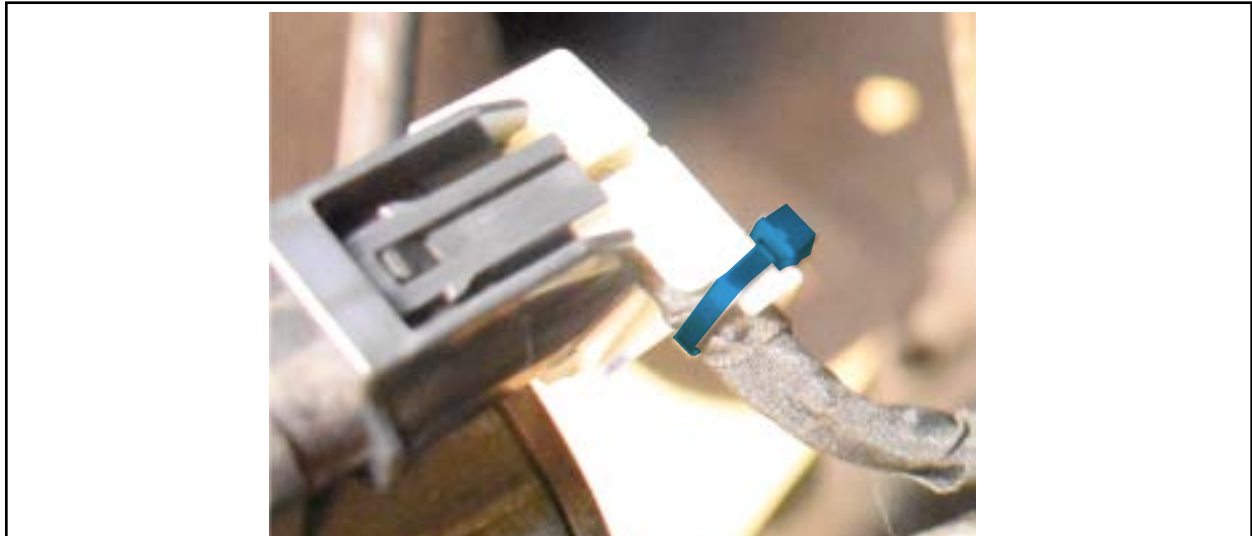
**FIGURE 14**

17. Reinstall the last tie strap that secures the white retaining clip to the harness. See Figure 14.
