CERTAIN 2021-2023 MACH-E VEHICLES — PAINT SEALANT ISSUES - DOOR HEMS INSPECTION - REPAIR

SERVICE PROCEDURE

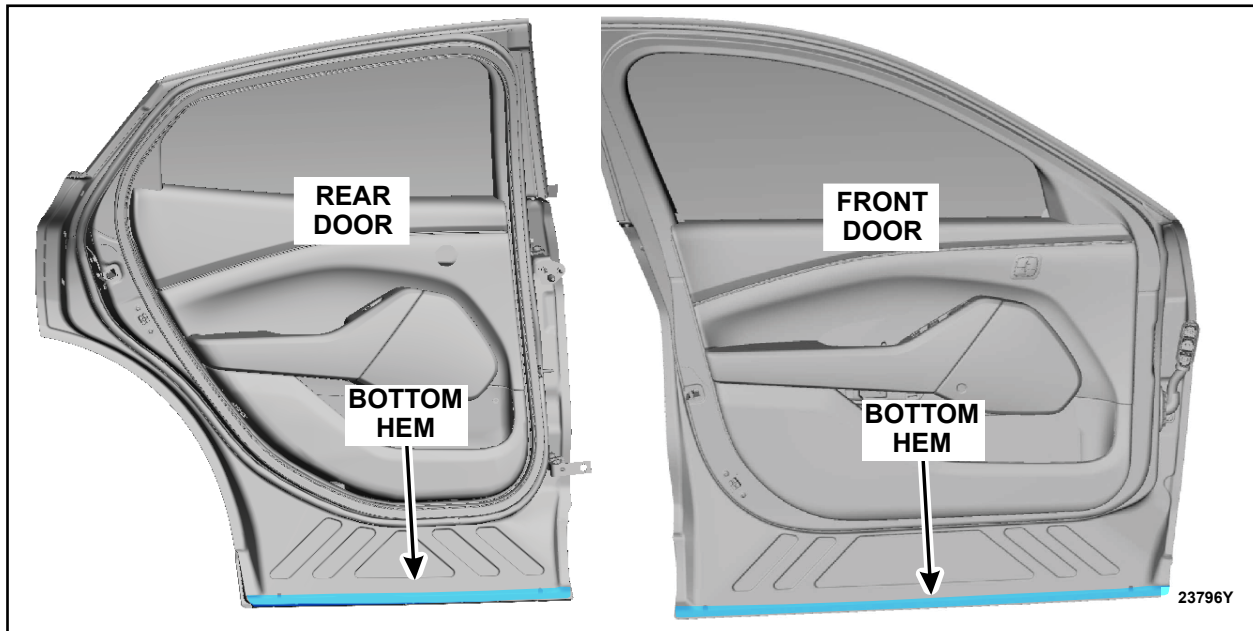
FIGURE 1

1. Clean the bottom hem of all four doors. See Figure 1.
2. Inspect the bottom hem of all four doors for any signs of paint sealant issues. See Figure 1.

NOTE: Driver's side doors shown. Passenger side similar.

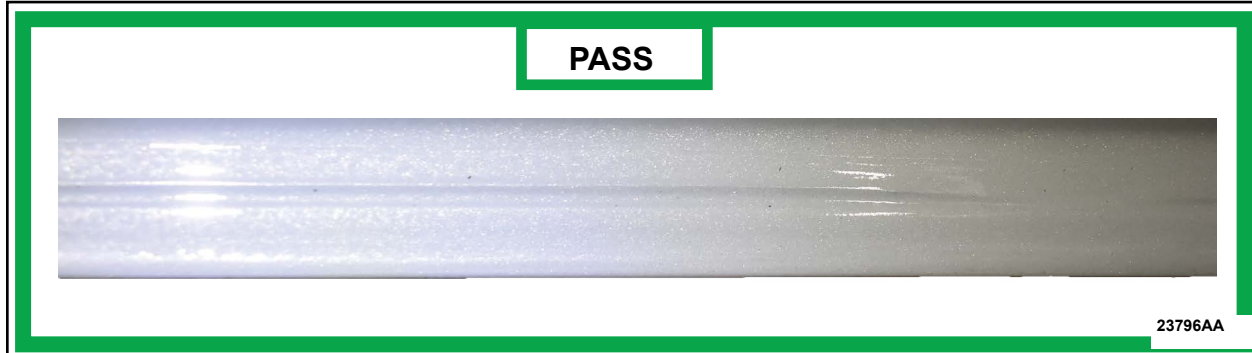
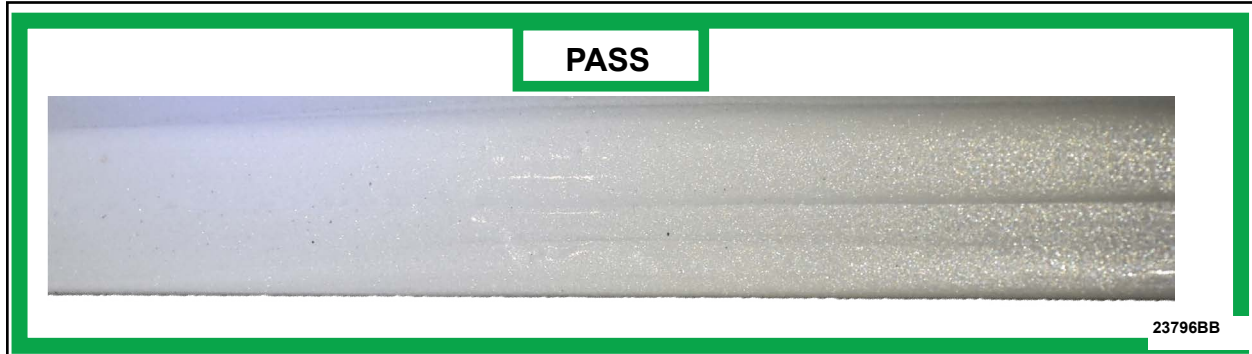
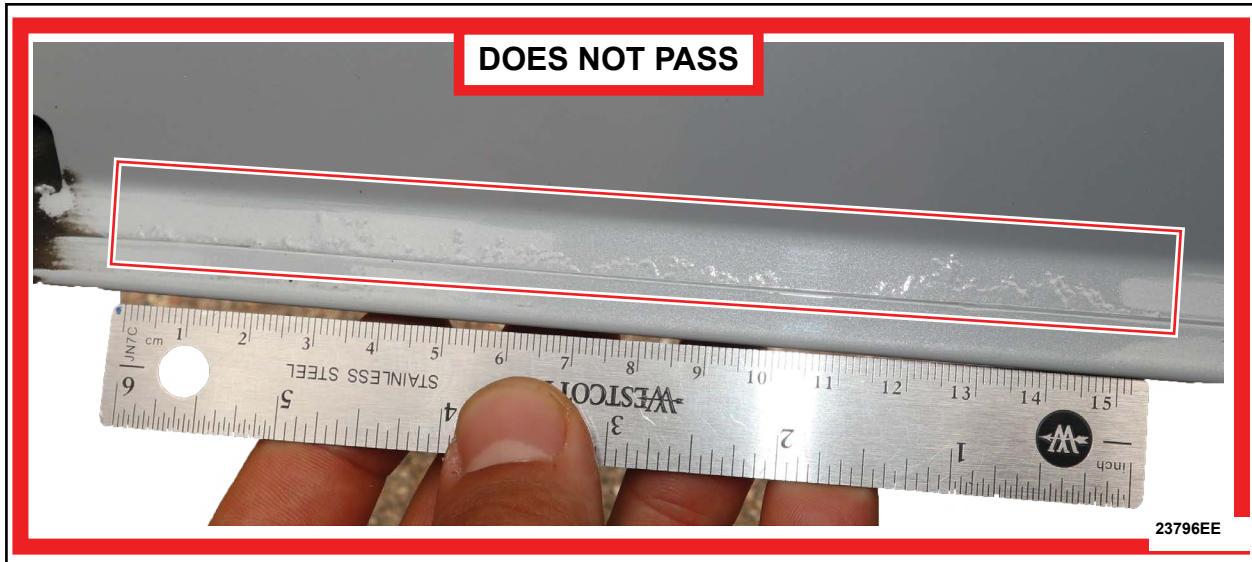
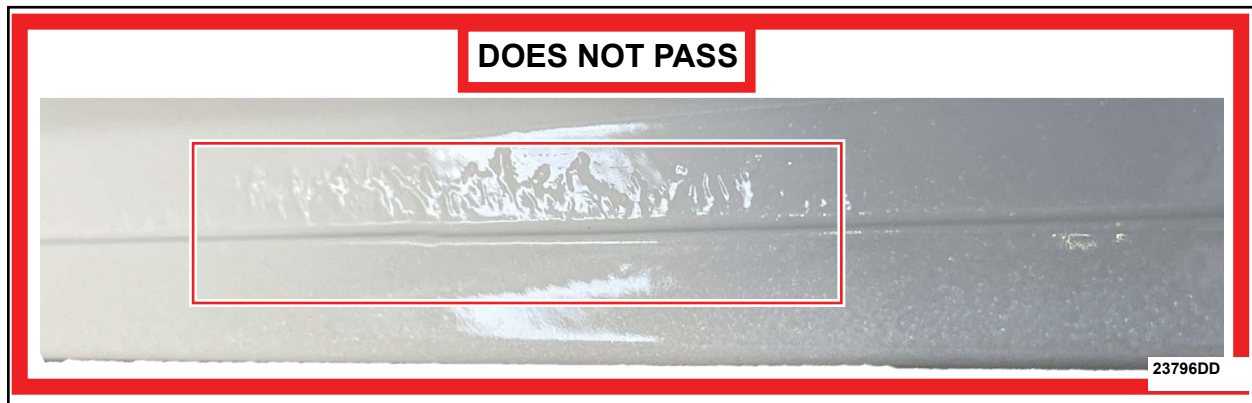
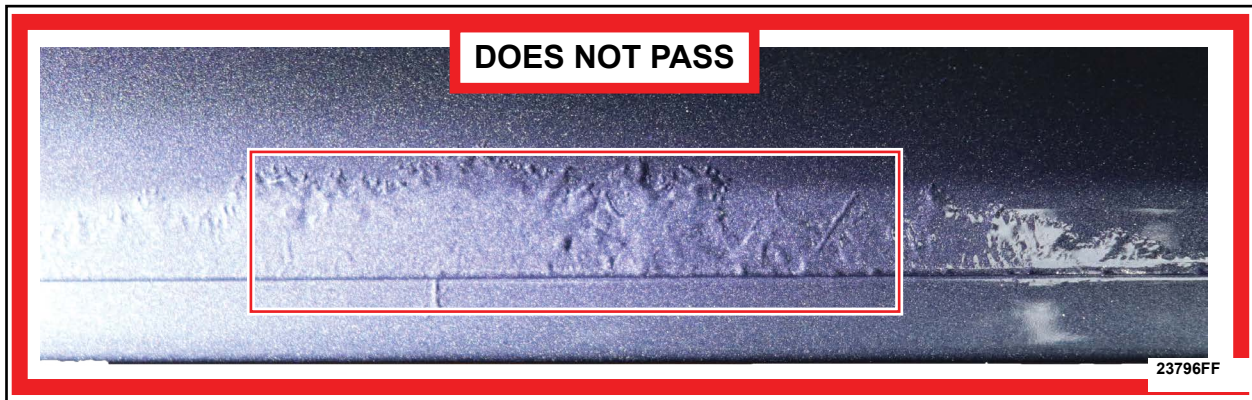
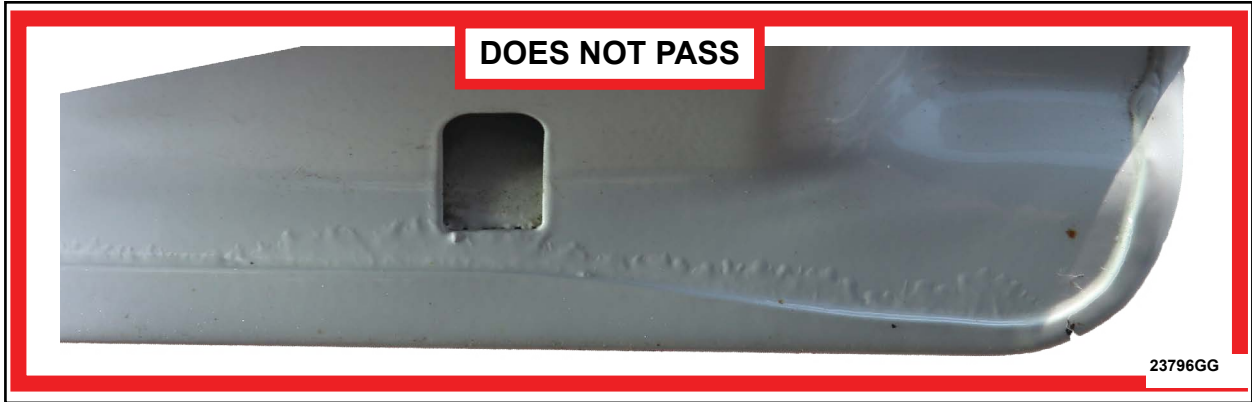
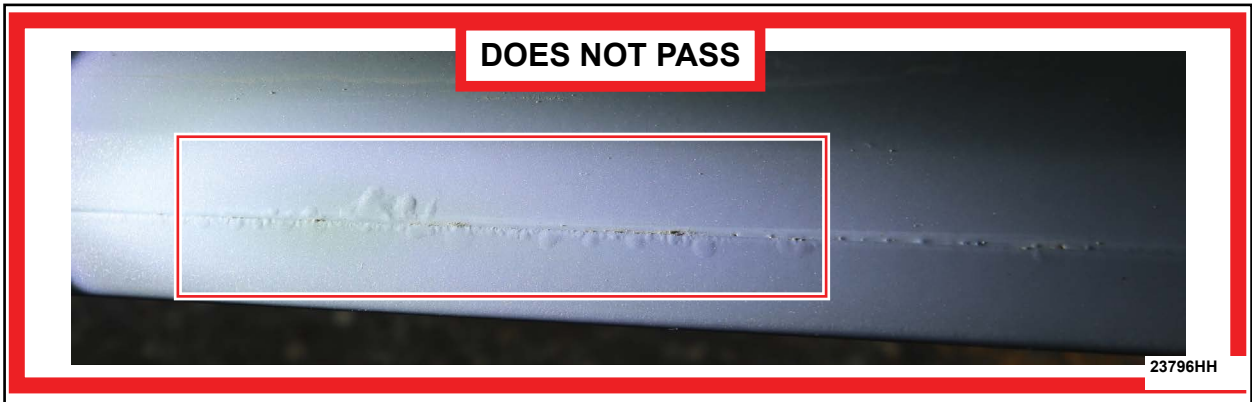
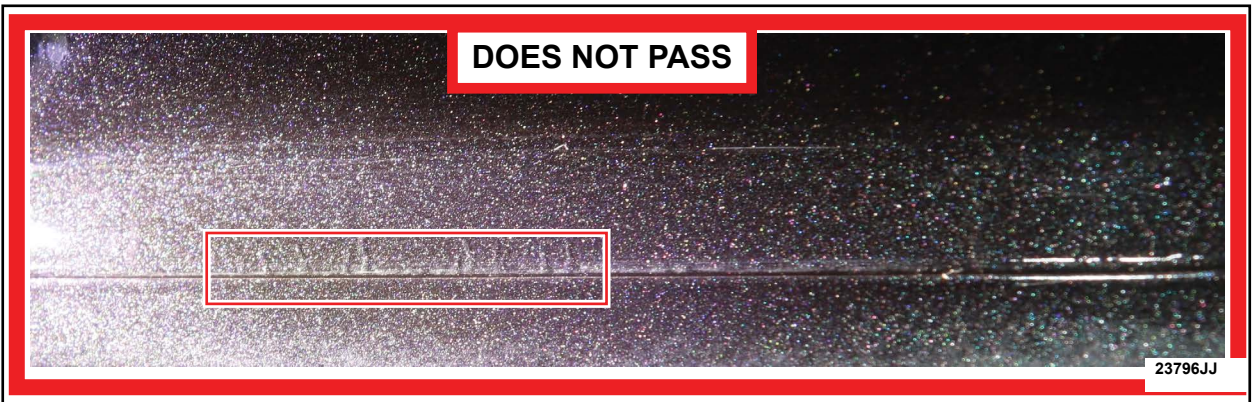
3. Were any signs of paint sealant issues present on the bottom hem of any of the 4 doors? See Figures 2-9.

Yes - Does not pass inspection, proceed to Step 4.

No - Passes Inspection, submit photos to the SSSC. This completes the Field Service Action.

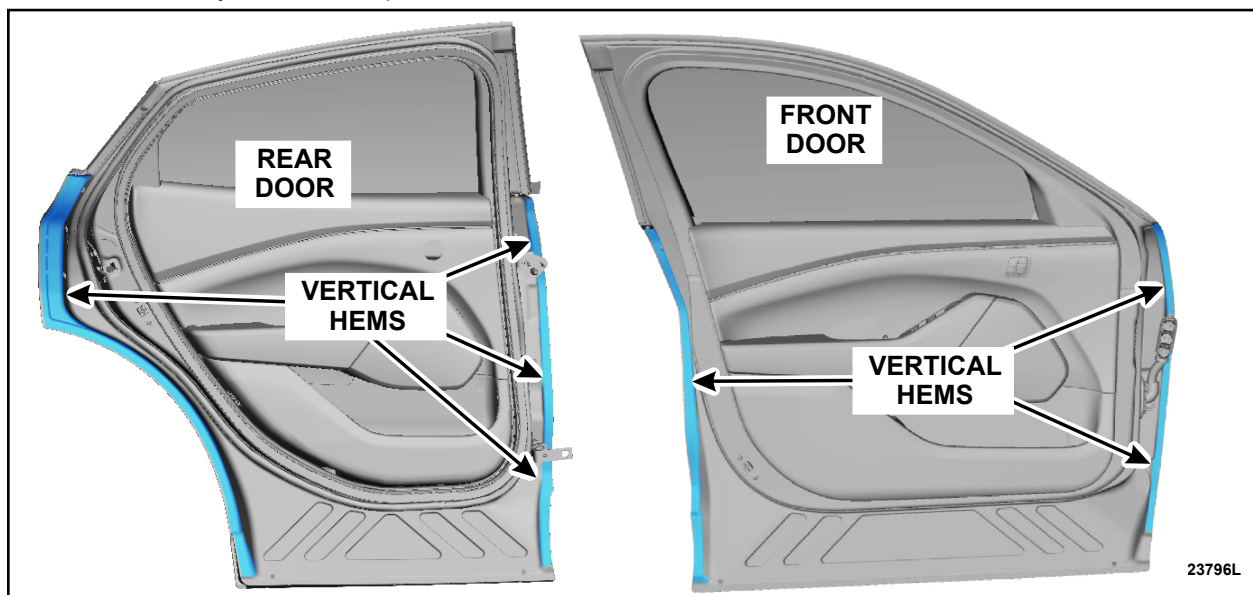
FIGURE 10

4. For door(s) that show evidence of paint sealant issues on the bottom hem, clean the vertical hems. See Figure 10.
5. For door(s) that show evidence of paint sealant issues on the bottom hem, inspect the vertical hem on both sides of the door(s) for paint sealant issues. See Figure 11-18. Were any signs of paint sealant issues present on the vertical hems of the affected door(s)?

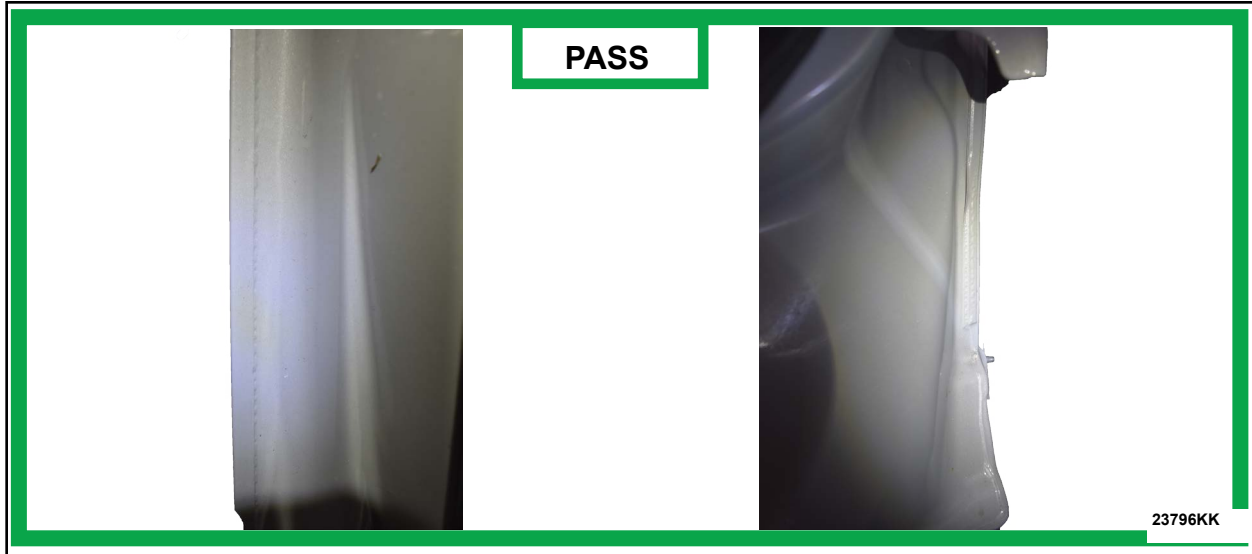
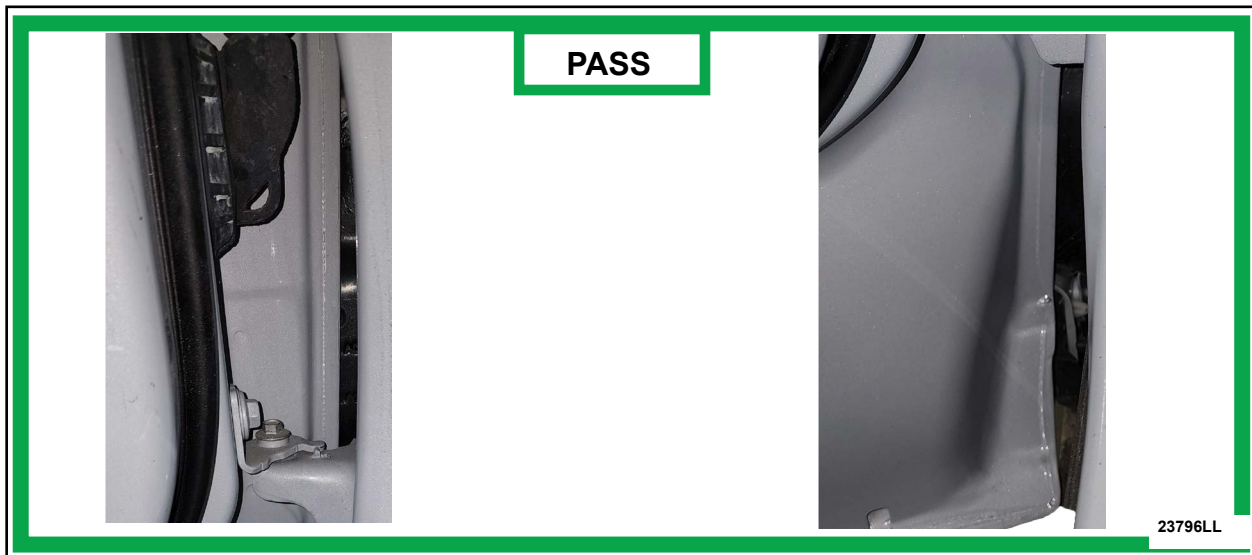
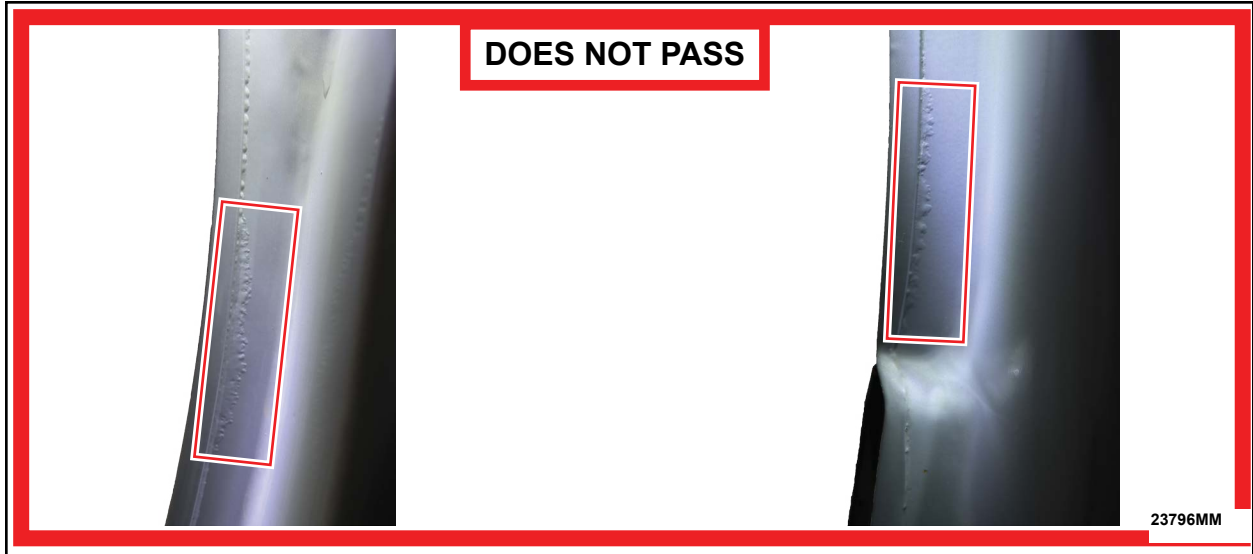
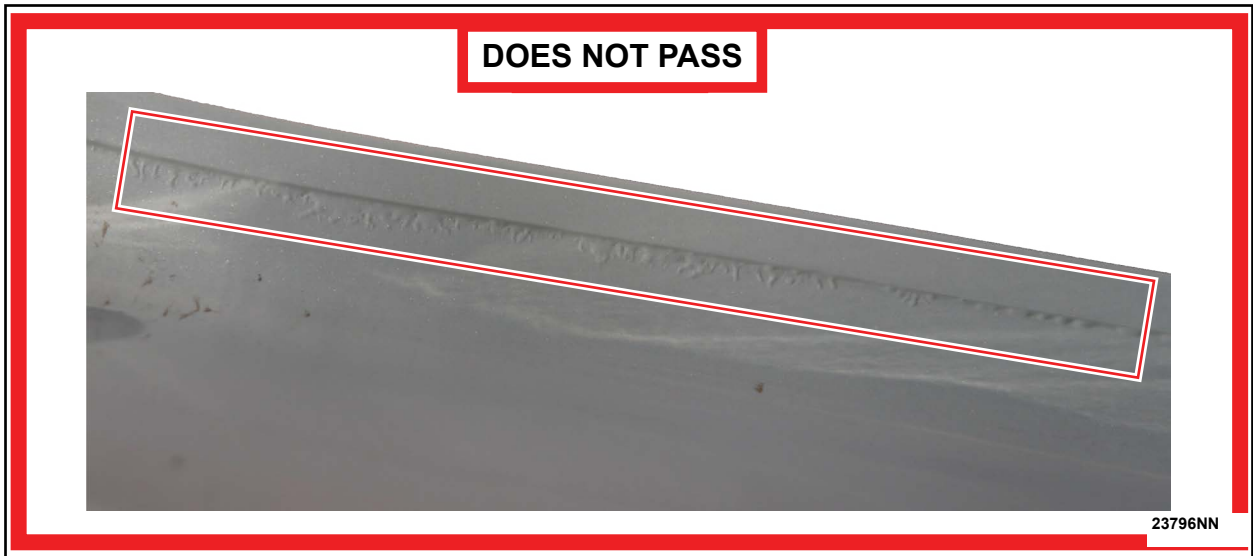
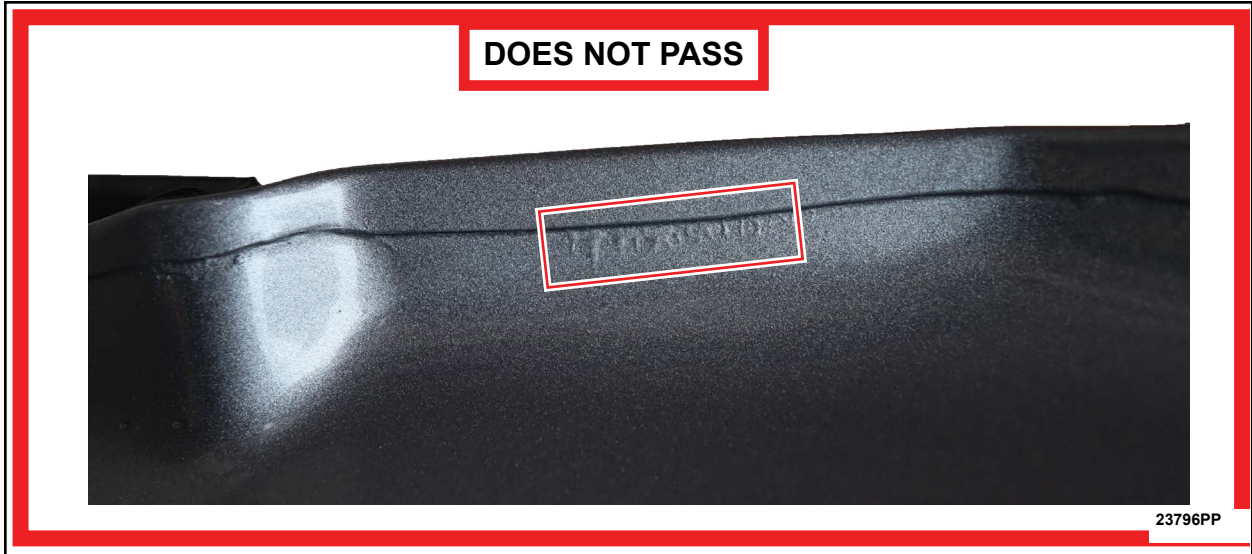
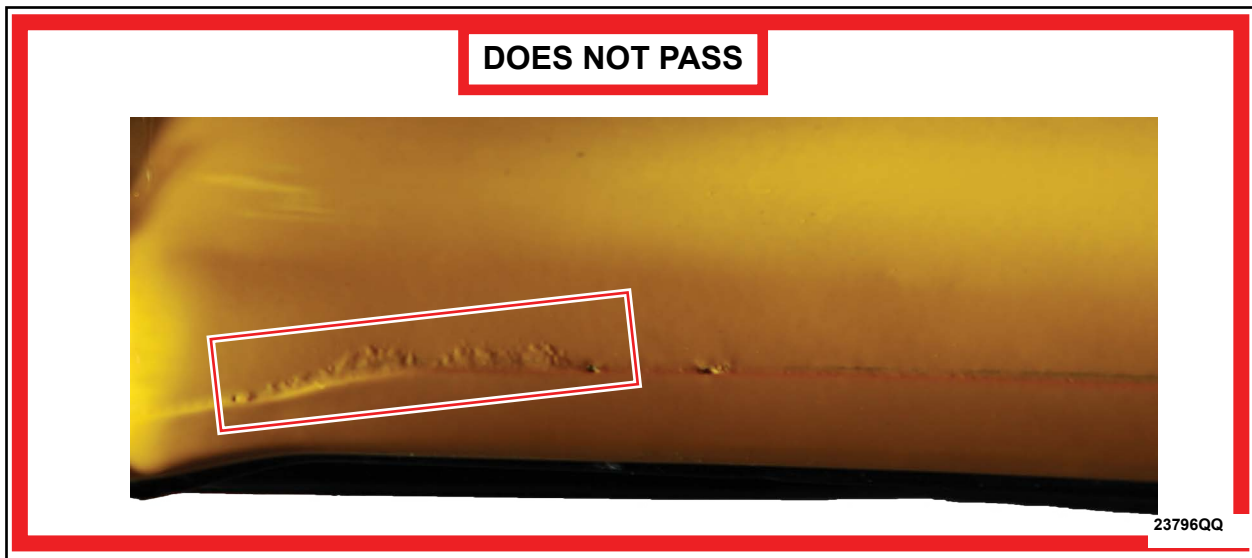
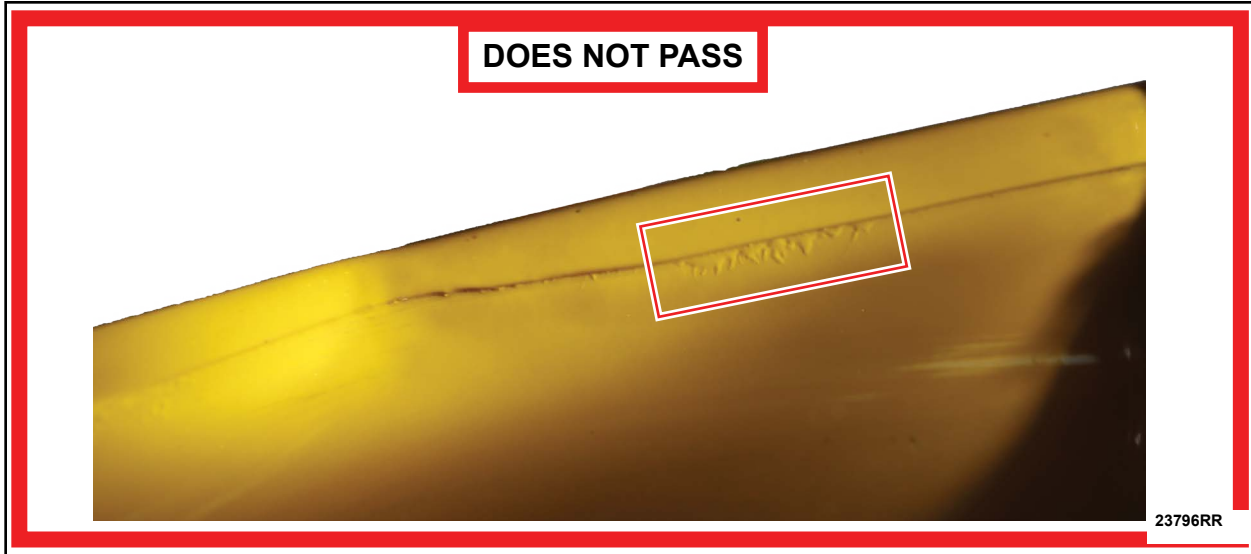
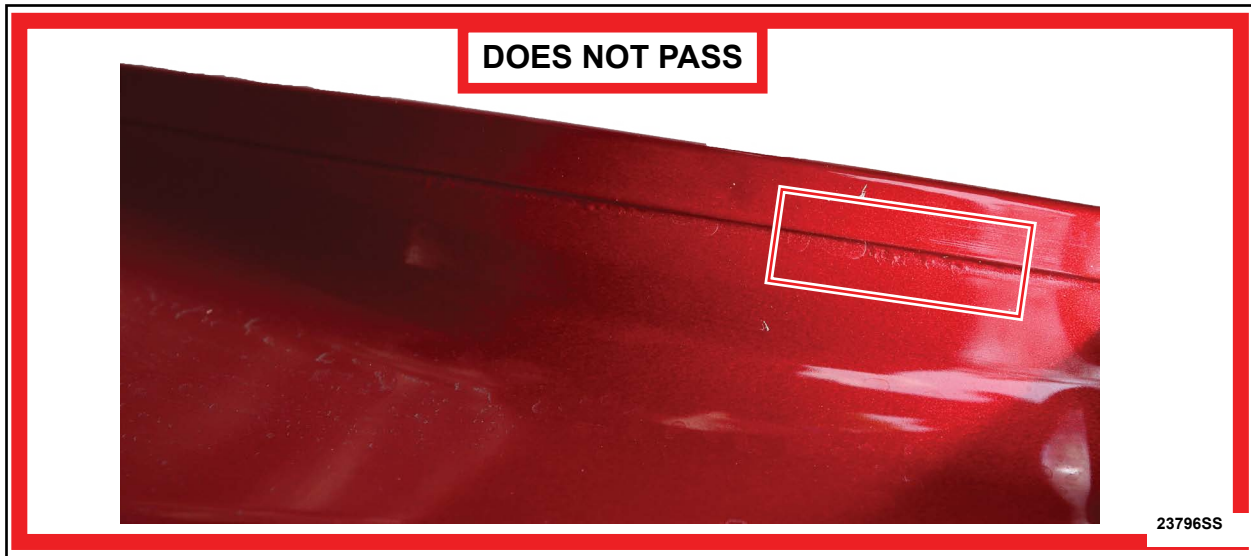
Yes - Submit photos of both the bottom and vertical hems of the doors to the SSSC. Wait for SSSC approval to begin any repairs.

- Be clear, focused and well lit.
- Have each door labeled identifying the position of the door (i.e. Left Front Door).
- Identify whether the photo is of the bottom or vertical hem of the door.

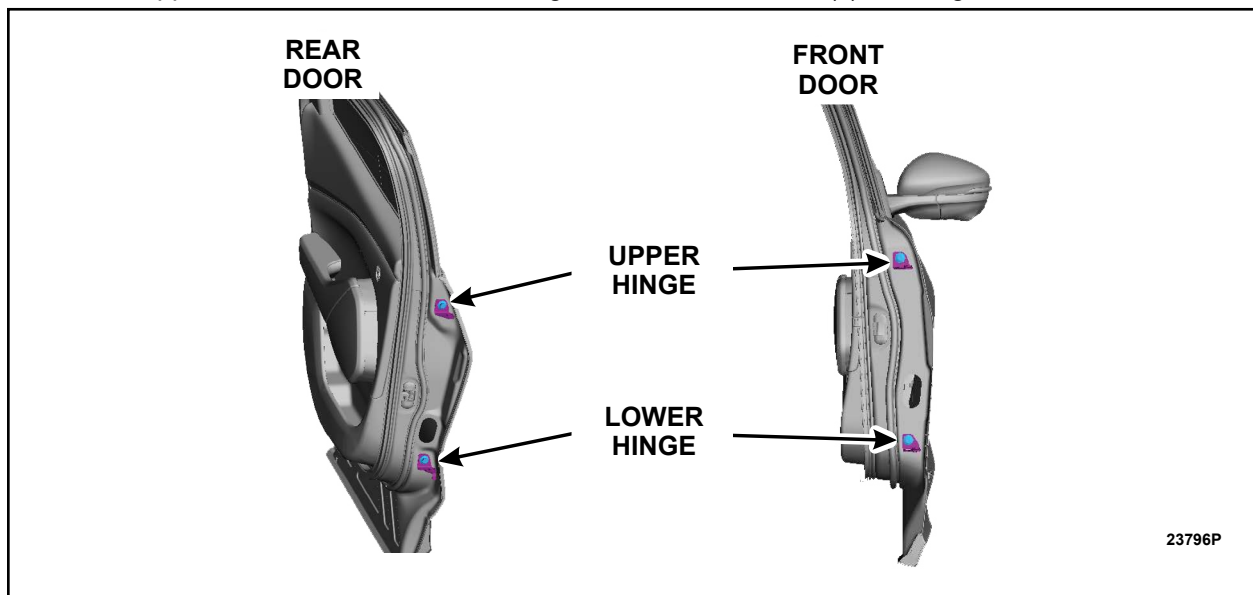
FIGURE 19

8. Remove upper and lower door mounted hinges of the affected door(s). See Figure 19.

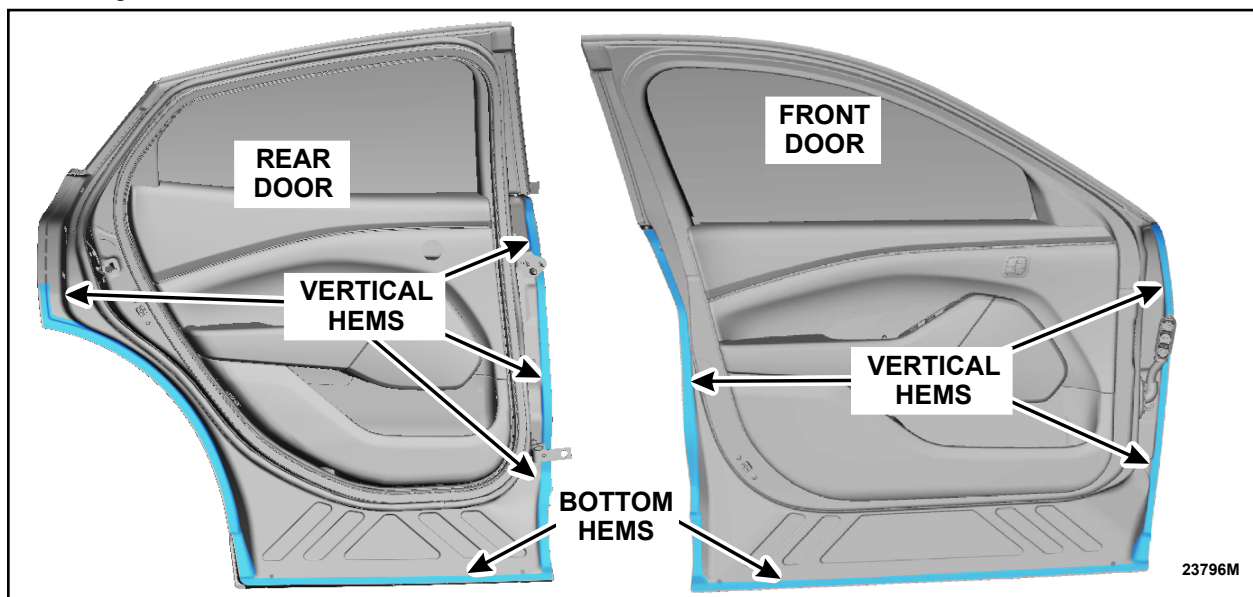
FIGURE 20

1. Mask and cover the affected door(s) to prepare for prime and paint.
2. Using a cleaner/degreaser, clean the wax and grease from the vertical and bottom hems of the affected door(s). See Figure 20.
3. Using a wire wheel, scuff the vertical and bottom hem areas of the affected door(s). See Figure 20.
4. Using a sanding tool, sand the ridge off of the vertical and bottom hem areas of the affected door(s). See Figure 20.

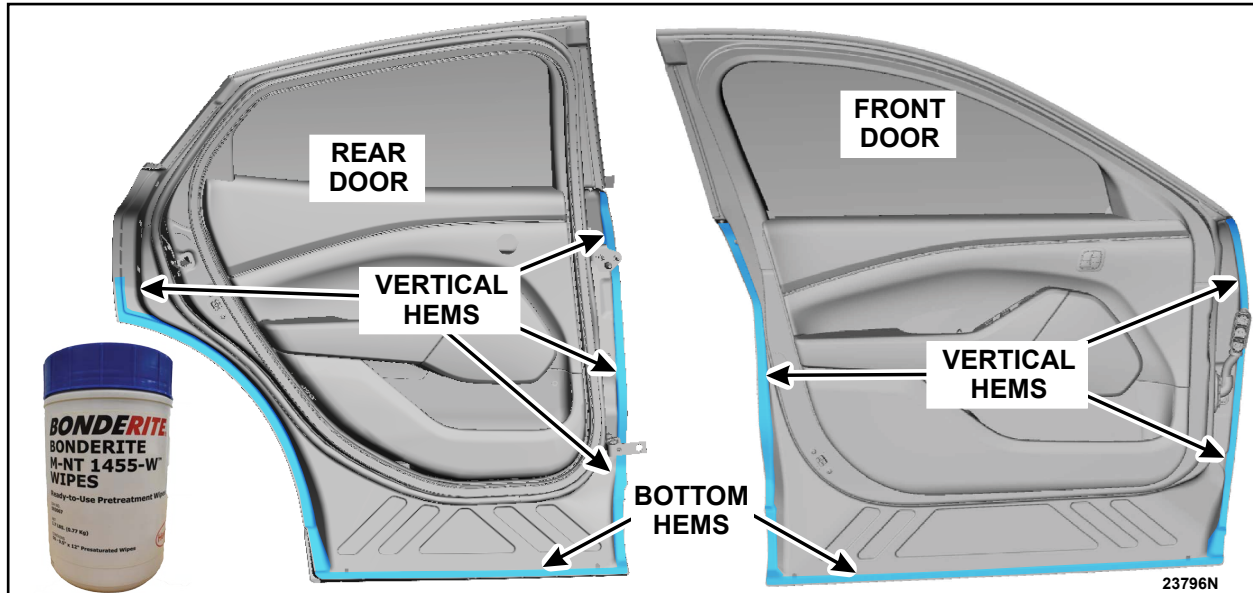
FIGURE 21

5. Remove dust and debris from the affected door(s).
6. Using a cleaner/degreaser, clean the vertical and bottom hem areas of the affected door(s). See Figure 21.
7. Using Bonderite® wipes, prepare the vertical and bottom hem areas of the affected door(s) to be painted by thoroughly cleaning the surfaces that will be primed and painted. See Figure 21.

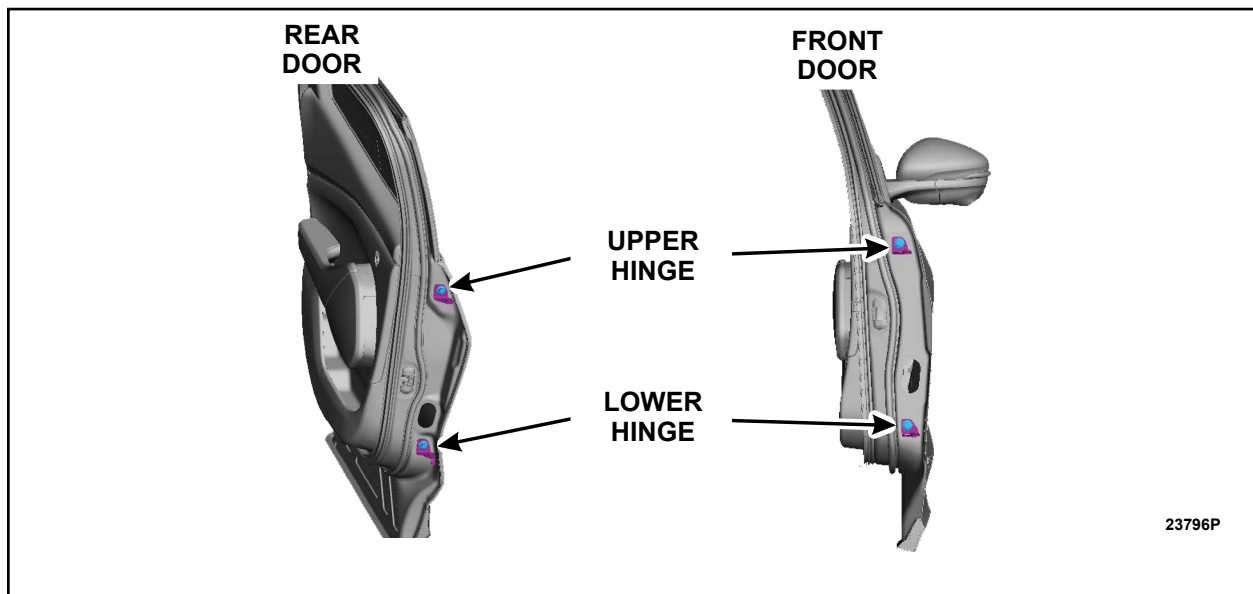
FIGURE 22

8. Following the paint manufacturers prescribed procedure(s), apply epoxy primer to the vertical and bottom hems of the affected door(s).
9. Following the manufacturers prescribed procedure(s), apply seam sealer to the vertical and bottom hems of the affected door(s).
10. Following the paint manufacturers prescribed procedure(s), apply two coats of paint to the vertical and bottom hems of the affected door(s). Allow for sufficient dry time between coats.
11. Following the paint manufacturers prescribed procedure(s), apply clear coat to the vertical and bottom hems of the affected door(s).
12. Remove tape and coverings from the affected door(s).
13. Install the upper and lower door mounted hinges of the affected door(s). See Figure 22.

- Torque: 35 lb.ft (48 Nm)

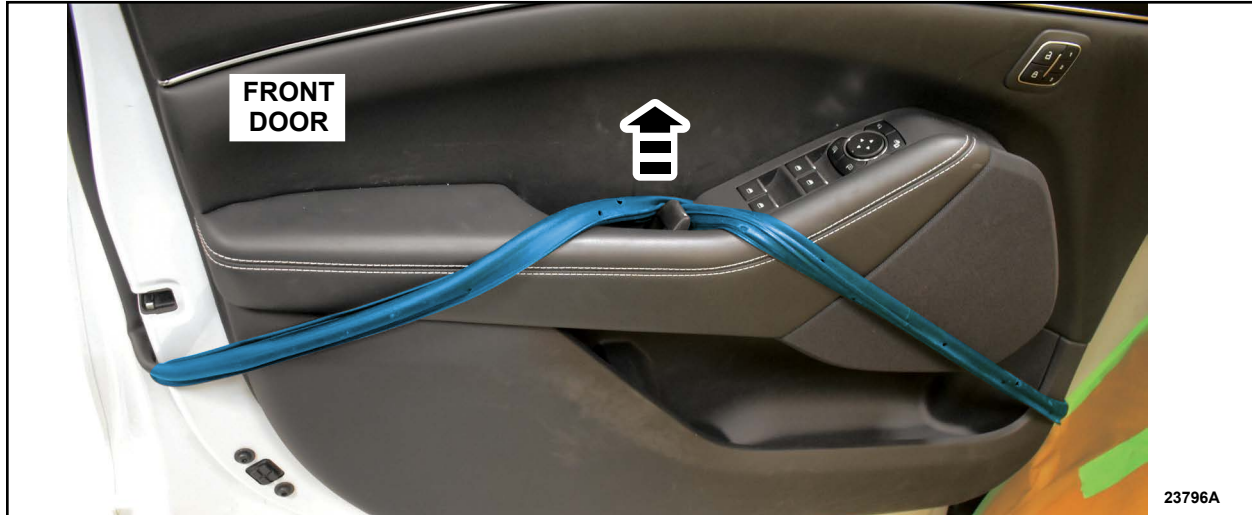
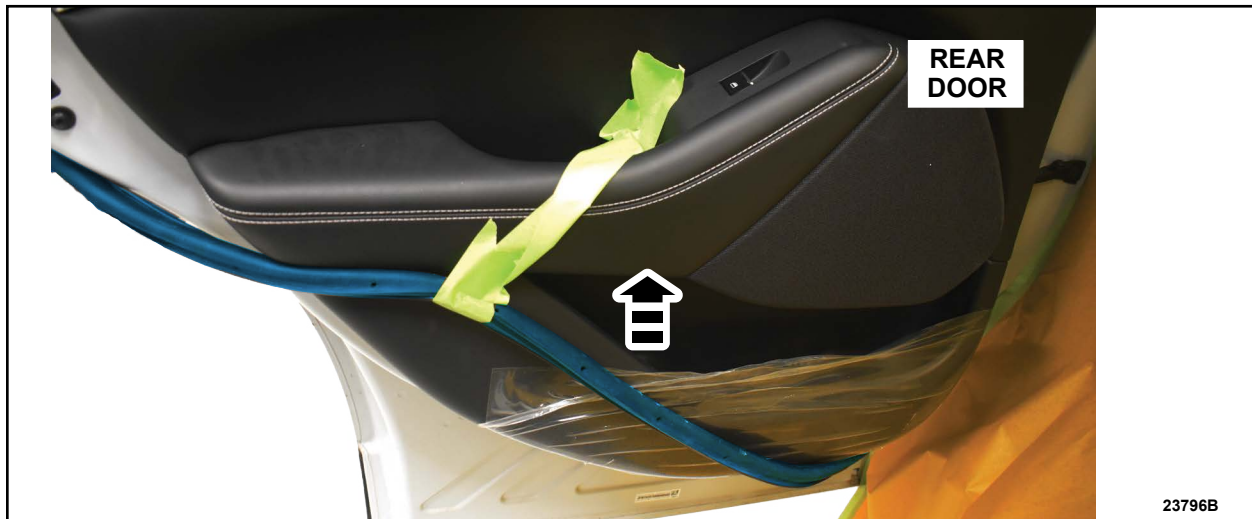
1. Position door seal(s) aside on affected door(s). See Figure 23 and 24.

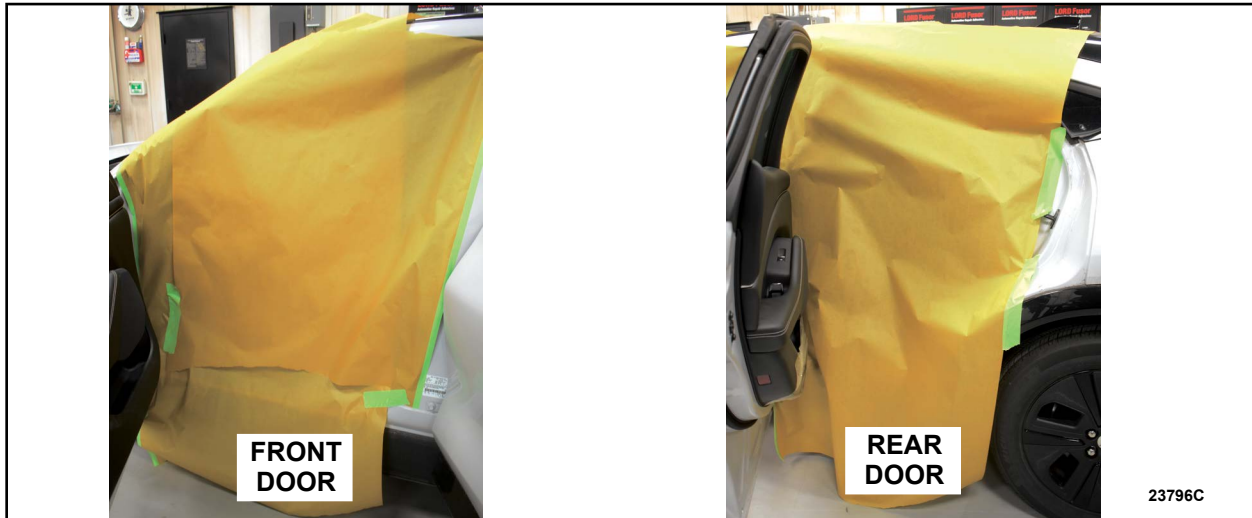
FIGURE 25

2. Cover the door opening(s) on the affected door(s) to avoid dust and debris from getting inside the vehicle. See Figure 25.

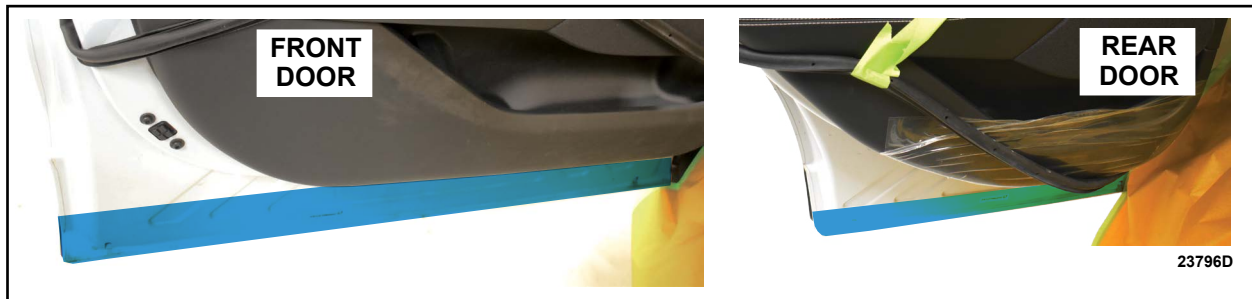
FIGURE 26

3. Using a cleaner/degreaser, clean the wax and grease from the bottom of the affected door(s). See Figure 26.

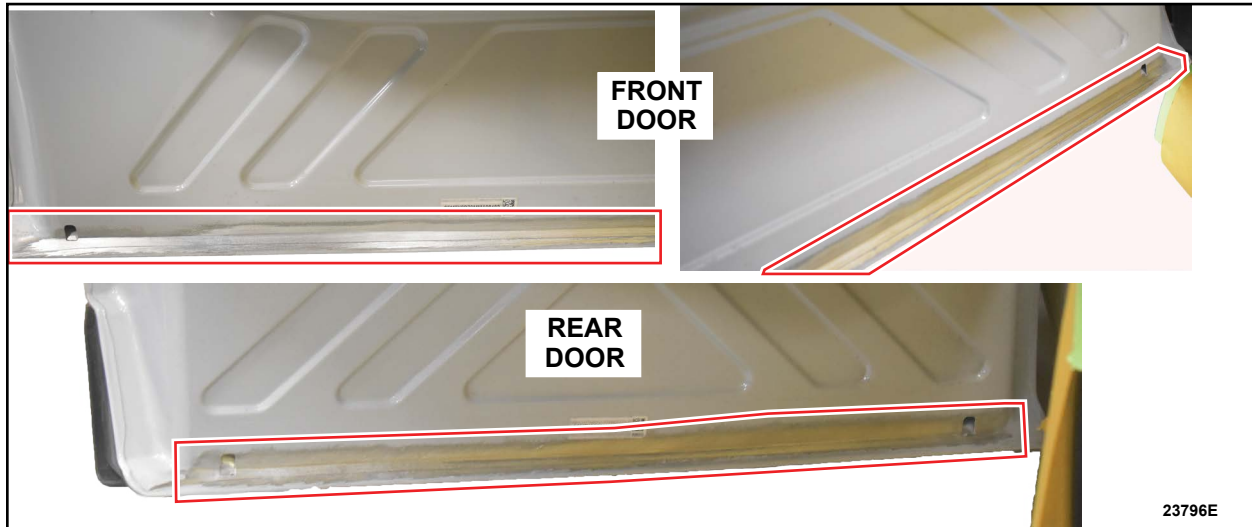
FIGURE 27

4. Using a wire wheel, scuff the bottoms of the affected door(s). See Figure 27.

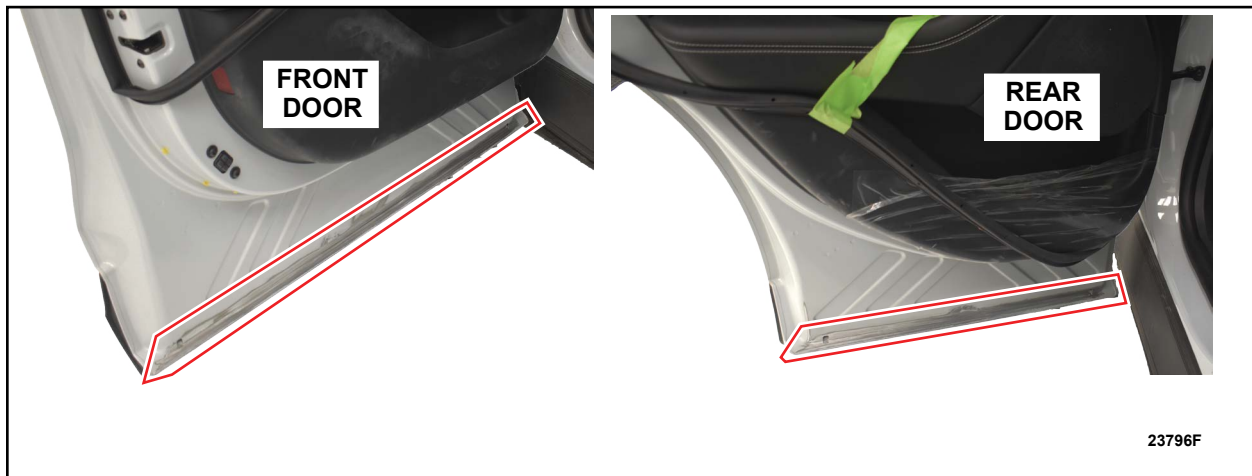
FIGURE 28

5. Using a sanding tool, sand the ridge off all the affected door(s). See Figure 28.

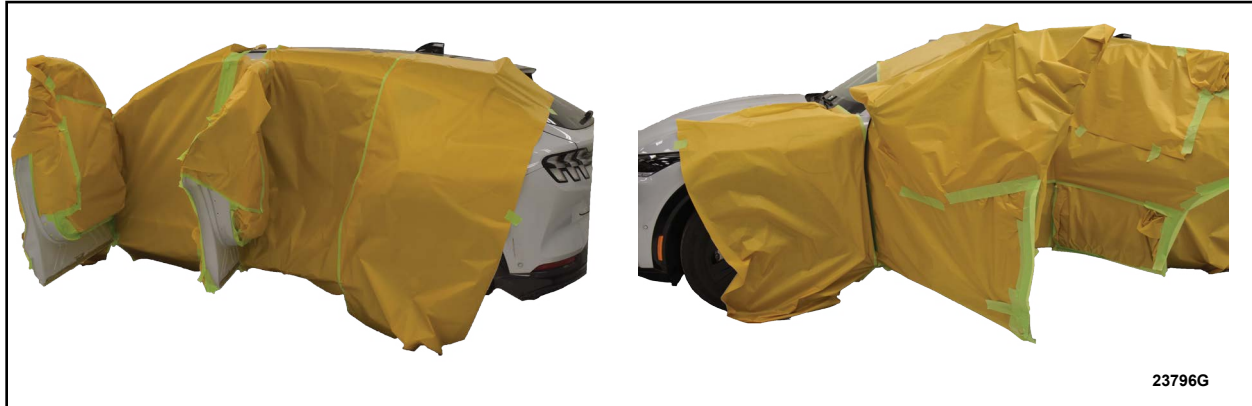
FIGURE 29

7. Tape and cover the affected door(s) to prepare for prime and paint. See Figure 29.

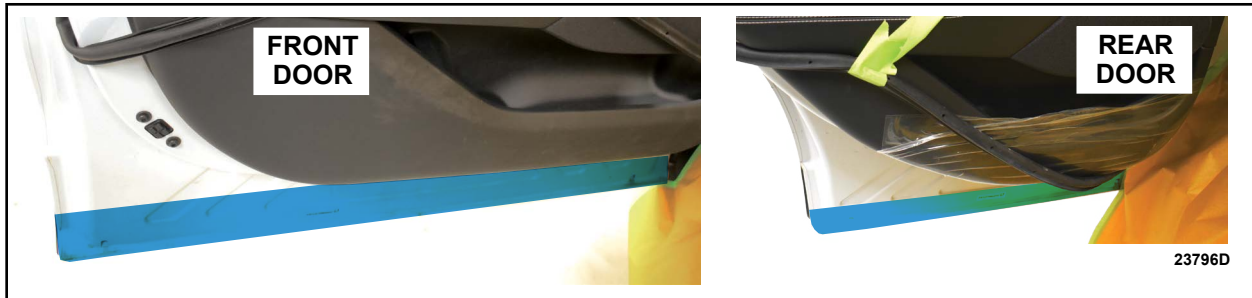
FIGURE 30

8. Using a cleaner/degreaser, clean the wax and grease from the bottom of the affected door(s). See Figure 30.

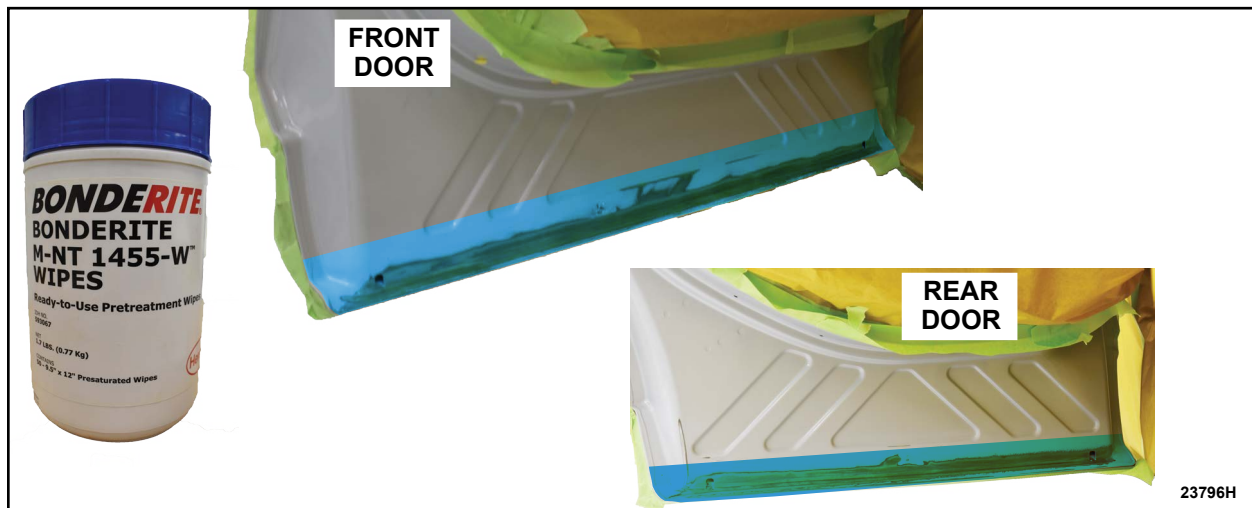
FIGURE 31

9. Using Bonderite® wipes, prepare the areas to be painted by thoroughly cleaning the surfaces that will be primed and painted. See Figure 31.

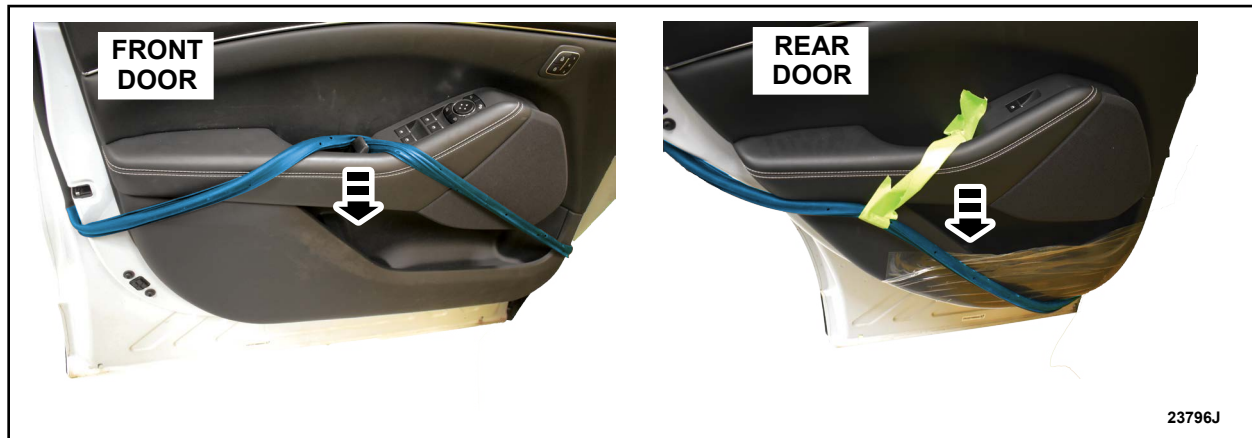
FIGURE 32

10. Following the paint manufacturer's prescribed procedure(s), apply epoxy primer to the affected door(s), in the affected areas.
11. Following manufacturers prescribed procedure(s), apply seam sealer to the affected door(s), in the affected areas.
12. Following the paint manufacturers prescribed procedures apply two coats of paint to the affected door(s), in the affected areas. Allow for sufficient dry time between coats.
13. Following the paint manufacturers prescribed procedure, apply clear coat to the affected door(s), in the affected areas.
14. Remove tape and coverings from the affected door(s).
15. Position back seals on the affected door(s). See Figure 32.
