CERTAIN 2024-2025 MODEL YEAR MUSTANG MACH-E VEHICLES — ANTENNA PLATE FILM REMOVAL

SERVICE PROCEDURE

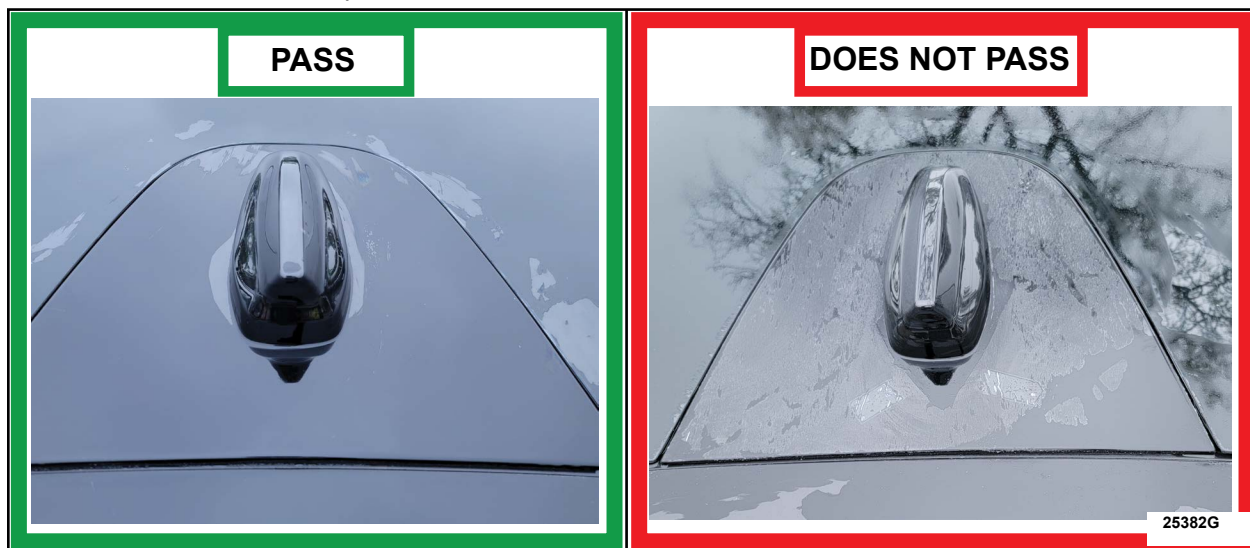
FIGURE 1

1. Inspect the antenna plate for the presence of film. See Figure 1.

2. Vehicle was previously inspected during PDI, and there is still film residue present on the antenna plate. See Figure 1.

3. Does the antenna plate film remove easily?

Yes - Passes Inspection. This FSA is complete.

No - Does not pass inspection. Continue to Step 4.

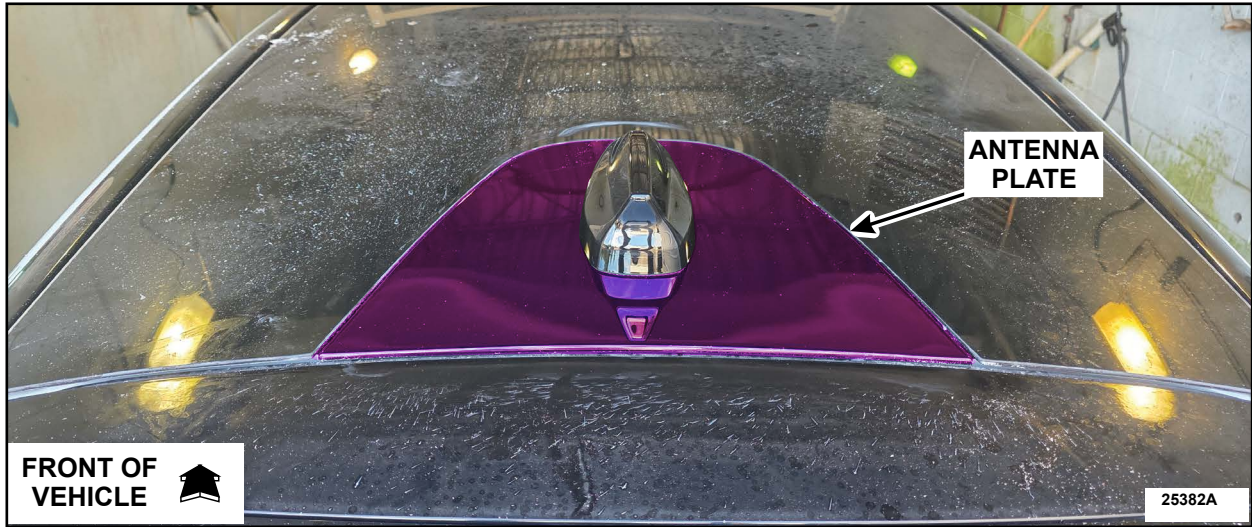
FIGURE 2

8. Spray the antenna plate with Isopropyl Alcohol and wipe with a paper towel. See Figure 2.

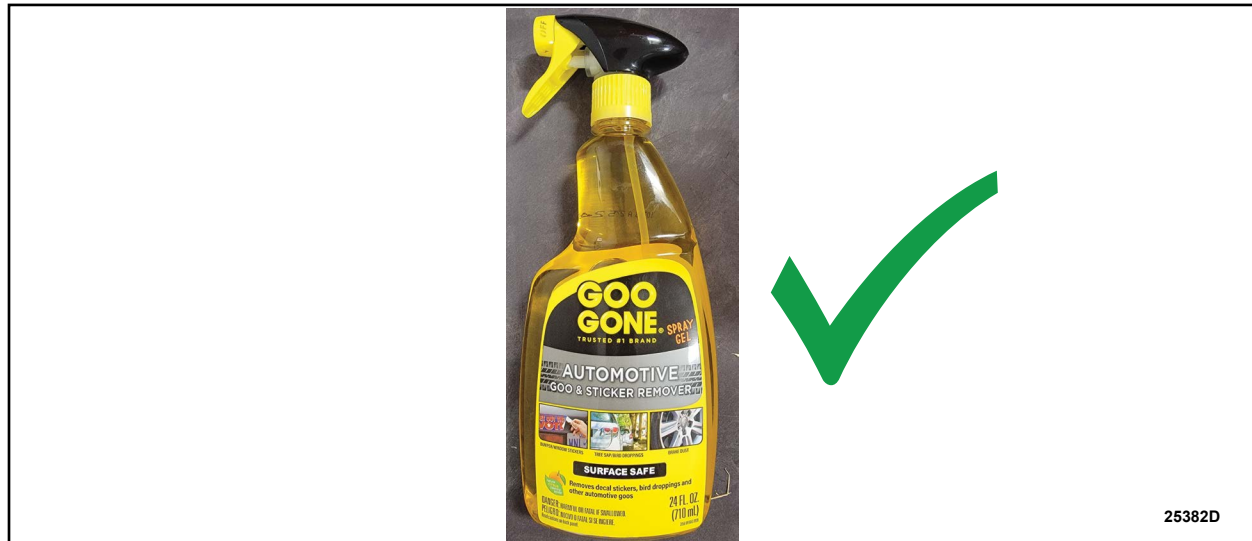
FIGURE 3

9. Using the Automotive Goo Gone, spray generous amounts over the antenna plate area. See Figure 3.

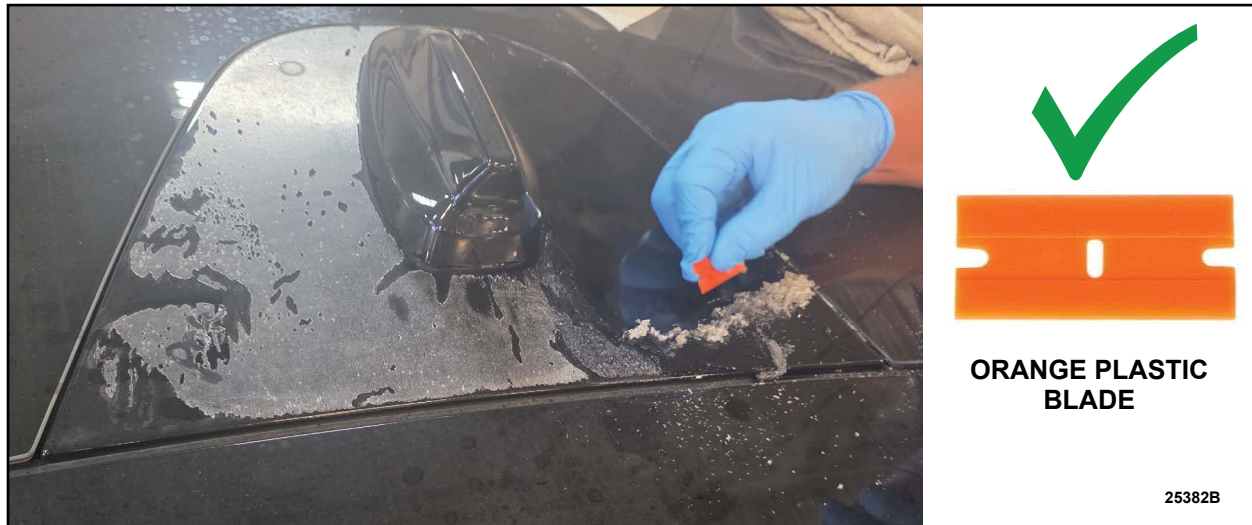
FIGURE 4

10. Using the orange plastic blade, scrape off the film residue by starting at one corner and working your way around the antenna plate. Continue to spray the antenna plate with the Automotive Goo Gone as necessary. See Figure 4.

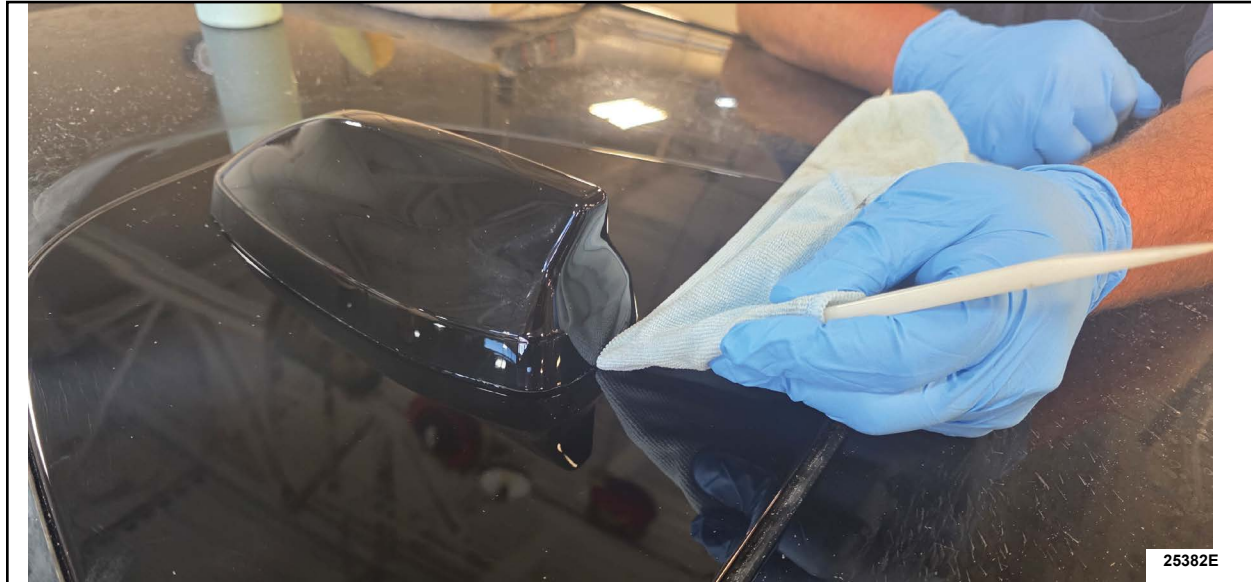
FIGURE 5

16. Using a Q-tip, plastic trim tool covered with a clean rag, or similar tool, clean any remaining polishing compound that may be present between the antenna and antenna plate, and between the antenna plate and body. See figures 5 and 6.
