## TECHNICAL SERVICE BULLETIN

### Parking Brake Fault Service Now Message In IPC - DTCs C2008, C2007,C1034, U0293 And/Or U0100 - Built On Or Before 15-Mar-2022

22-2143

Ford 2021-2022 Mustang Mach-E	Built on or before 15-Mar-2022
----------------------------------	--------------------------------

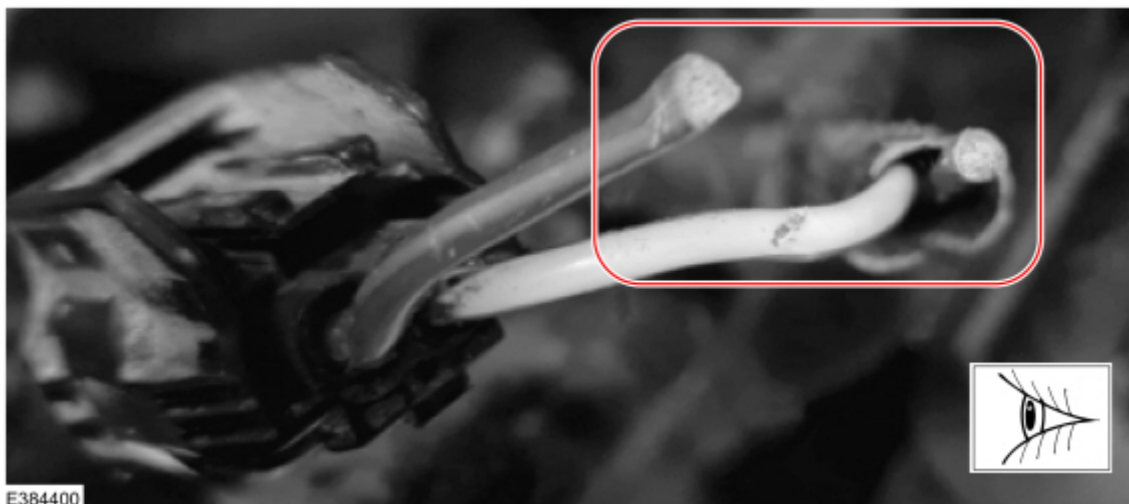
Figure 1

**Issue:** Some 2021-2022 Mustang Mach-E vehicles built on or before 15-Mar-2022 may exhibit a Parking Brake Fault Service Now message in the instrument panel cluster (IPC) and DTCs C2007, C2008, C1034, U0293 and/or U0100 in the anti-lock brake system (ABS) module. This may be due to an open/corroded circuit near the rear brake caliper. To correct the condition, follow the Service Procedure to replace the electronic parking brake (EPB) connector.

1. Remove both rear tires. Refer to Workshop Manual (WSM), Section 204-04A.
2. Remove the tape and the conduit on the wiring harness to both the left/right rear brake calipers.
3. Inspect the wiring for damage or open circuit. Is there a damaged or open circuit? (Figure 1)
  - (1). Yes - proceed to Step 4.
  - (2). No - proceed to Step 9.
